CONSERVATION MANAGEMENT PLAN 2017

REPAIR, RESTORATION AND CONSERVATION OF THE JOHANNESBURG ART GALLERY, JOUBERT PARK

Prepared by
JONATHAN STONE ARCHITECT

OCTOBER 2017
JHB ART GALLERY CMP03.wpd

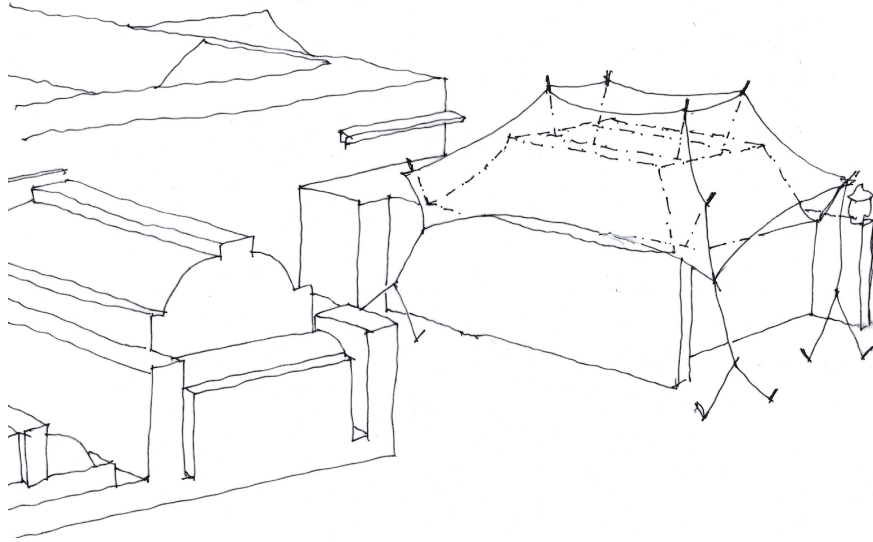
Fig 2: Temporary emergency roof to South West wing

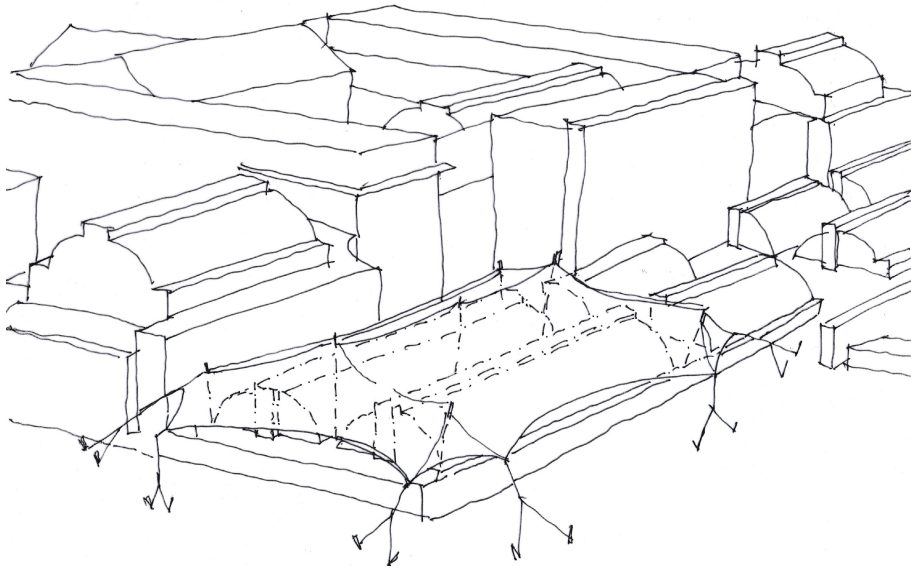
Fig 3: Temporary emergency roof to north east Gallery / store

- 10.1.2 THE NORTH EAST SEMI-BASEMENT GALLERY / STORE (MEYER PIENAAR).
- 10.1.2.1 This area is substantially water damaged. In particular the drywall partitions and screens as well as the service gondolas and dropped skim coated ceilings and bulkheads. The floor to this have a power floated granolithic finish and apart from surface cracks and some staining appear intact. In areas where a lino floor has been laid, this has been damaged and must be replaced.

- 10.1.2.3 There is no point in repairing or restoring the internal finishes until the barrel vaulted roof / box gutter problem is eliminated. We have proposed elsewhere that this can be done by replacing the present roof system with one of far simpler design. This will also allow for a more flexible and appropriate use of the space below for both exhibitions, installations and storage.
