# HARNESSING HERITAGE TO EMPOWER PEOPLE IN THE WAKE OF DISASTER

The rescue restoration of the  
historic town centre of Wupperthal Mission Station  
Cedarberg, South Africa  
2019-2021

Graham Jacobs

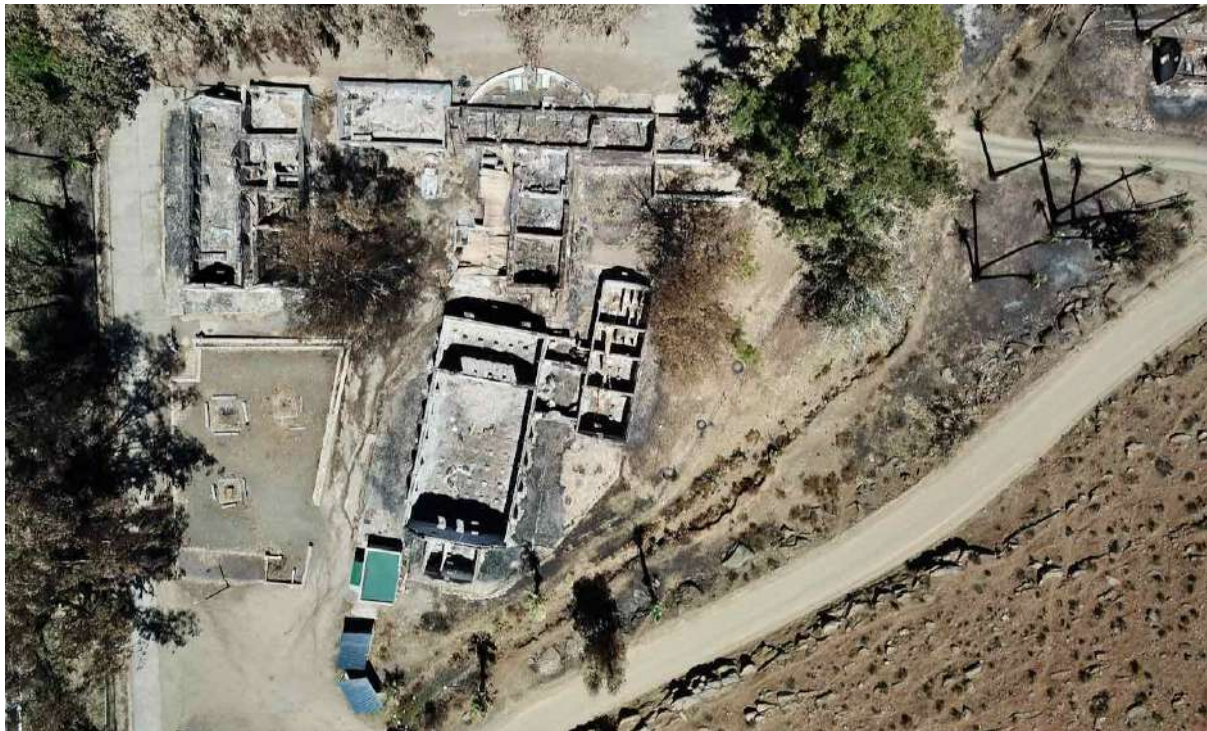
**FIGURE 1:** *Aerial view showing the gutted state of some of the buildings in the town centre after the fire. Top centre are the remains of Leipoldt House with its T-shaped plan and semicircular stoep. To the left are the remains of the old Mission Stores building, the first school building in the settlement. Below are the remains of the Community Hall. The Old Blacksmith's Shop (Smitswinkel) where wagon wheels were repaired after a torturous trip down the mountain pass is just visible on the extreme upper right. The latter was the first building to be gutted in the fire. The road on the bottom right enters Wupperthal from the pass. (Drone image: Goal Zero Consulting).*

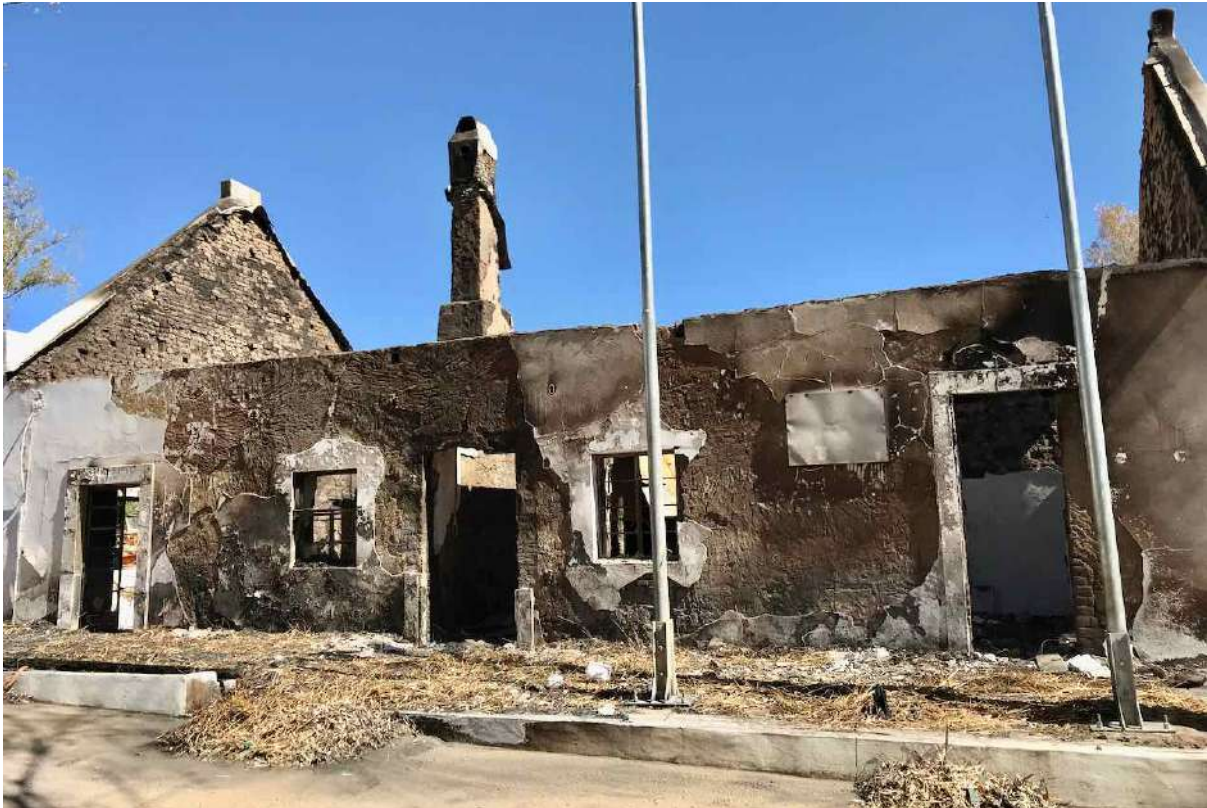
**FIGURE 4:** *The fire gutted 'Winkelhuis' (Shopkeeper's House) after the fire. The building had been the administration headquarters for the town before the fire. This image is typical of the degree of damage sustained. (Image: ARCON, 24 January 2019).*

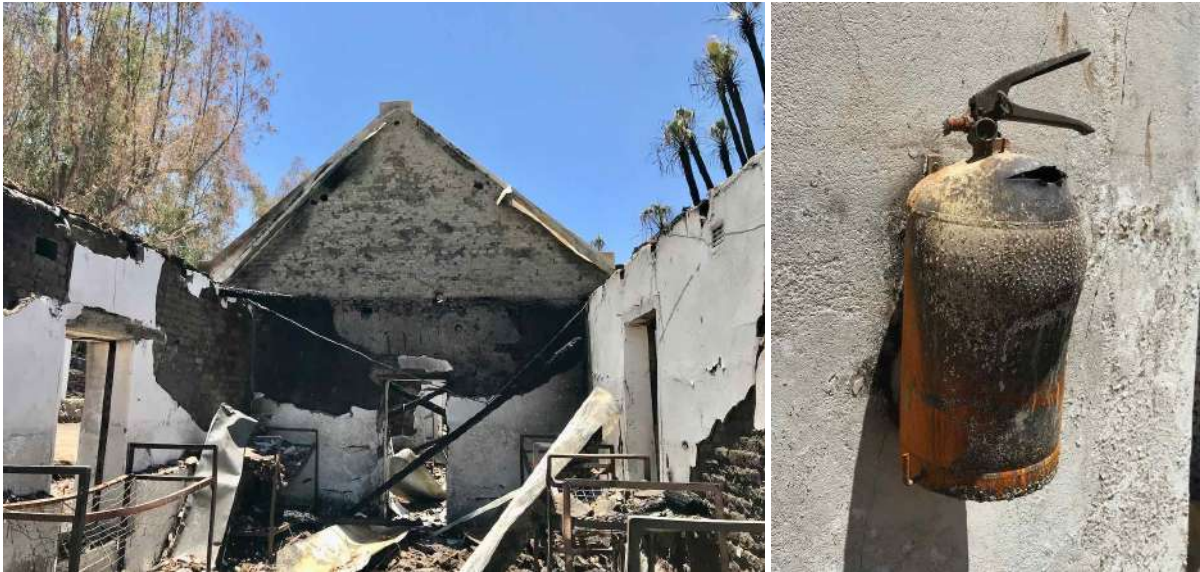
**FIGURE 6:** *Left: One of the gutted school hostels littered with mangled bed frames and building debris. Right: The fire spread so rapidly that the fire extinguishers could not be used. This example was left to explode on its wall bracket. (Image: ARCON, 24 January 2019).*

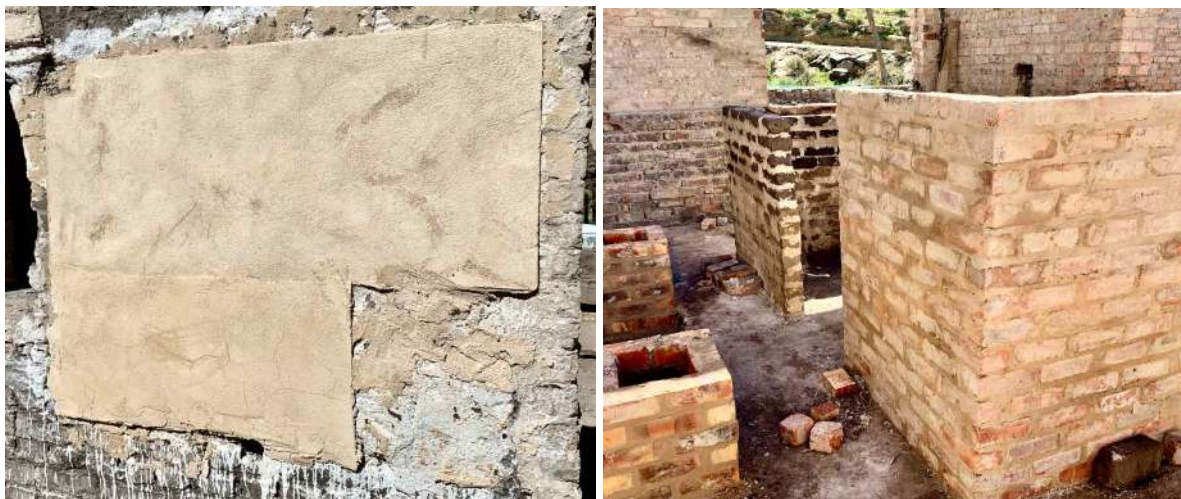
**FIGURE 8:** *Trial panels using lime/sand mixes for plastering and laying brickwork. Left: Two separate lime plaster panels experimenting with water proportions. The shrinkage cracks in the lower panel show that too much water was added. Right: Trial samples of brick walls constructed using exclusively lime/sand mortars to convince an initially skeptical contractor that such lime mortars without Portland cement would be structurally sound. The wall in the foreground is constructed using modern fired bricks. The darker wall in the background experiments with bricks recovered from the fire damaged ruins. (Image: ARCON, 30 August 2019).*

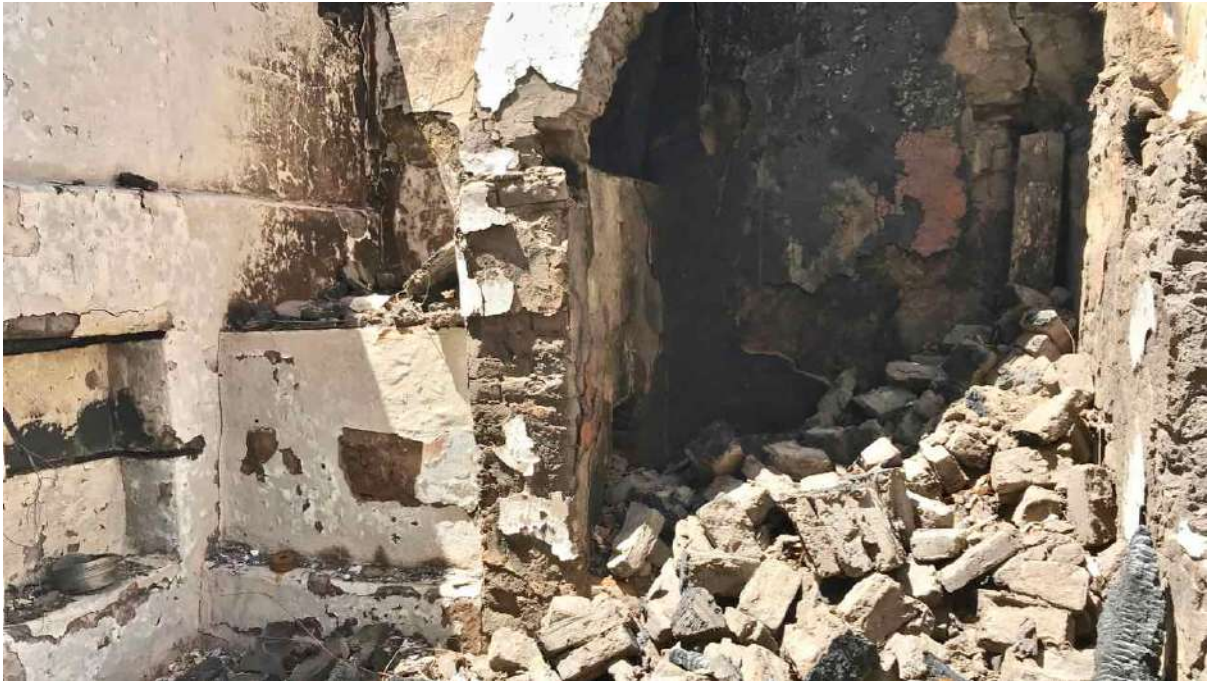
**FIGURE 10C:** *The kitchen hearth of Leipoldt House after the fire which collapsed after the supporting bressumer beam burned through.* (Image: ARCON, 24 January 2019).

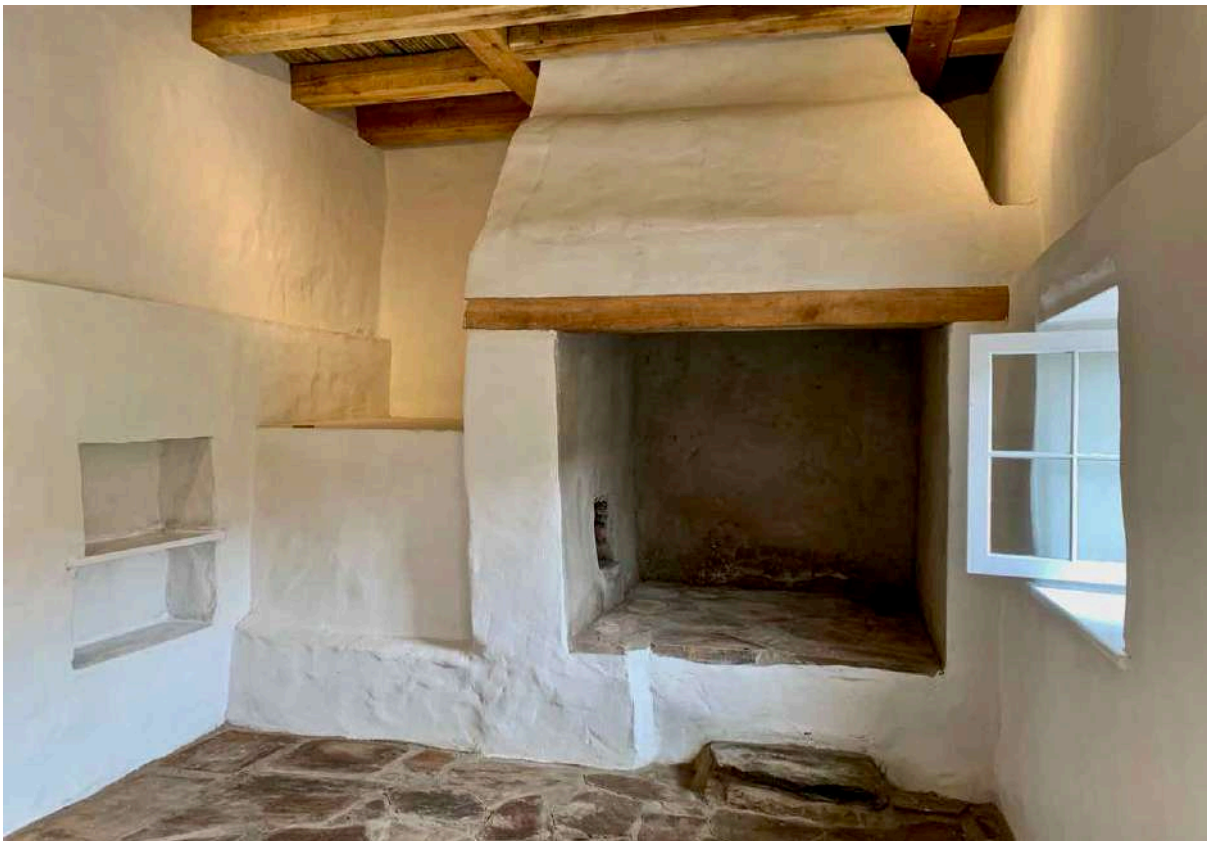
**FIGURE 10D:** *The kitchen of Leipoldt House after restoration and reconstruction of the hearth flue.* (Image: ARCON, 1 September 2020).

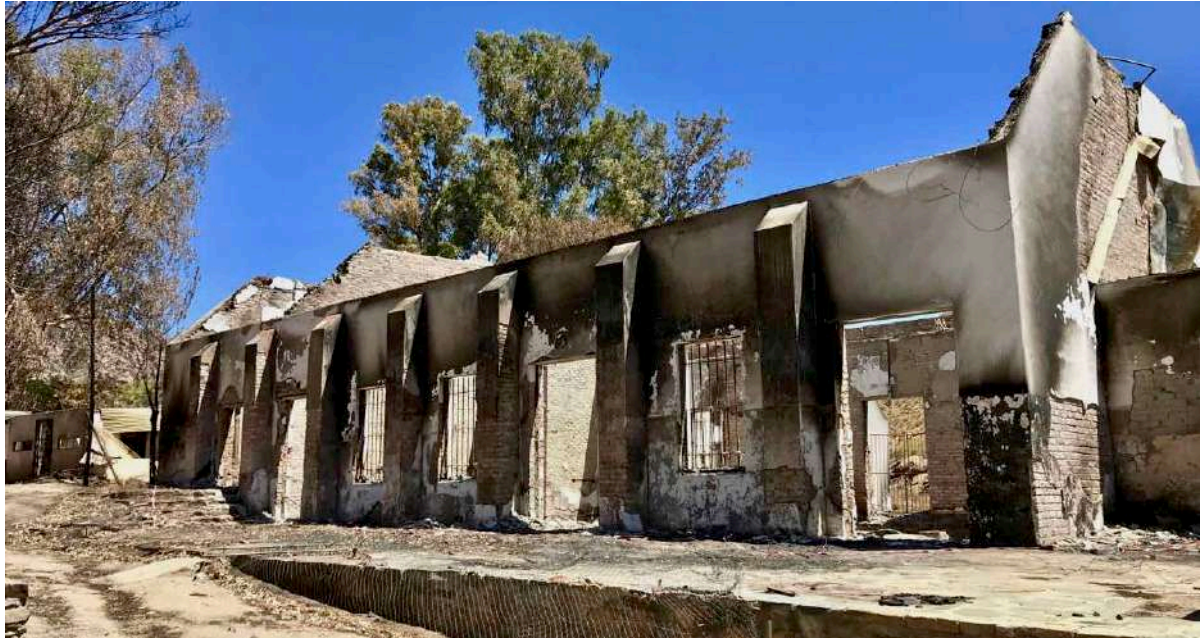
**FIGURE 11A:** *Exterior of the Community Hall after the fire.* (Image: ARCON, 24 January 2019).

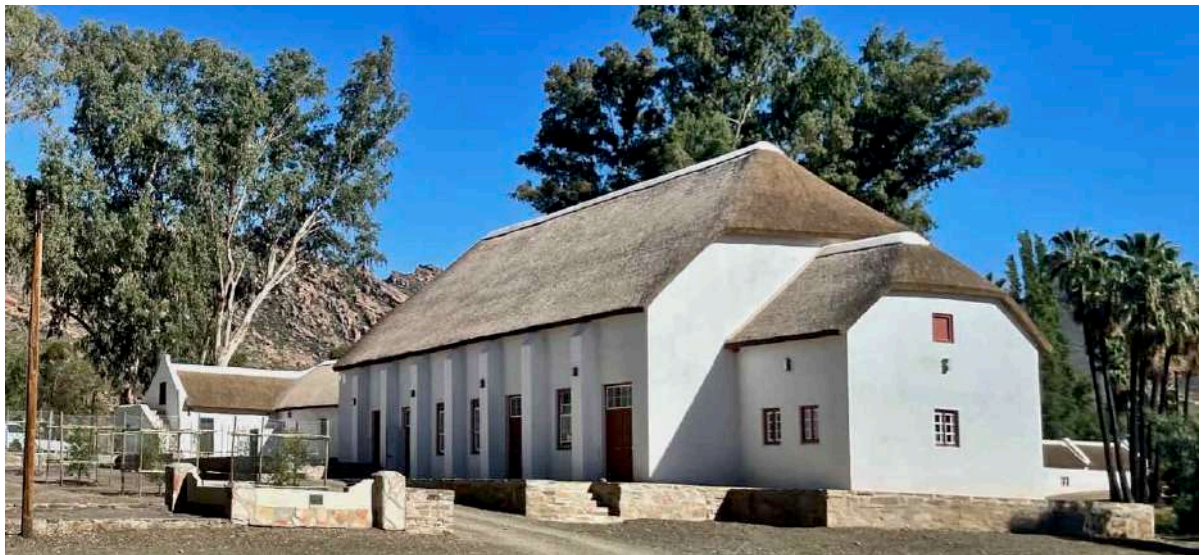
**FIGURE 11B:** *Exterior of the Community Hall after restoration.* The small addition in the foreground replaces an earlier cement brick addition that stored the brass band's instruments, and suffered bad structural cracking in the fire. It had to be totally reconstructed because of the damage sustained to its cement brick walls. The walls and buttresses of the main hall were able to be retained. The building is relatively recent, having been constructed in 1980. It was designed by renowned architects Revel Fox & Pnrs. (Image: ARCON, 8 June 2021).

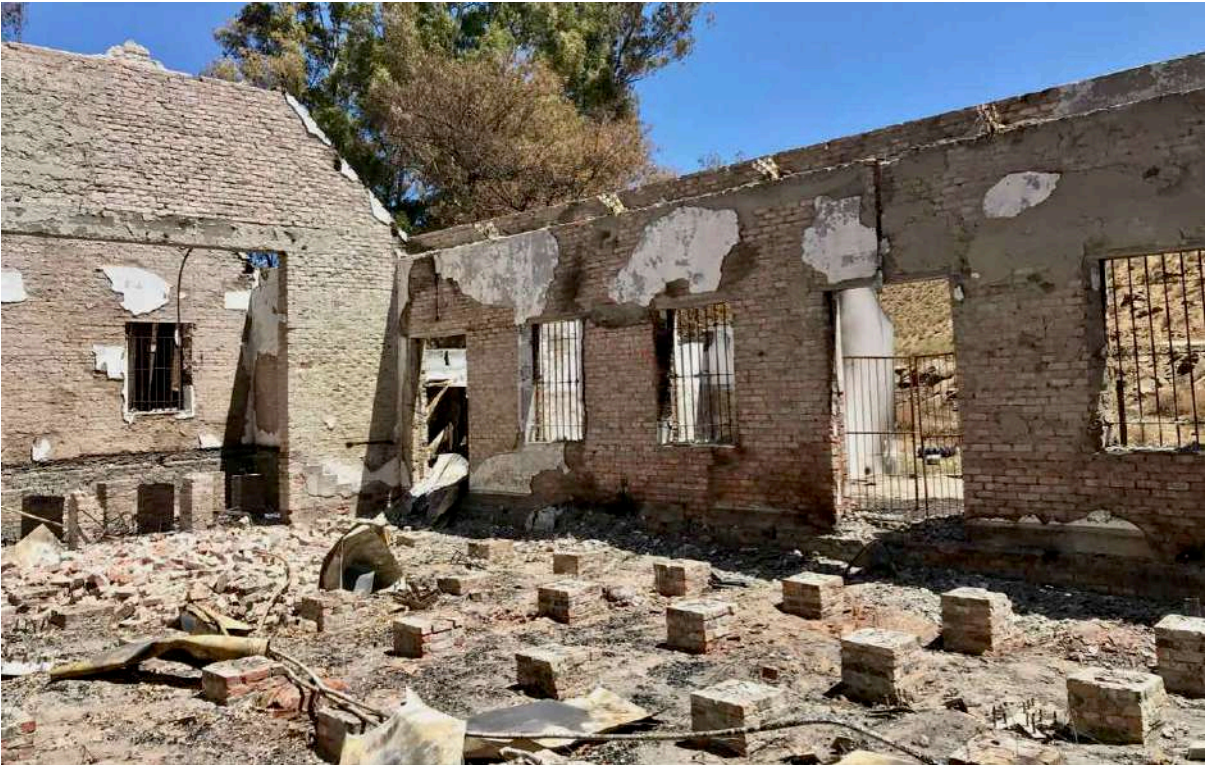
**FIGURE 11C:** *Gutted interior of the Community Hall after the fire.* (Image: ARCON, 24 January 2019).

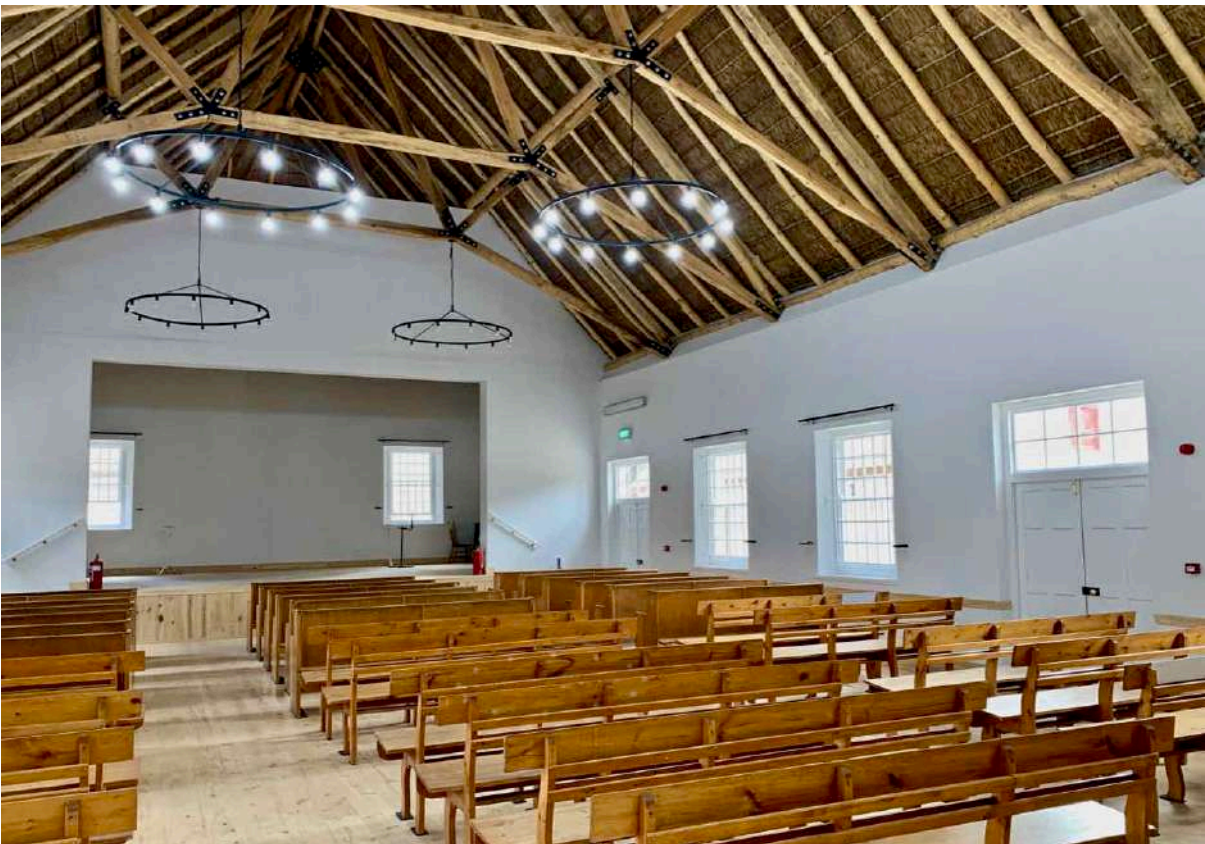
**FIGURE 11D:** *The interior of the Community Hall after restoration was practically complete. The roof trusses are a more rustic re-design of the destroyed originals, which had been made of uniformly turned members. The simple chandeliers were specially designed for the interior.* (Image: ARCON, 9 July 2020).

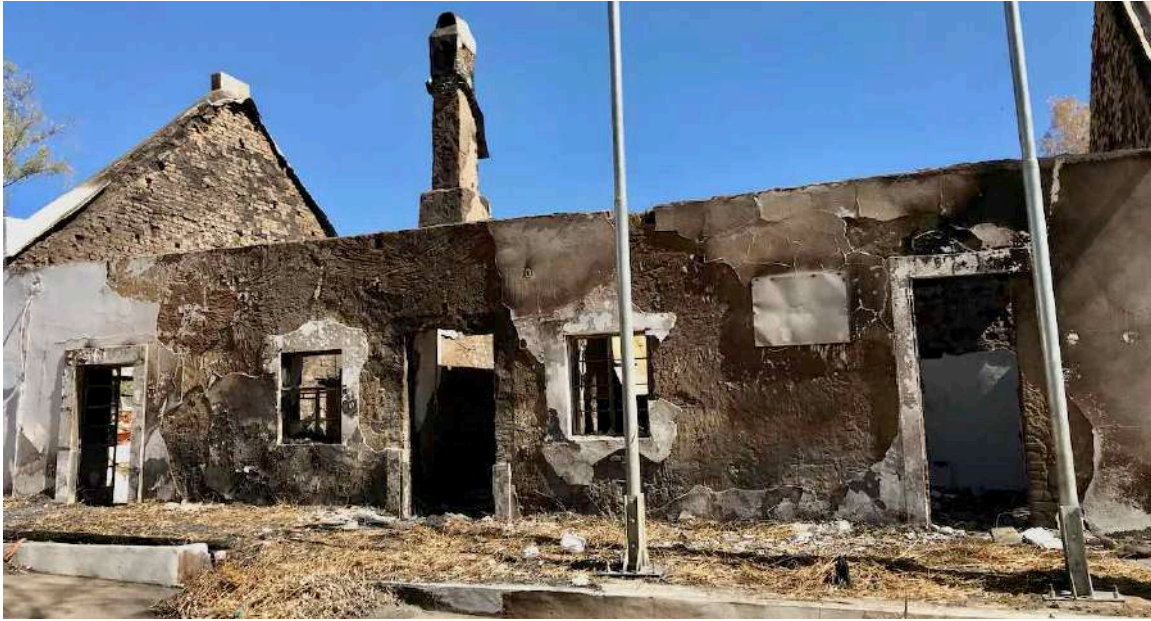
**FIGURE 15A:** *The front façade of the Winkelhuis after the fire. This was one of the buildings initially considered particularly dangerous with various large wall cracks. However, on closer examination, it was found that the cracks pre-dated the fire. (Image: ARCON, 23 March 2021).*

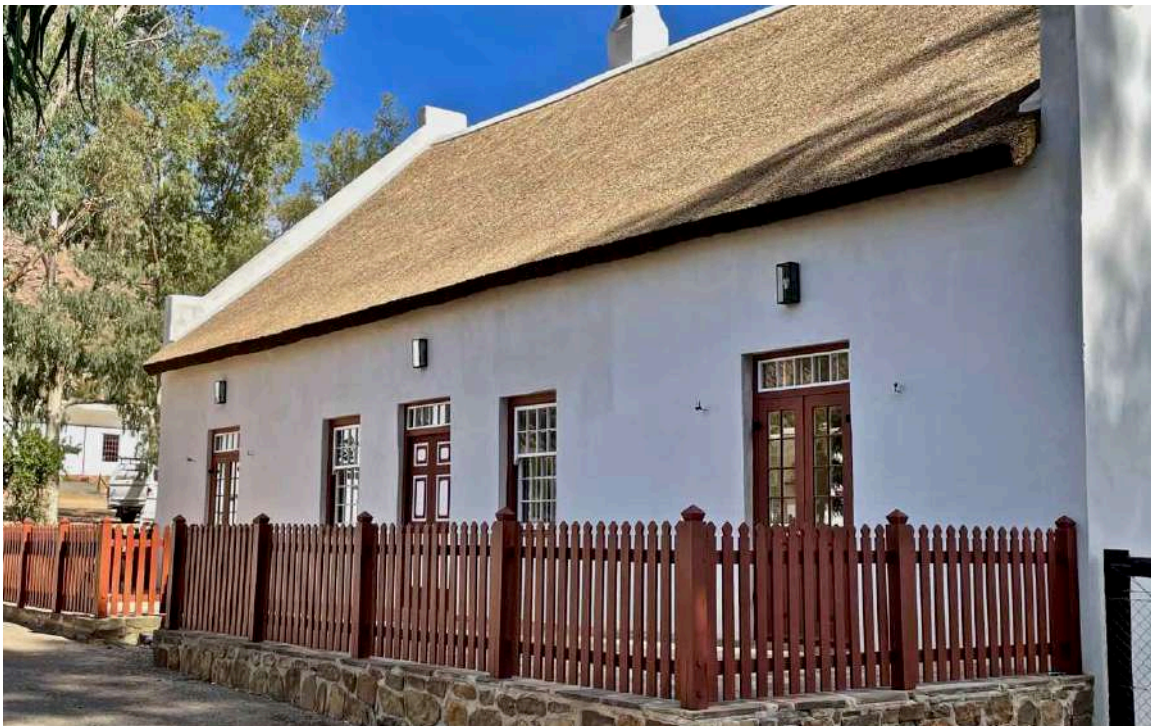
**FIGURE 15B:** *The Winkelhuis front façade after restoration. (Image: ARCON, 9 March 2021).*

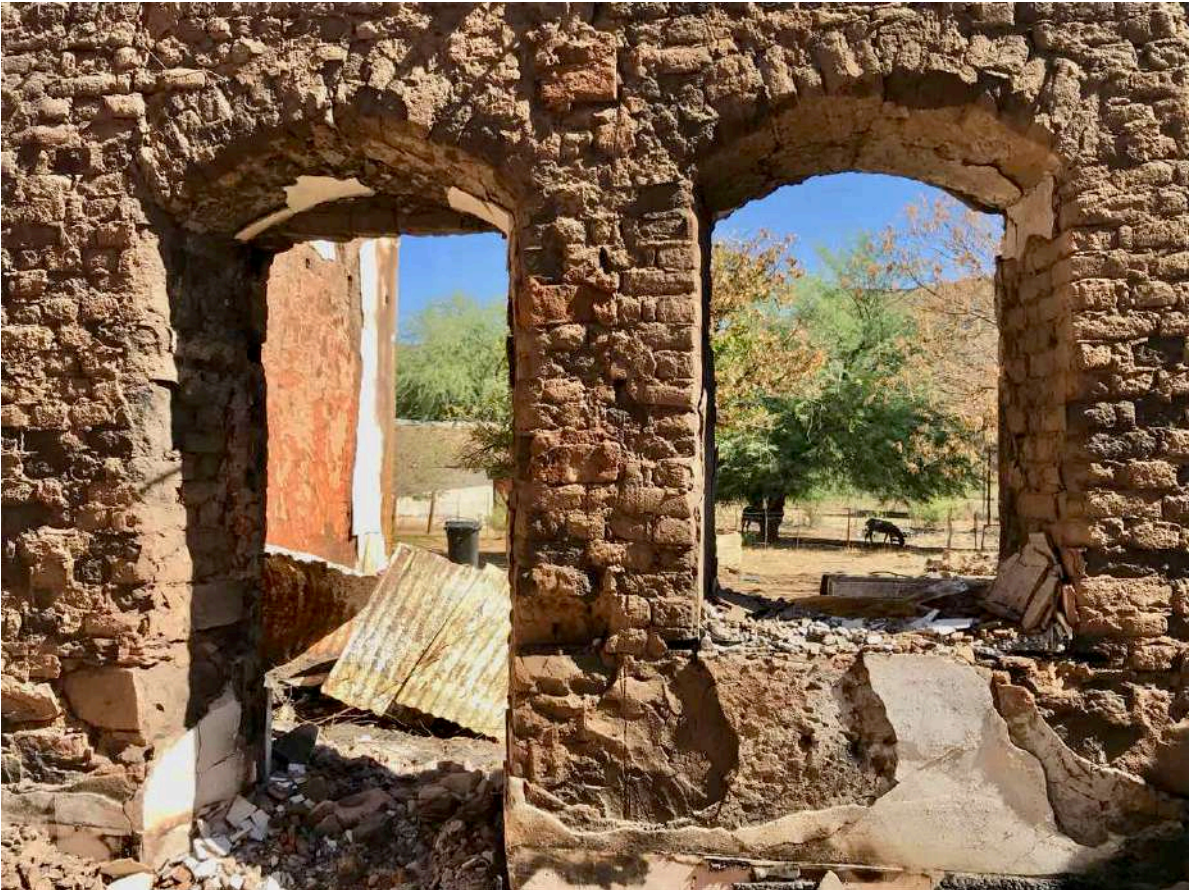
**FIGURE 15C:** *From the lounge interior of the Winkelhuis looking through to the back garden after the fire.* (Image: ARCON, 24 January 2019).

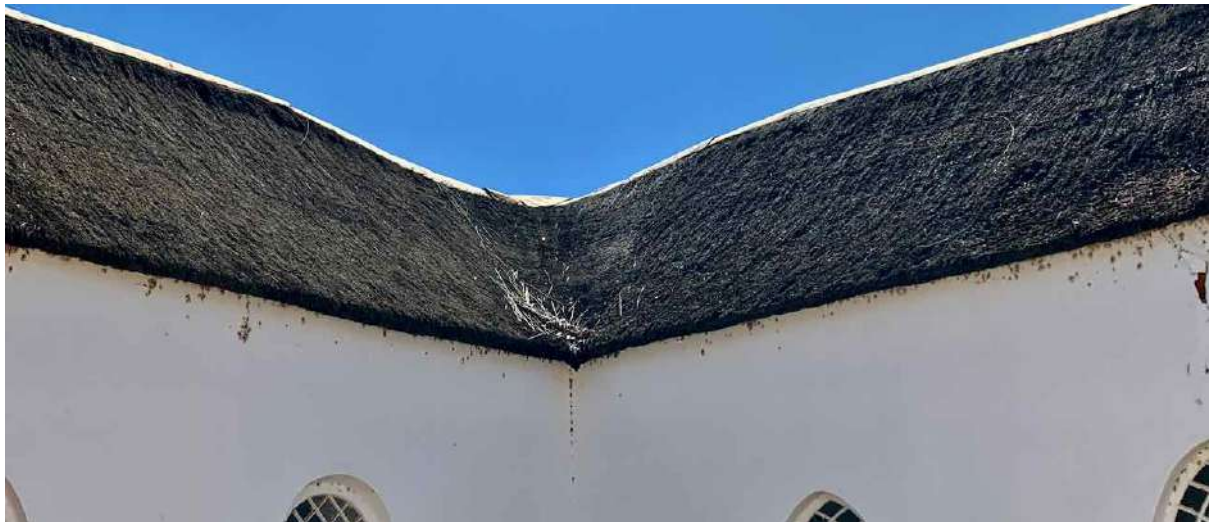
The church building, inaugurated in 1835 by the Rhenish missionaries, was found to have a structurally poor roof. The Foundation therefore generously decided to broaden the project brief, leading to the entire re-roofing of the building despite it not having sustained fire damage. Carpenter's marks on one of the ceiling ribs (**Figure 16C**) show the ceiling to have been a later addition. It was found that the original installation had involved the cutting away of diagonal trusses between the nave and transept, presumably because those trusses would have extended below the new vault line. That resulted in a badly weakened roof at the intersection between nave and transept, and was on the point of collapse. The roof consequently had to be strengthened with new trusses placed between the old, effectively becoming a new roof structure. The building was then fully re-thatched.

**FIGURE 16A:** *View of the thatch roof of the church before reconstruction. The roof was in very poor condition and in a state of near collapse between nave and transept. (Image: ARCON, 1 Nov. 2019).*

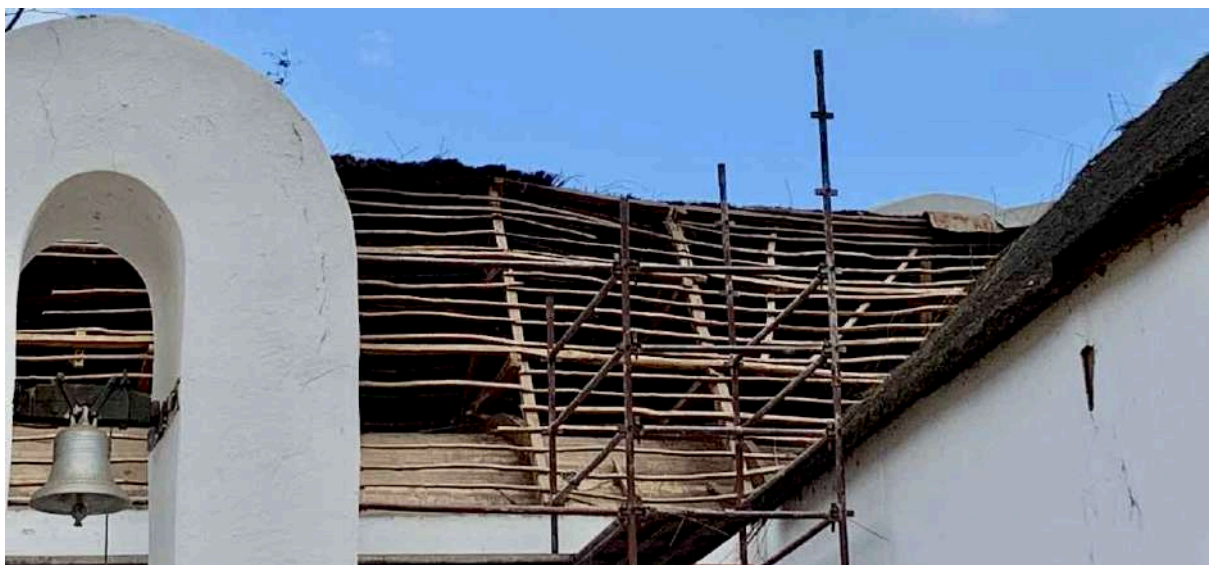
**FIGURE 16B:** *The roof with thatch removed showing the very poor condition of the roof timbers. (Image: ARCON, 1 Nov. 2019).*

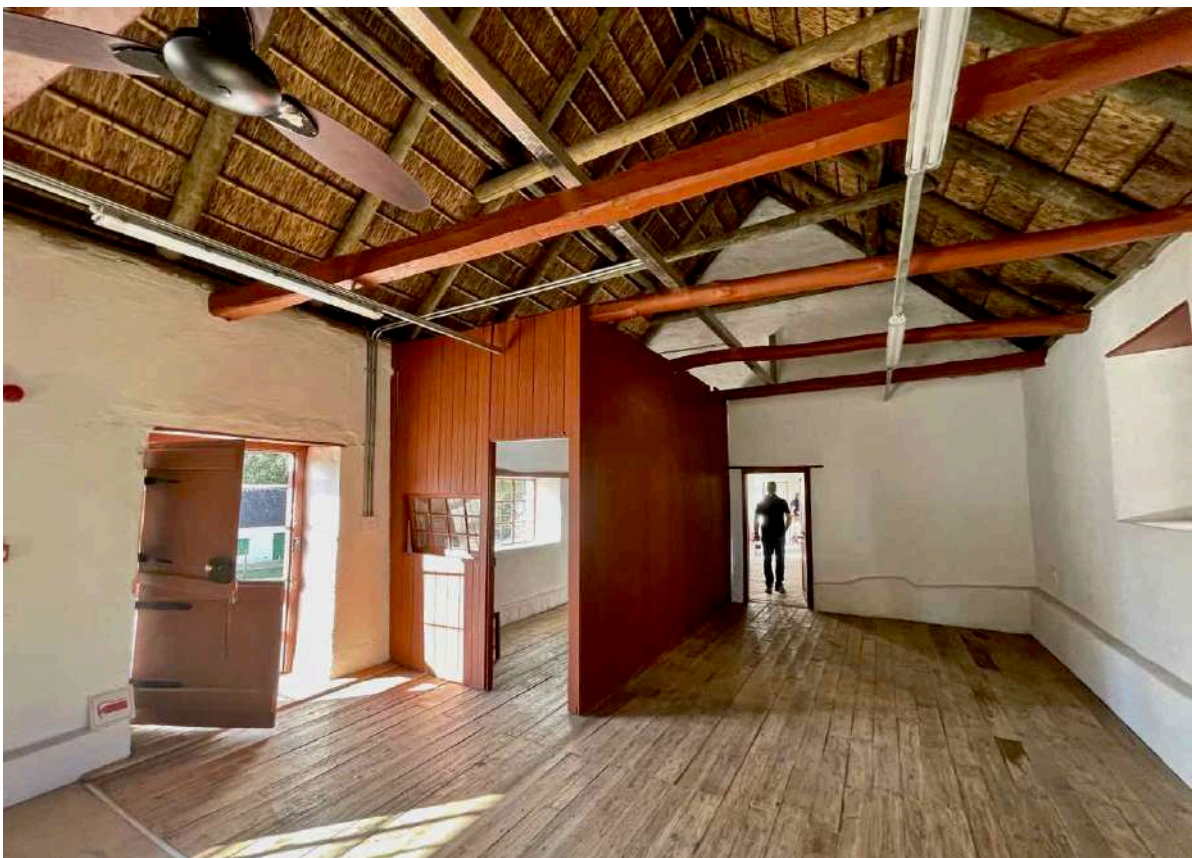
**FIGURE 18C:** *Interior of the Shoe Factory after refurbishment.* The floor had to be entirely re-laid, but using planks cleaned and recycled from the old floor. There was a conscious effort to retain as much of the floor's worn, rustic quality as possible. New lighting, fans, workstations and electrical systems were added. (Image: ARCON, 4 May 2021).

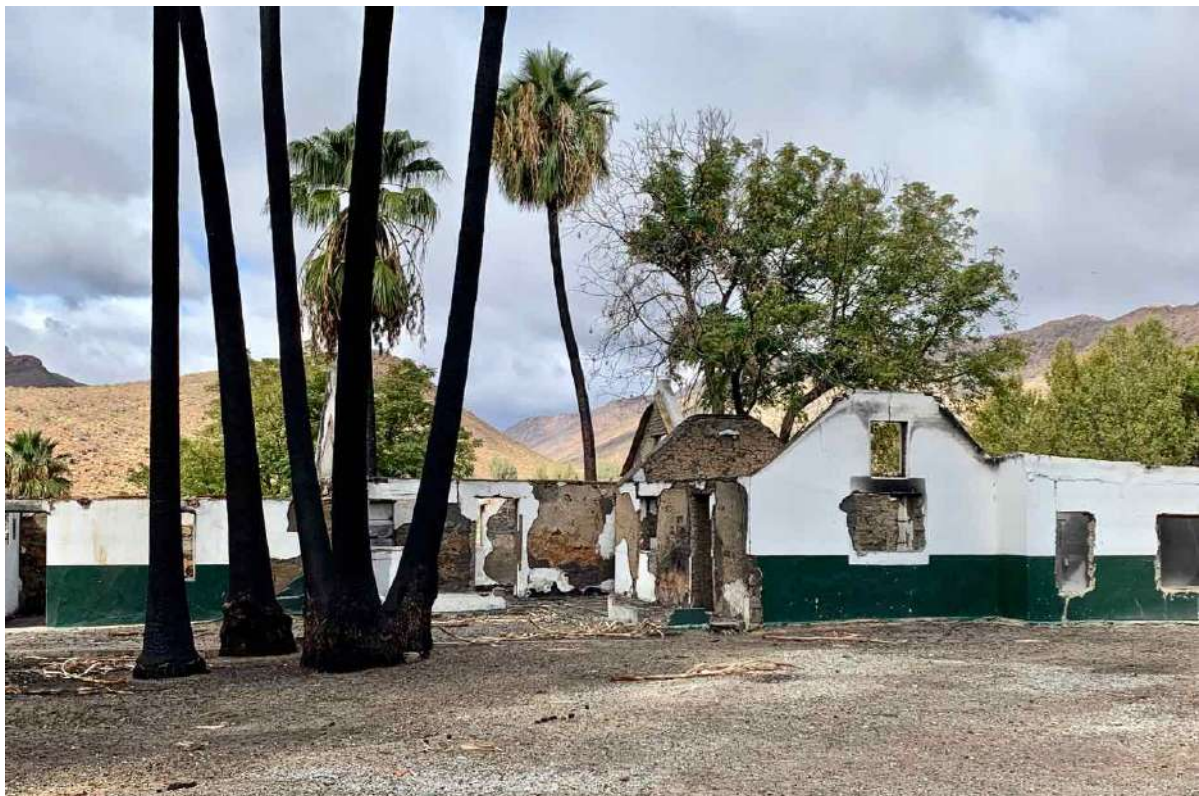
**FIGURE 19A:** *The Old Tannery after the fire. Burning palm fronds played a large role in spreading the fire in the strong wind that had prevailed. (Image: ARCON, 26 May 2020).*

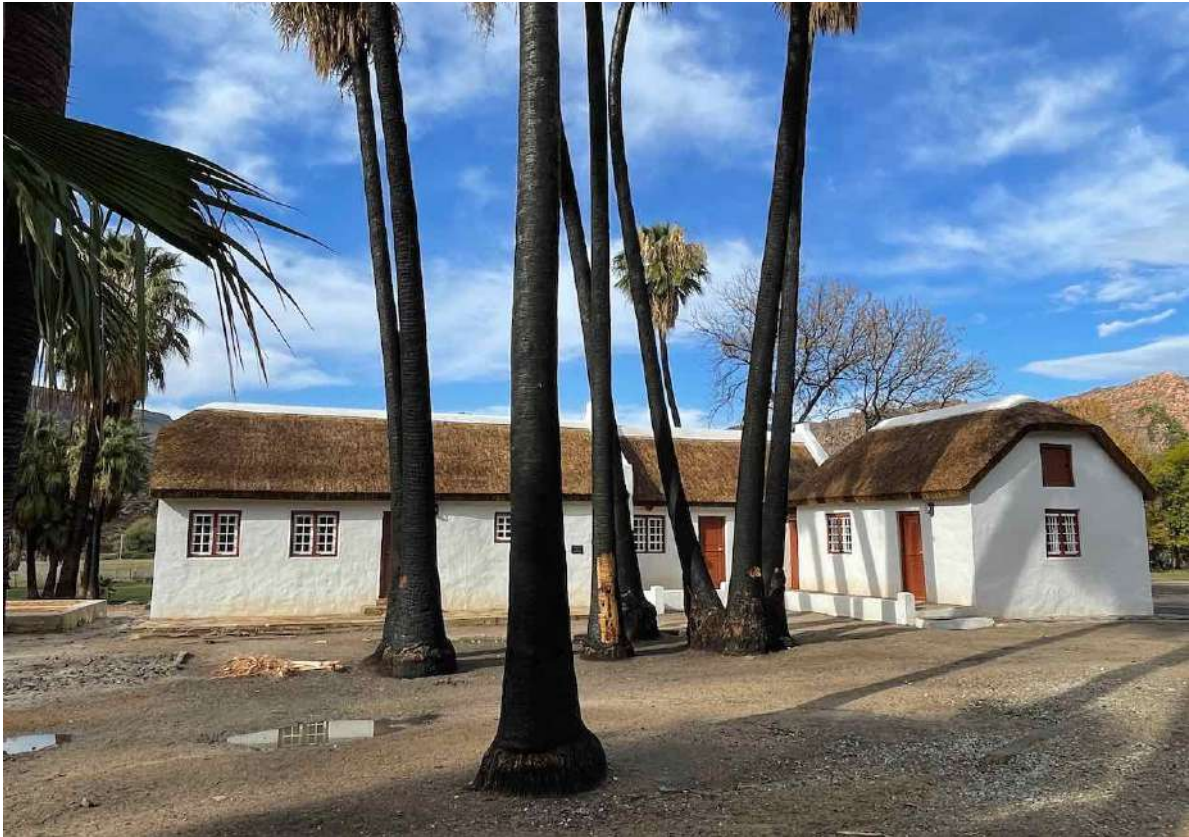
**FIGURE 19B:** *The Old Tannery after restoration/reconstruction. Part of one of the old tanning tanks is just visible in line with the building on the extreme left. (Image: ARCON 4 May 2021).*

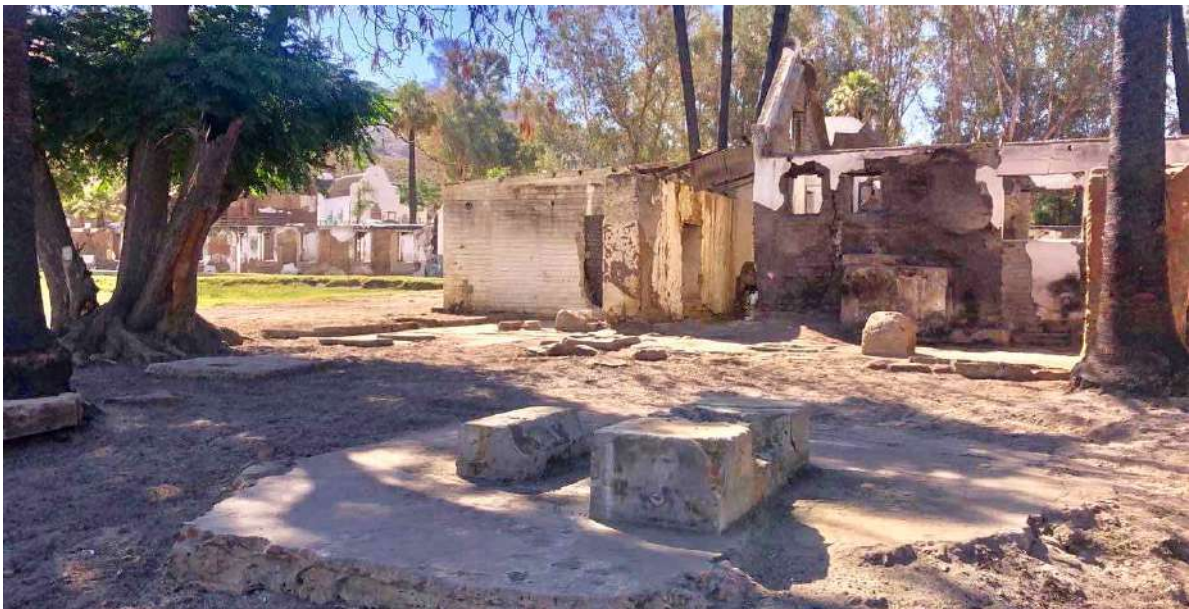
**FIGURE 19C:** *View of the back (southwest end) of the fire gutted shell of the tannery. The fabric on the extreme left comprised the remains of a shallow mono-pitch extension which has stylistically latter 1950's/1960's bagged and horizontally raked 1 brick thick walls constructed with cement mortar. The burned out shell of one of the school hostels is visible in the background to the extreme left. The cement and concrete slabs and bases in the foreground once formed part of the now defunct tanning operation. These elements were finally removed after the project archaeologist gave the go-ahead. The concrete tanning tanks (not visible in this image) were retained. (Image: ARCON, 6 December 2019).*

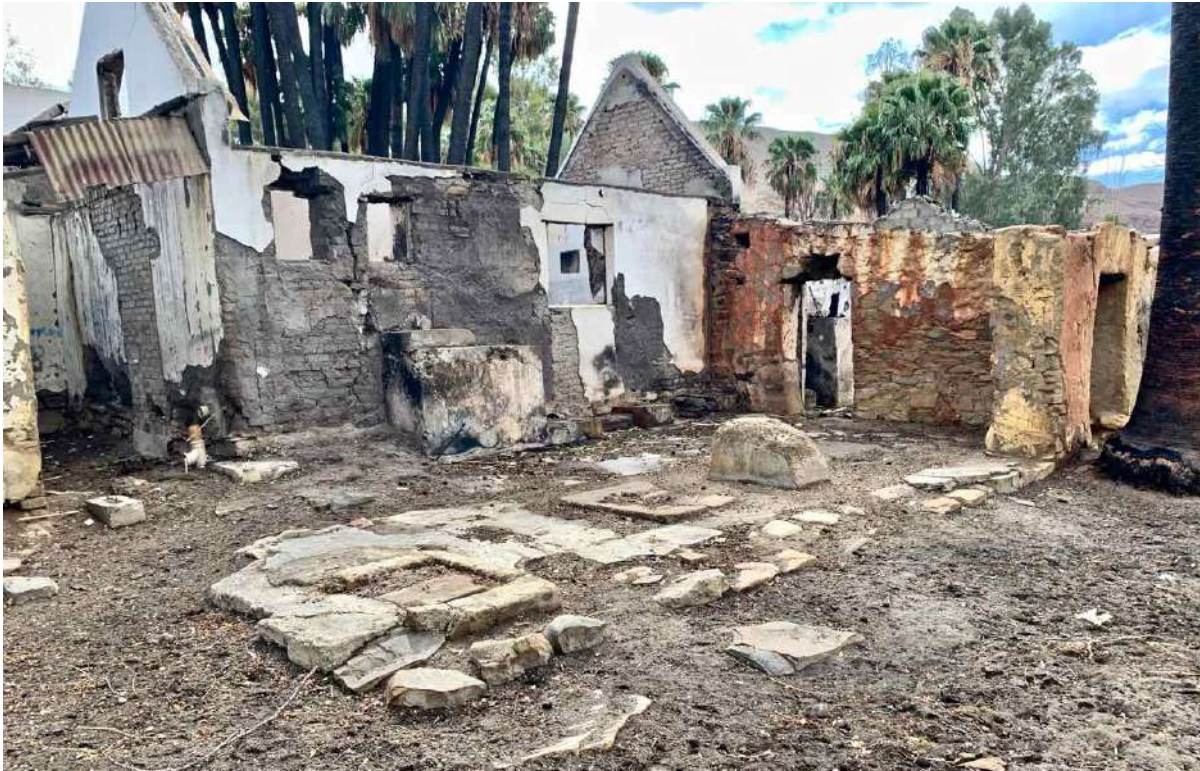
**FIGURE 19D:** *View of the back of the tannery after the fire (southwest end) showing various remnants of cement and concrete bases which once supported tanning machinery. The 'stoep' in the foreground was once under a lean-to roof, and remains of an old stone wall base are visible running diagonally across the foreground (Image: ARCON, 6 December 2019).*

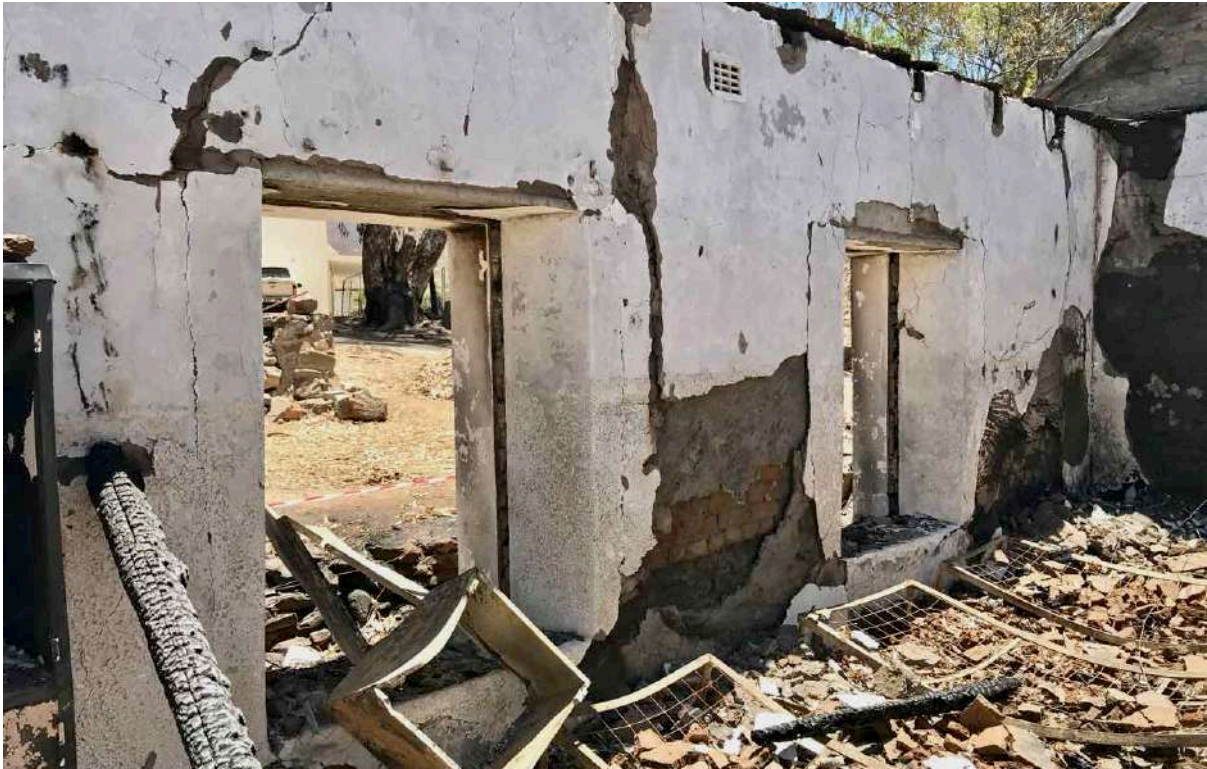
**FIGURE 20C:** *Part of one of the hostel interiors shortly after the fire. The twisted remains of beds lie amongst the wreckage. (Image: ARCON, 24 January 2019).*

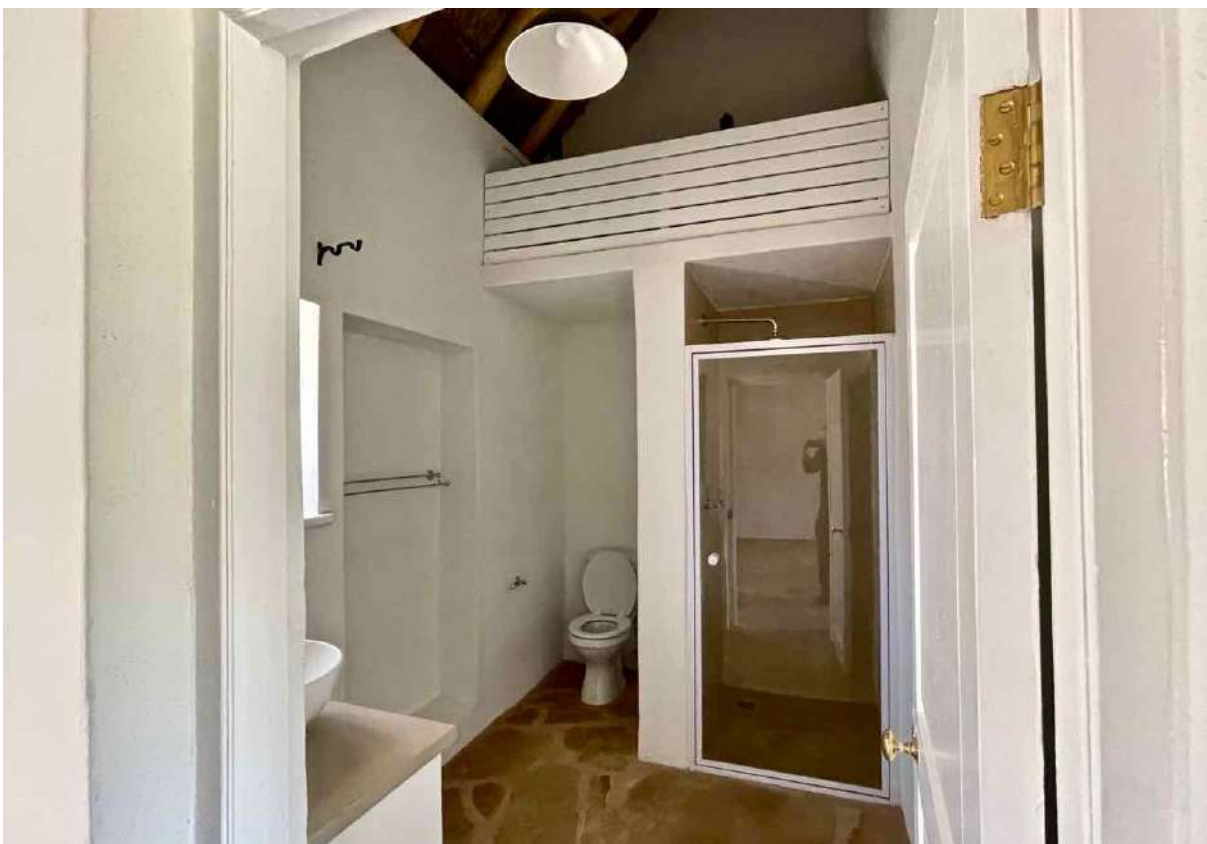
**FIGURE 20D:** *Part of the same interior, now a bathroom for one of the new guest flatlets. Where window openings were bricked in, the infill brickwork was recessed as a record of that opening. Stone for the new floors was all locally sourced. (Image: ARCON, 18 May 2021).*

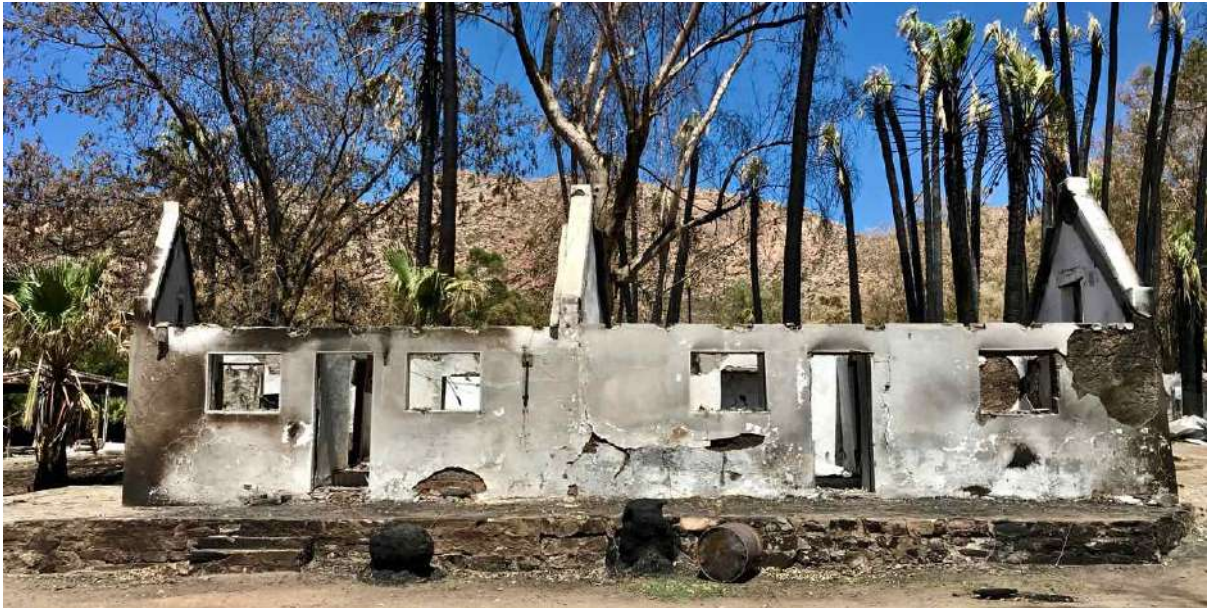
**FIGURE 21A:** *The gutted Palms Guest House after the fire.* (Image: ARCON, 24 January 2019).

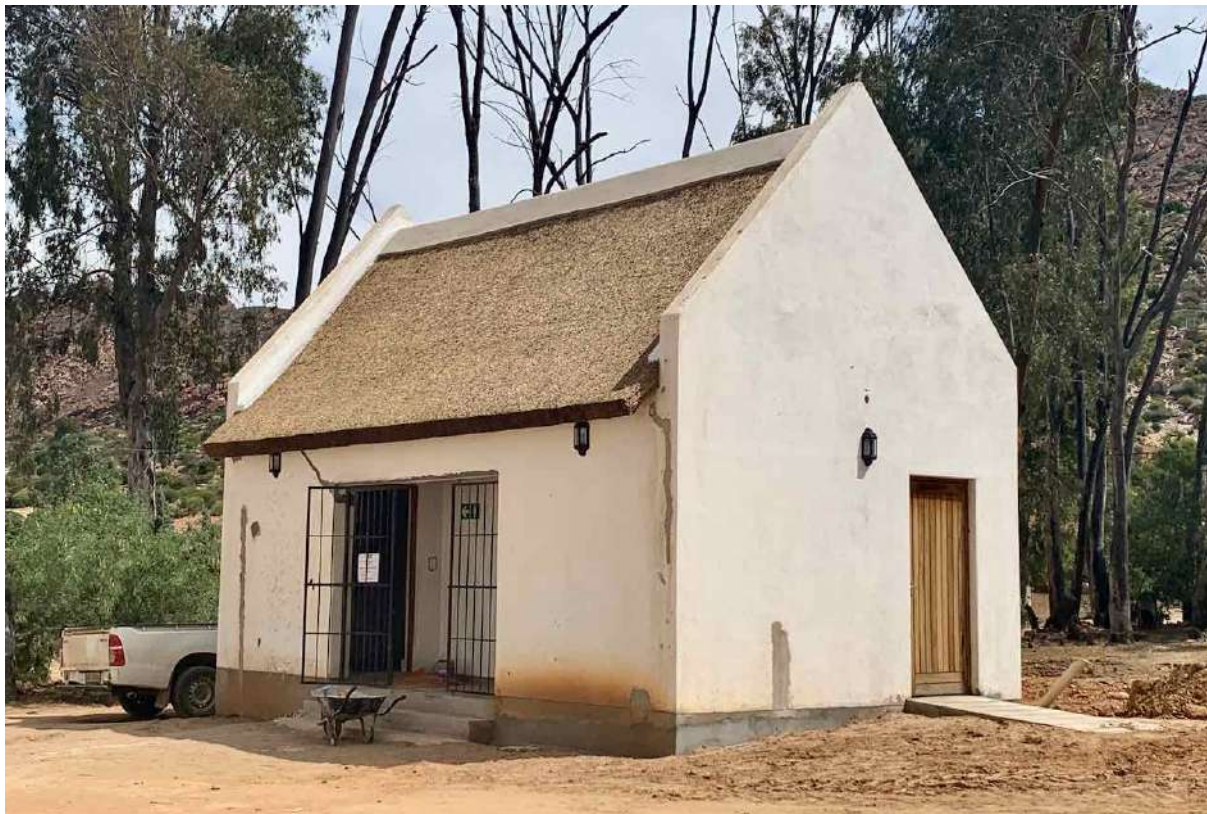
**FIGURE 24B:** *The church ablution after re-thatching and undergoing crack repairs prior to repainting. (Image ARCON, 27 October 2020).*
