# HARNESSING HERITAGE TO EMPOWER PEOPLE IN THE WAKE OF DISASTER

The rescue restoration of the  
historic town centre of Wupperthal Mission Station  
Cedarberg, South Africa  
2019-2021

Graham Jacobs

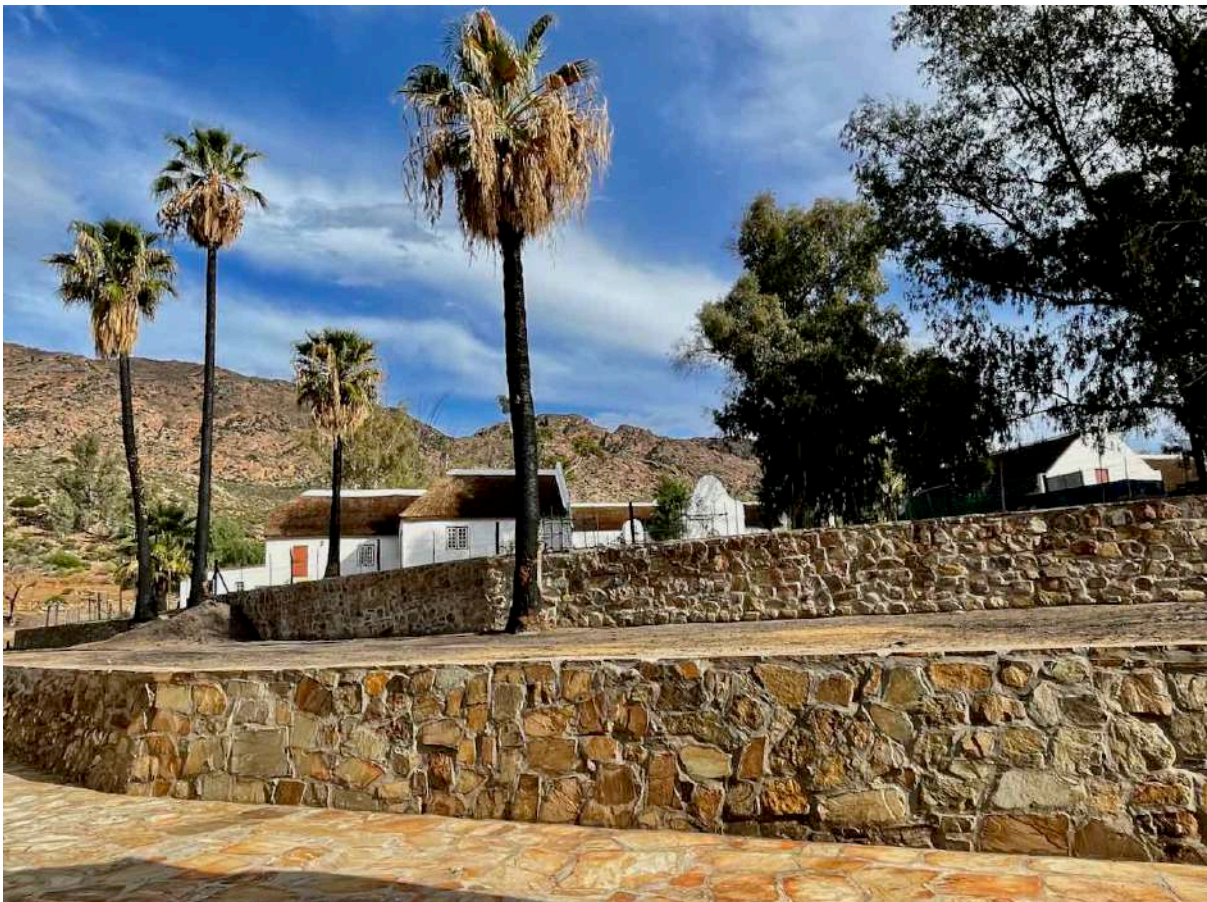
**FIGURE 26E:** *The stone retaining walls after reconstruction behind the Hostel Buildings. (Image ARCON, 8 June 2021).*
