**Draft Report**

**Heritage Impact Assessment  
&  
Conservation Management Plan**

**for**  
**Joubert Park**  
Erf No. 5105 & Ptn 1 to 3 of Erf 5105, Johannesburg  
September 2018

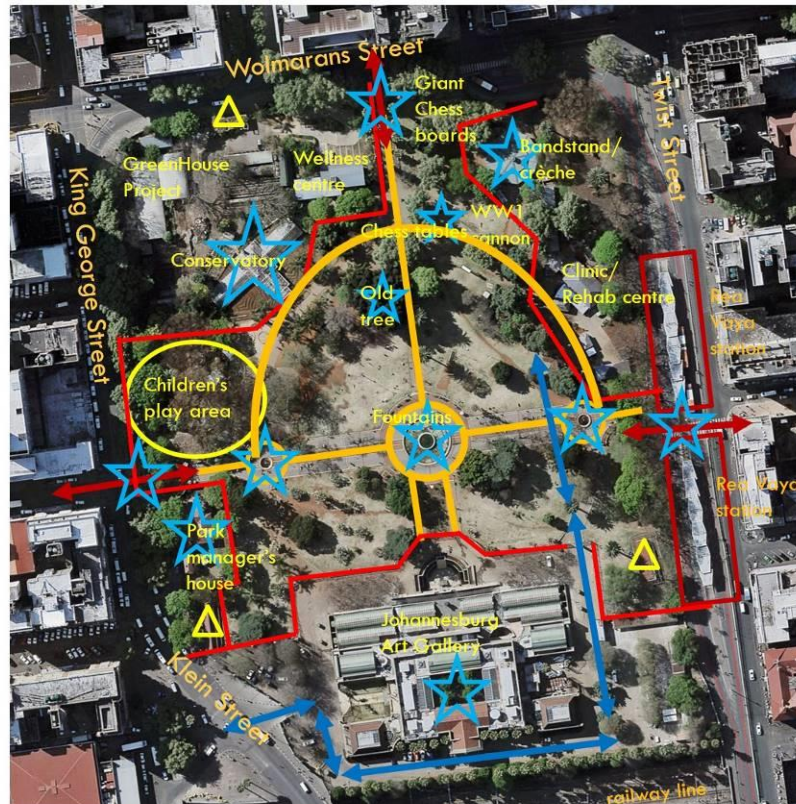
Fig. 17\_ Identified Heritage elements within Joubert Park, Public toilets, paved walkways, pedestrian entrances, internal fences and vehicular circulation  
(Source: Blueprint Landscape Architecture)

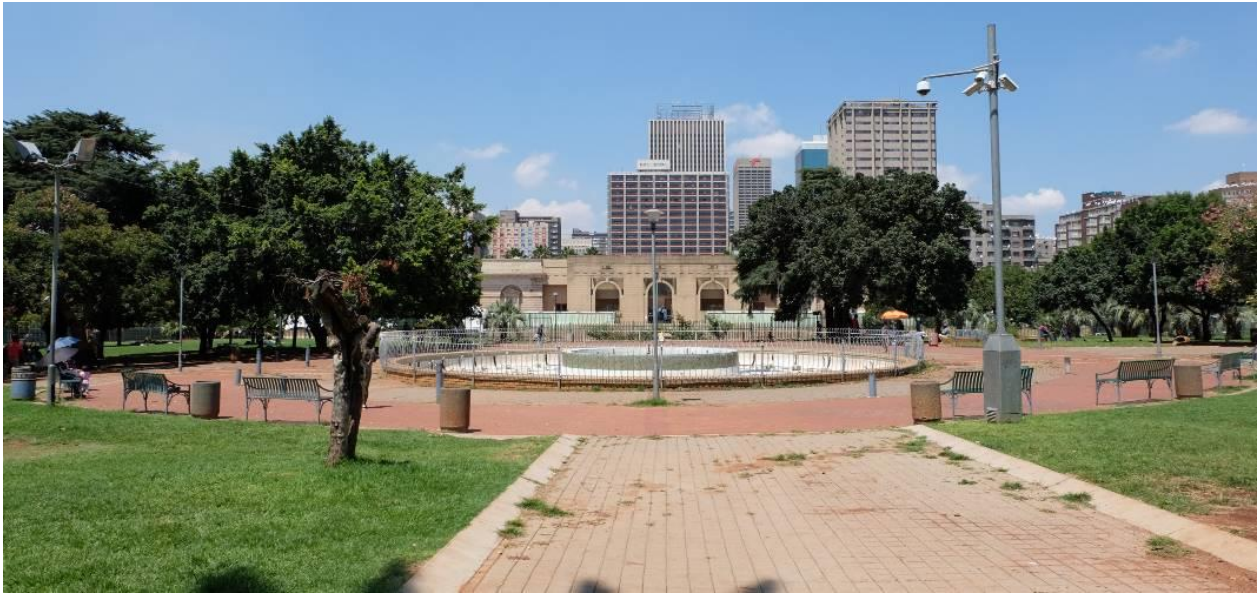
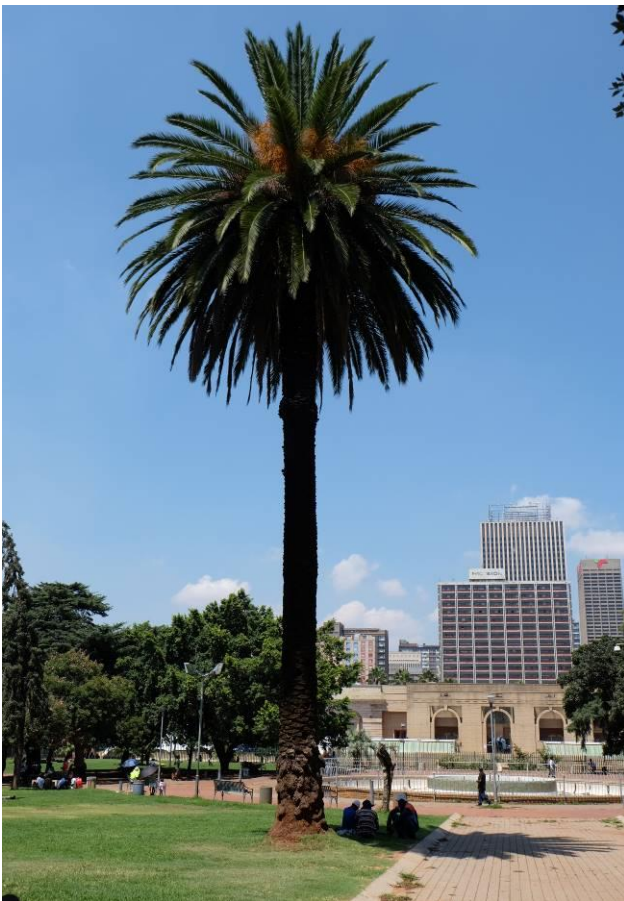
Fig. 18 & 19\_Views in southern direction towards the Johannesburg Art Gallery with centrally located fountain and paved walkways and palm tree  
(Source: tsica heritage consultants, 2018)

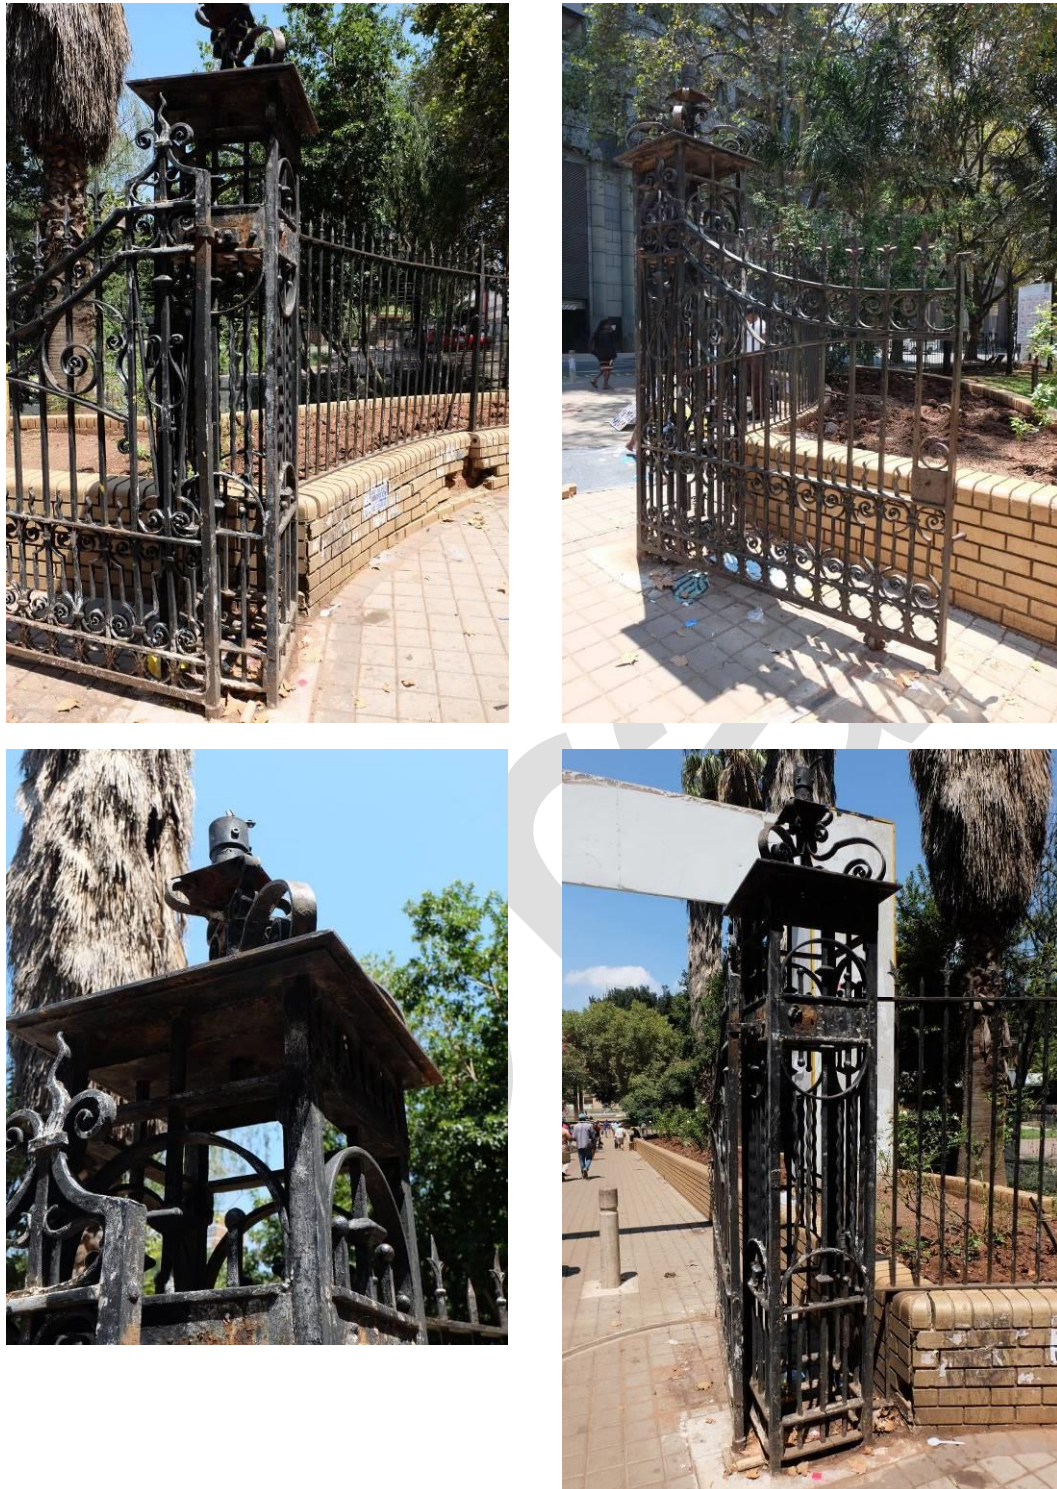
Fig. 20 to 23\_Northern entrance gate with decorative cast iron pillar and gates  
(Source: tsica heritage consultants, 2018)

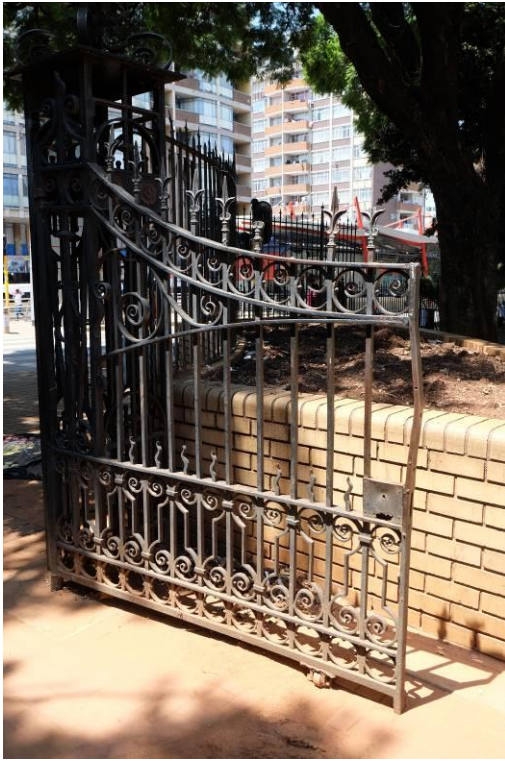
Fig. 24\_Eastern entrance gate with decorative cast iron pillar and gates  
(Source: tsica heritage consultants, 2018)

<b><i>Heritage Feature</i></b>	<b><i>Nature of Development as Detailed in the Master Plan</i></b>	<b><i>Impact and Recommendation</i></b>
	Repave the existing pathways	maintained
<b>Historical Entrance Gates, Columns and Perimeter Fence</b>	<p><b>Short Term</b> The historical entrance gates and columns be cleaned and stickers, glue etc. be washed off according to the City of Johannesburg Departments of Arts Culture and Heritage Guidelines.</p> <p><b>Medium Term and Long Term</b> Replace broken and missing parts of the historical fence to maintain additional security.</p>	<p>One of the most important and valuable heritage assets of the Park. It is recommended that the gates columns be kept in a pristine condition and be painted regularly in the present paint to avoid rusting.</p> <p>Make good and replace all the broken parts of the fence.</p> <p>Once a locking system for the gates has been put in place, care should be taken to use a system that does not damage the historical gates.</p>

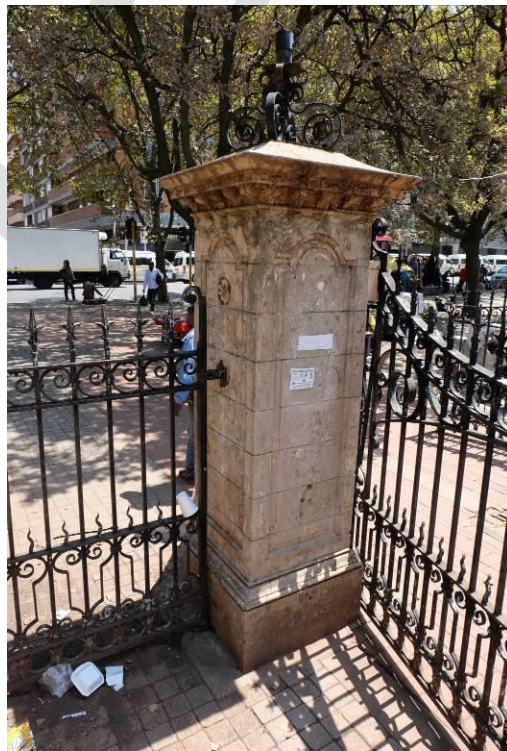
Fig. 25 & 26\_Western entrance gate with decorative cast iron fence and gates and stone pillars  
(Source: tsica heritage consultants, 2018)

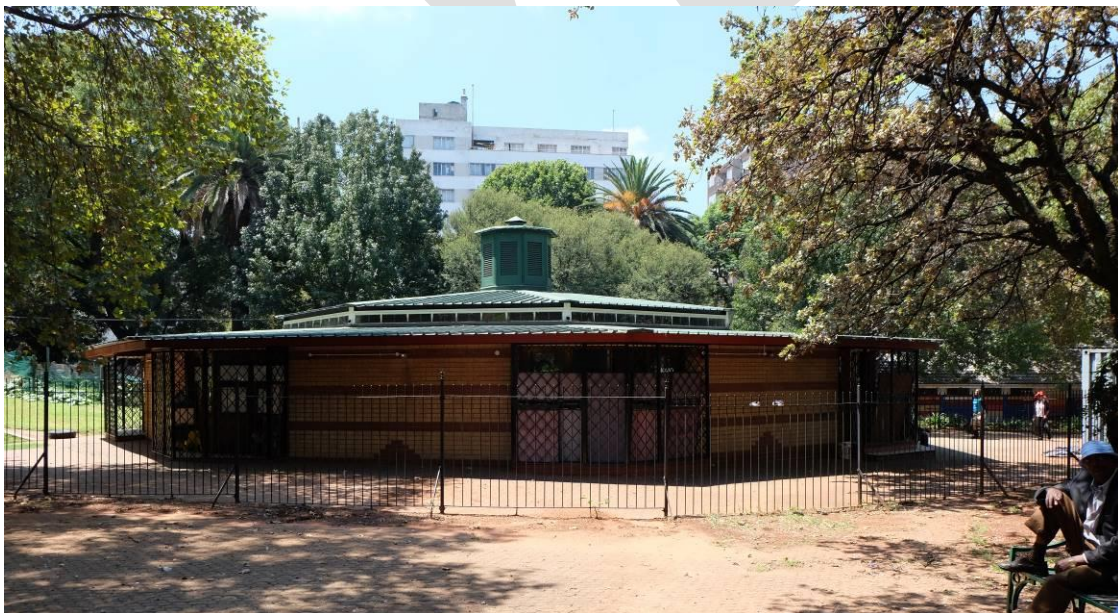
Fig. 28\_Original location of historical bandstand but enclosed and now used as a crèche  
(Source: tsica heritage consultants, 2018)

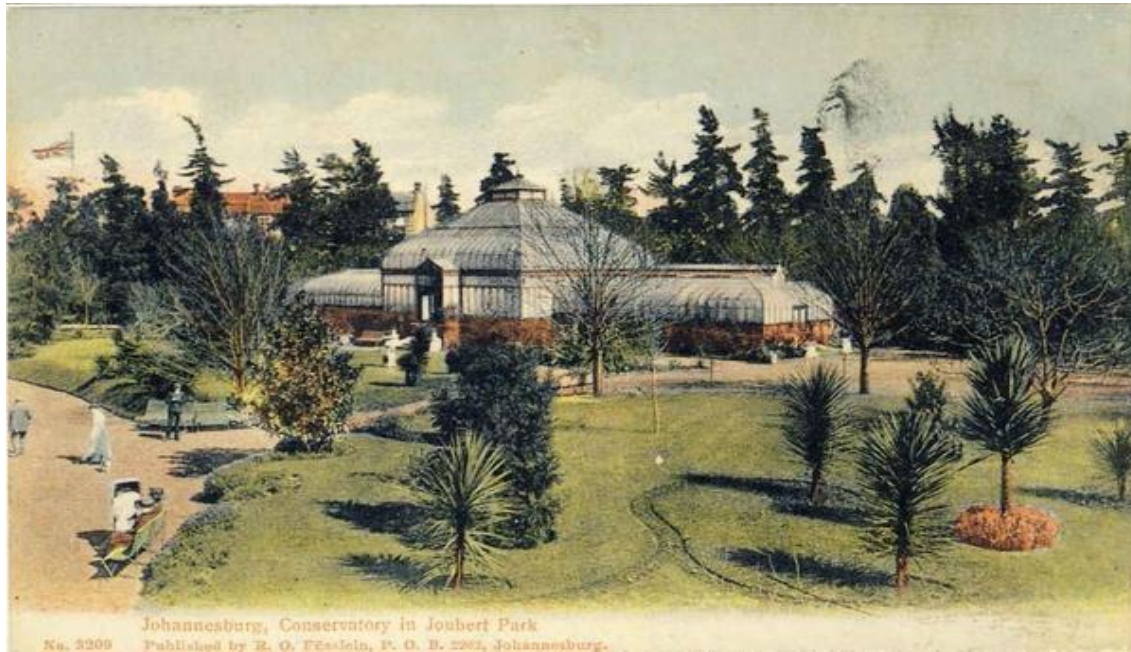
Fig. 29\_Victorian conservancy was known as the “Hothouse”, second design which was demolished in 1939

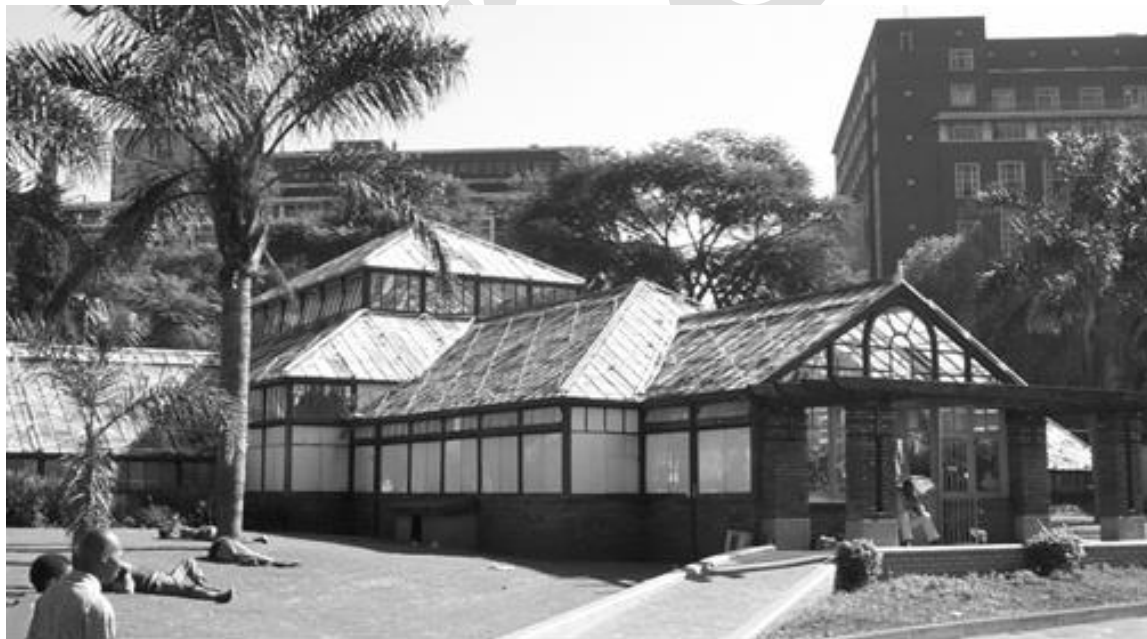
Fig. 30\_Consevancy which was built in 1940, here in 2002

<b>WW 1 Cannon</b>	<b>Short Term</b> The WW1 Cannon to be left in its position cleaned and plaqued. Educational signage explaining the cannon's story will be installed next to it.	The WW1 Cannon has an interesting story of how it was a battle prize for the soldier's British soldiers fighting against German soldier in a WW1 battle. It is recommended that the Cannon be plaqued.
<b>Gallery as Extension of Park</b>	<b>Long Term</b> Once security has been established, restoration of part of Lutyens plan to make the Park part of the Gallery by introduction of an exhibition space.	Impact will be positive as it will strengthen the relationship between the Gallery and the Park. It is recommended that some of the art pieces be in memorialisation to the Park history.
<b>Conservatory</b>	<b>Long Term</b> Restoration of the conservatory and making good. To establish hydroponics food production centre as	Impact will be positive as the conservatory will not change usage. Restoration of the conservatory will bring back its former glory. It

<b><i>Heritage Feature</i></b>	<b><i>Nature of Development as Detailed in the Master Plan</i></b>	<b><i>Impact and Recommendation</i></b>
	public private enterprise that will contribute to food production in the area. Establish a function venue with restaurant and tea garden area.	Is recommended that all alteration and additions be subject to a Section 34 application to PHRAG.
<b>Existing Ablution Facilities</b>	<b>Medium to Long Term</b> Reconfigure the entrance of the ablution facilities to face the Park as it is currently facing Twist Street.	Impact of the reconfiguration of the will be positive as it will make the ablution facilities safer to use.
<b>Info Centre with ablution facility and New Bath House</b>	<b>Medium to Long Term</b> Building that is currently used as a drug rehabilitation centre to be converted as an information centre and a bath house.	The building currently is not of heritage value but it is recommended that when converted to an information centre that it used as an opportunity to exhibit some historical pictures of the Park.

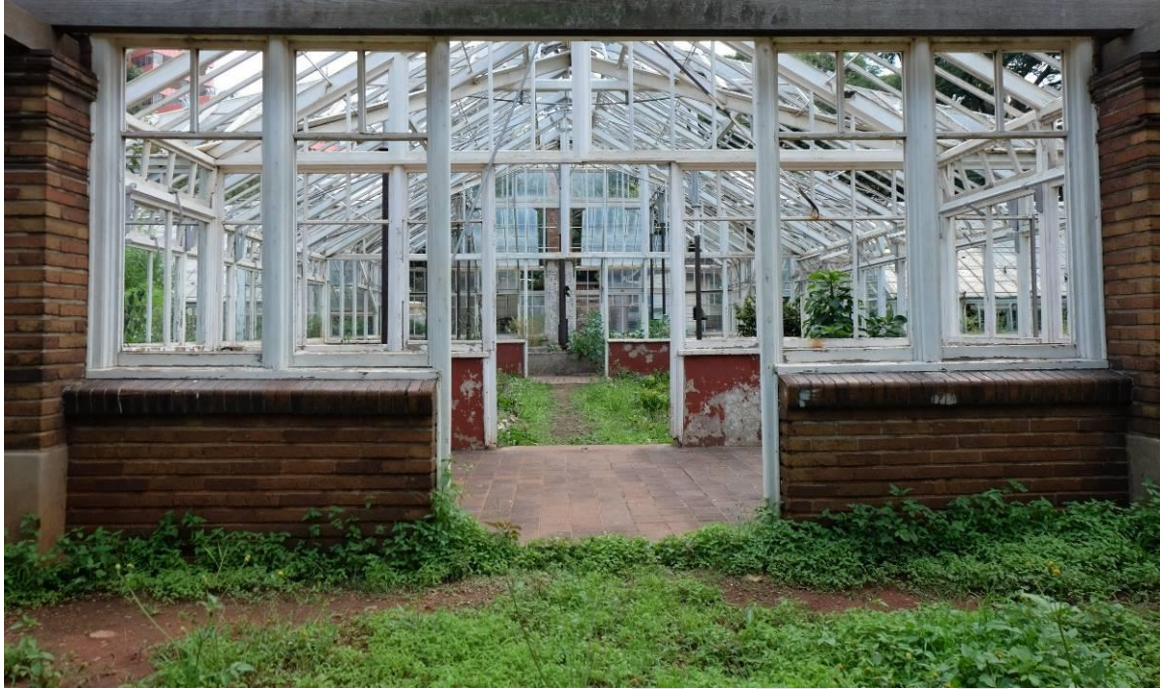
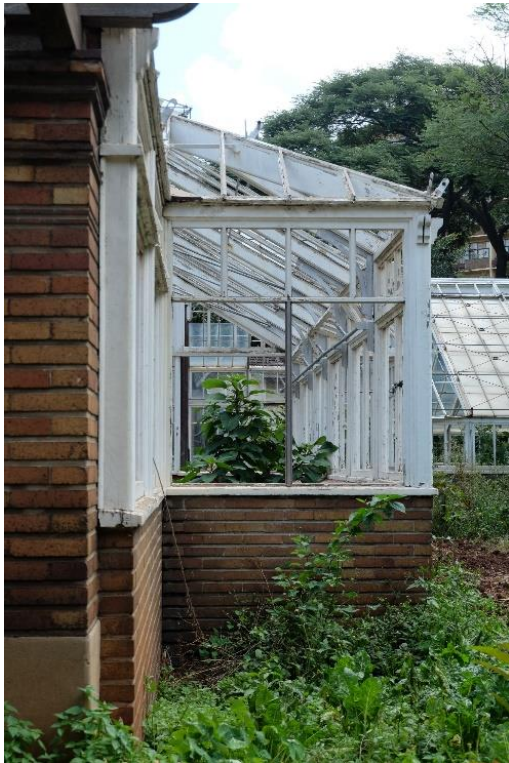
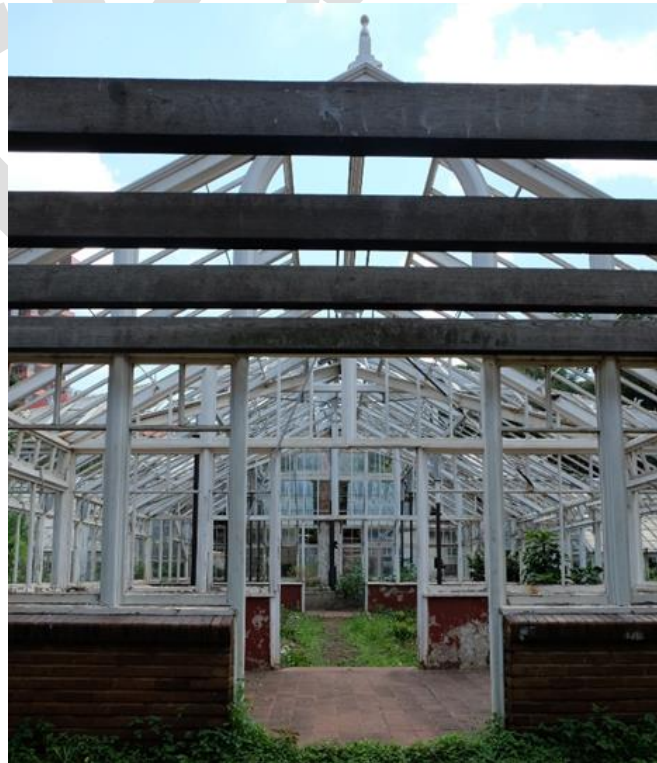
Fig. 31 to 33\_Current state of Conservatory  
(Source: tsica heritage consultants, 2018)

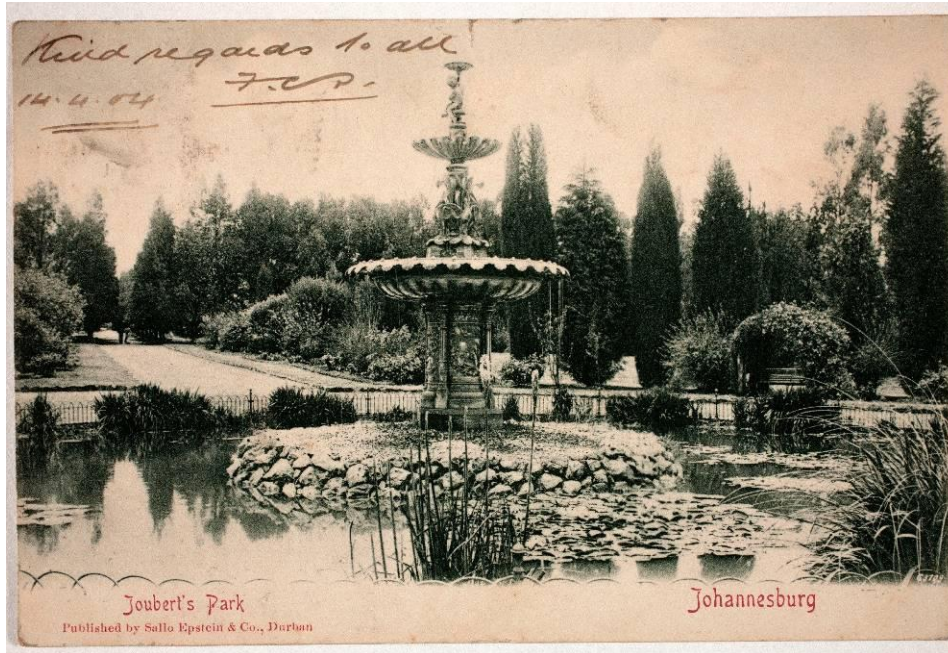
Fig. 34\_Historical postcard of the old central Fountain (1898), not existing anymore  
(Source: JAG Archives)

<b>Heritage Feature</b>	<b>Nature of Development as Detailed in the Master Plan</b>	<b>Impact and Recommendation</b>
<b>Central Fountain</b>	<p><b>Short Term</b> The Master Plan proposes to dismantle the remaining railing and working parts of the fountain that are slowly being stolen for safe keeping in storage. Cover the fountain for safety reasons and create a podium.</p> <p><b>Medium Term</b> Place an appropriate art piece on the podium covering the fountain.</p> <p><b>Long Term</b> Restore the fountain once the security of the Park has been established.</p>	<p>It is regrettable that the McFarlane Fountain cannot be restored because of the security issues. Dismantling the fountain will change the historical outlook of the Park. The impact is however short term as the fountain will be restored.</p> <p>It is recommended that the art piece be interactive and a plaque be placed on the art piece marking the original position of the fountain and its history.</p>

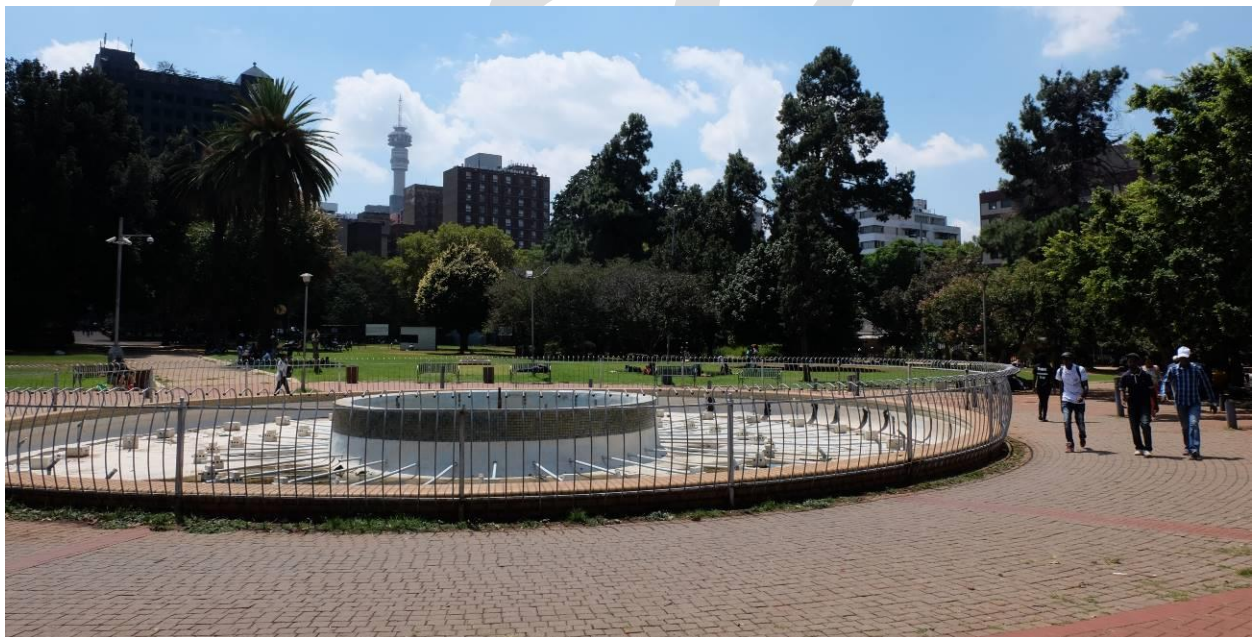
Fig. 35\_Centrally located fountain which was installed to replace the historical fountain  
(Source: tsica heritage consultants, 2018)

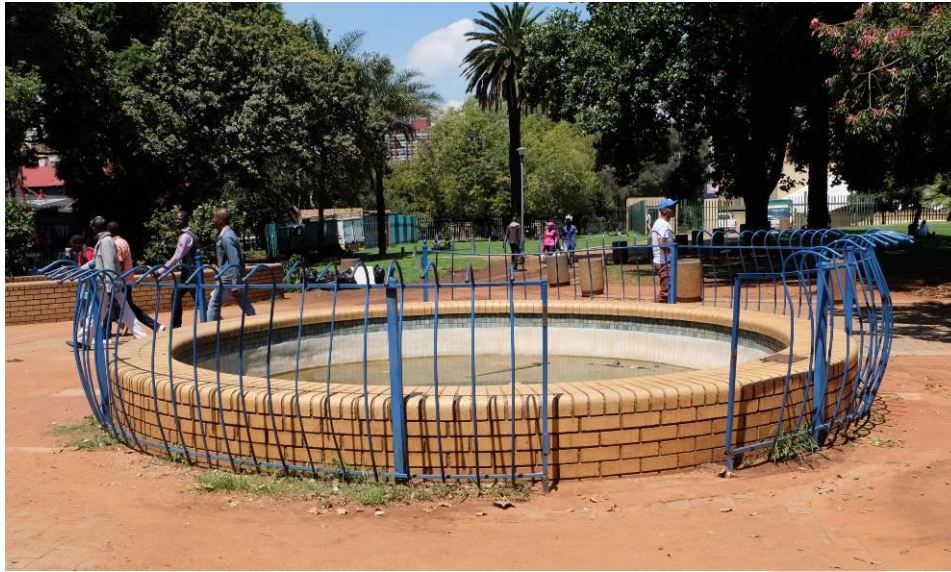
Fig. 36\_One of the two fountains located along secondary axis in line with the main fountain, both fountains are in a very bad condition and not functional anymore  
(Source: tsica heritage consultants, 2018)

- Historical fountains are now not functional and fencing around the central fountain is being stolen daily
- The water features are now health hazards with floating rubbish and stagnant water

<b>Smaller Fountains</b>	<p><b>Short Term</b> The two fountains on the secondary axis of the Park to be cleaned out and backfilled and covered to create podiums for artwork.</p> <p><b>Medium – Long Term</b> An art work be introduced to commemorate the position of the fountains.</p>	<p>To mitigate the backfilling of the smaller fountains it is recommended that the foot print of the fountain be maintained and interactive durable and sustainable art be introduced in the medium to long term.</p>
<b>Walkways</b>	<p><b>Short Term</b> Replace and make good uneven pathways. Remove weeds and soil on the pathways.</p> <p><b>Long Term</b></p>	<p>The paving of the pathways is not historical however the footprint of the pathways is in itself significant. It is therefore recommended that the historical footprint of the walkways be</p>

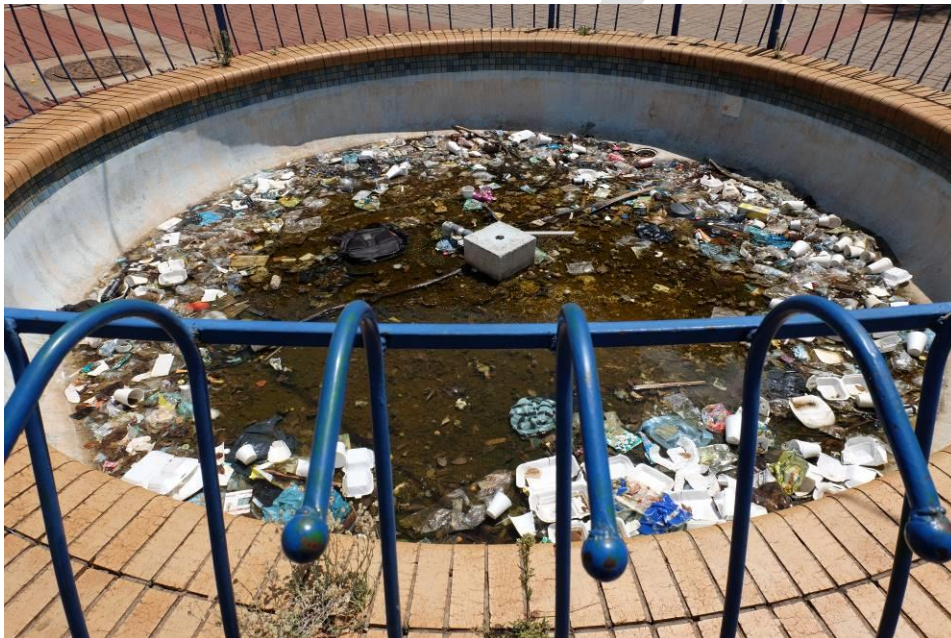
Fig. 37\_One of the two fountains located along secondary axis in line with the main fountain, both fountains are in a very bad condition and not functional anymore  
(Source: tsica heritage consultants, 2018)

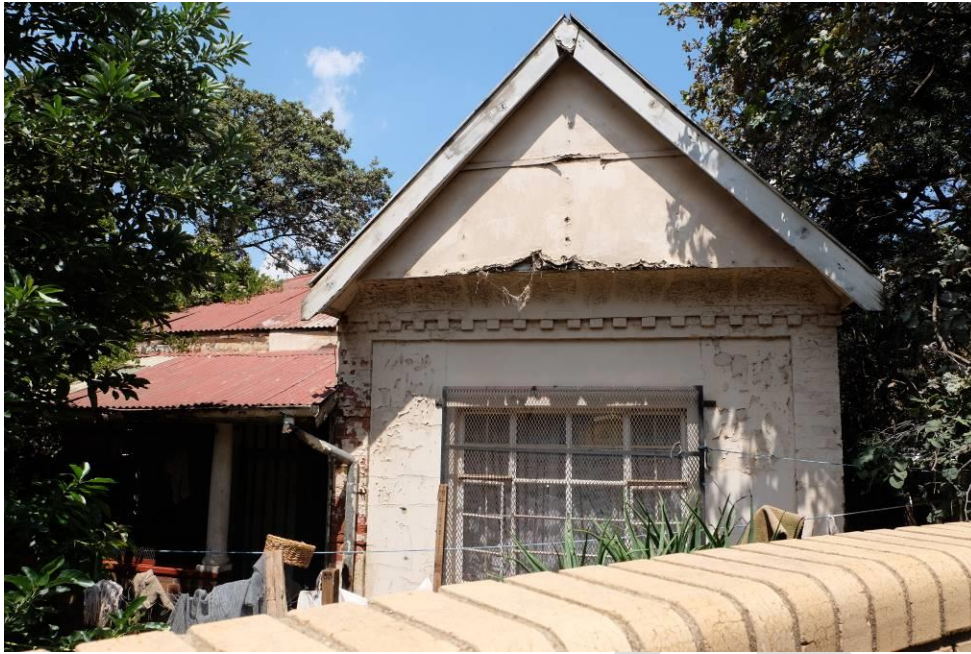
Fig. 38\_Original park managers house along the eastern boundary line of Joubert Park next to the western entrance gate, the building is in a very bad condition and is occupied by illegal residents

- Structural damage to some of the elements of the building e.g. the fountains, lights, fencing
- The Park Keepers house has been vandalised and is being illegally occupied

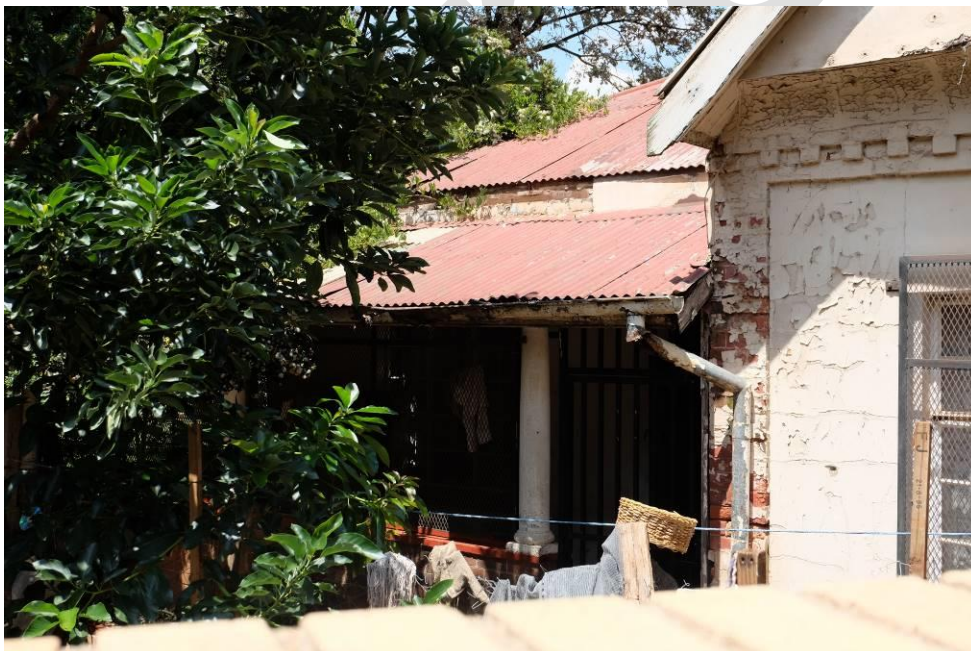
Fig. 39\_Original park managers house along the eastern boundary line of Joubert Park next to the entrance gate, the building is in a very bad condition and is occupied by illegal residents

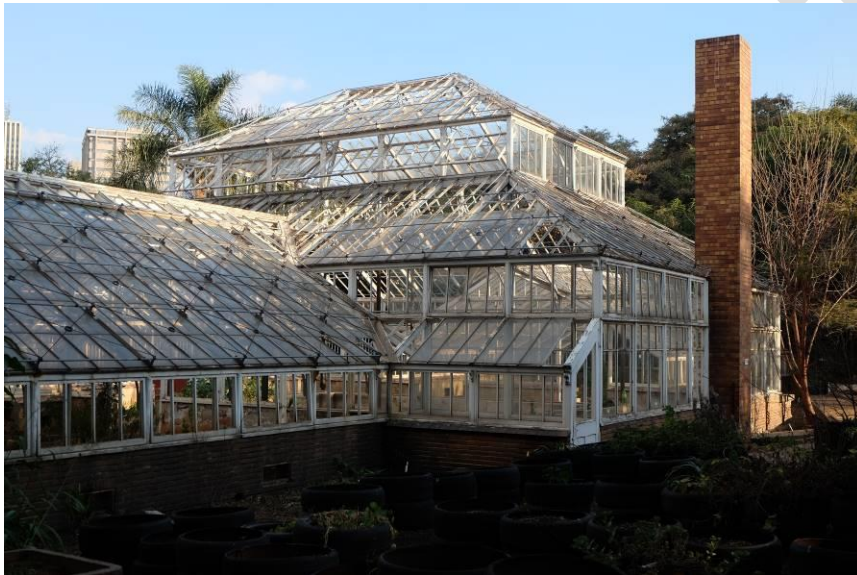
Fig. 40\_Current state of Conservatory with partly broken glass and in urgent need of repair  
(Source: tsica heritage consultants, 2018)

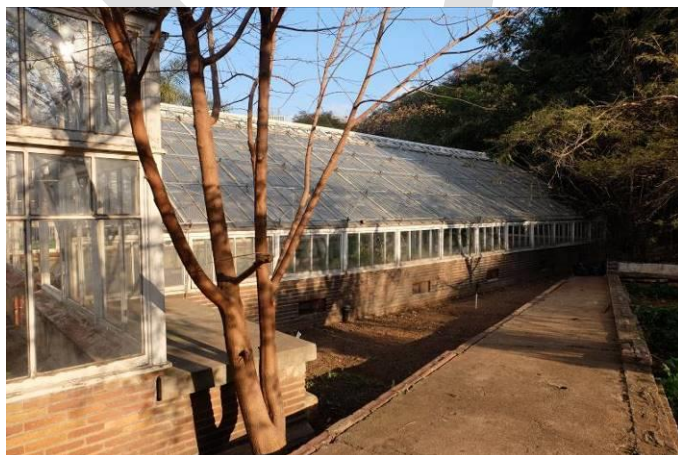
Fig. 41\_Current state of Conservatory with partly broken glass and in urgent need of repair  
(Source: tsica heritage consultants, 2018)

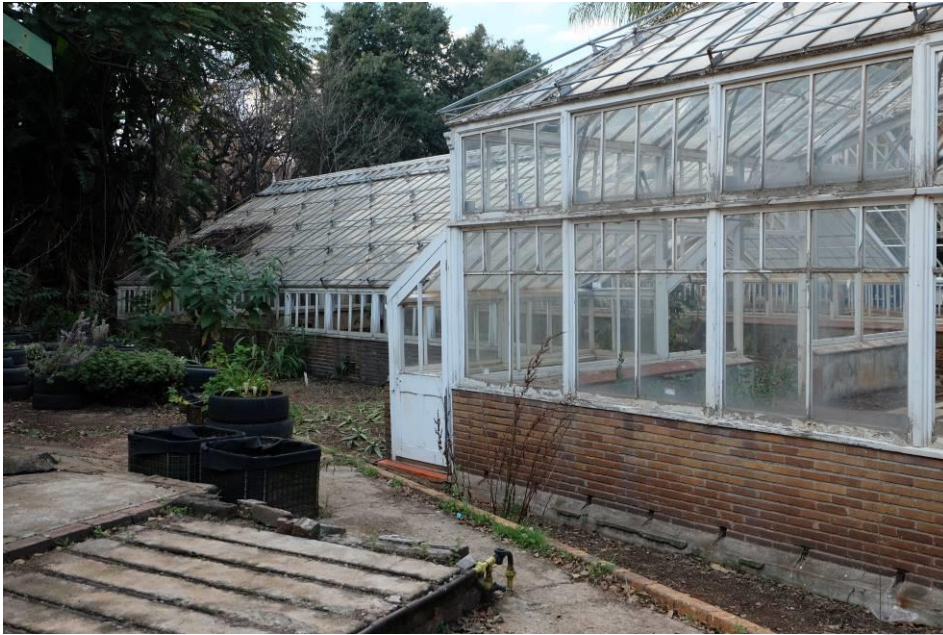
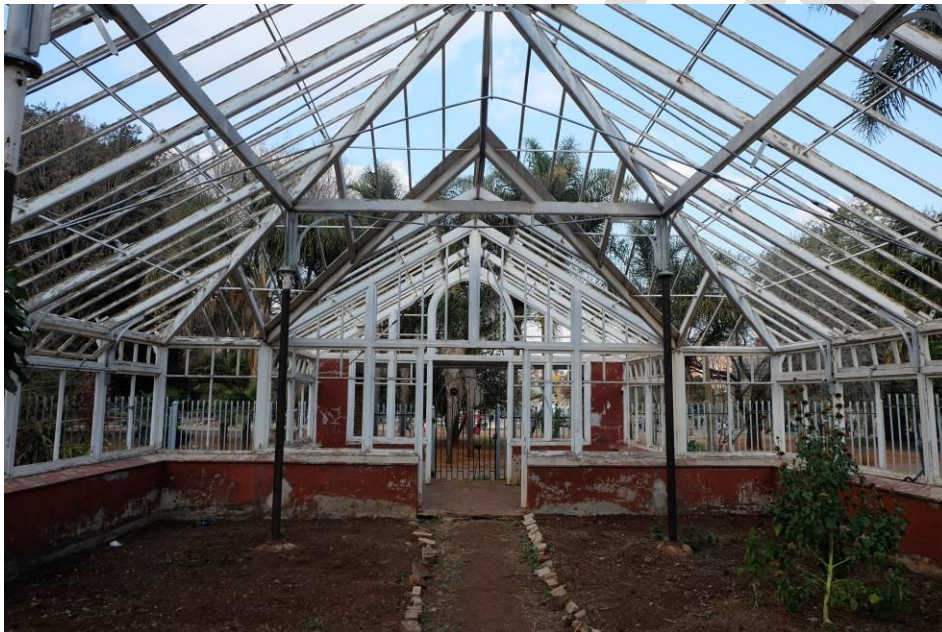
Fig. 42 & 43\_Current state of Conservatory  
(Source: tsica heritage consultants, 2018)

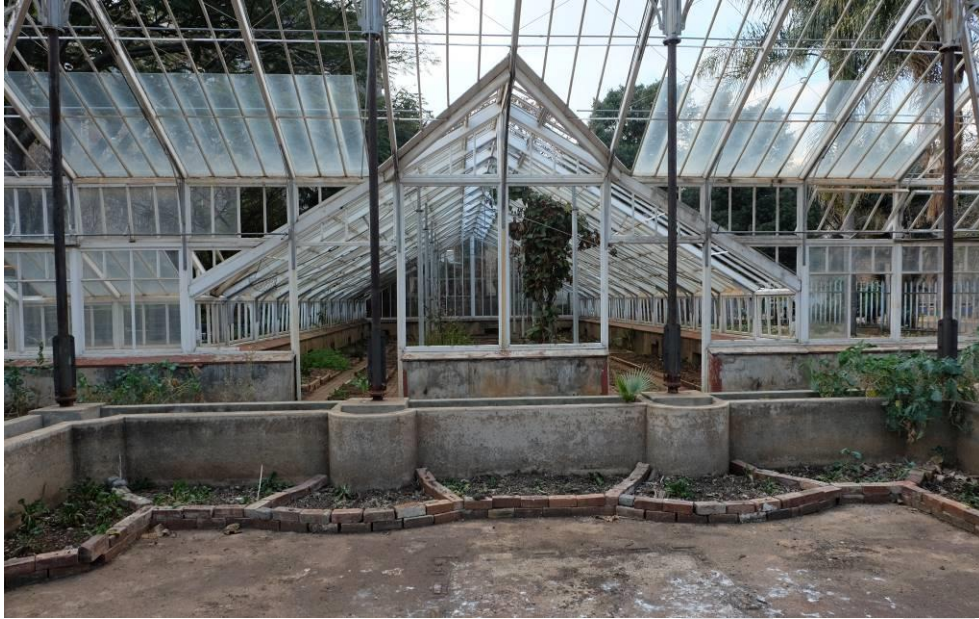
Fig. 44\_ Interior of current state of Conservatory  
(Source: tsica heritage consultants, 2018)

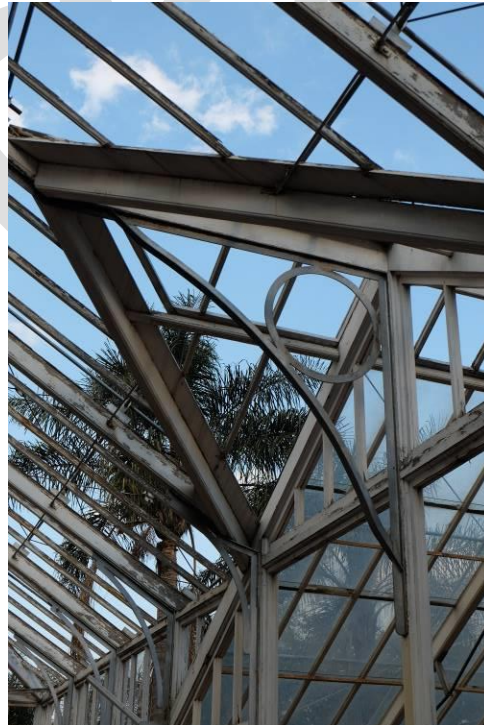
Fig. 45 & 46\_ Detailing of interior elements of current state of Conservatory  
(Source: tsica heritage consultants, 2018)

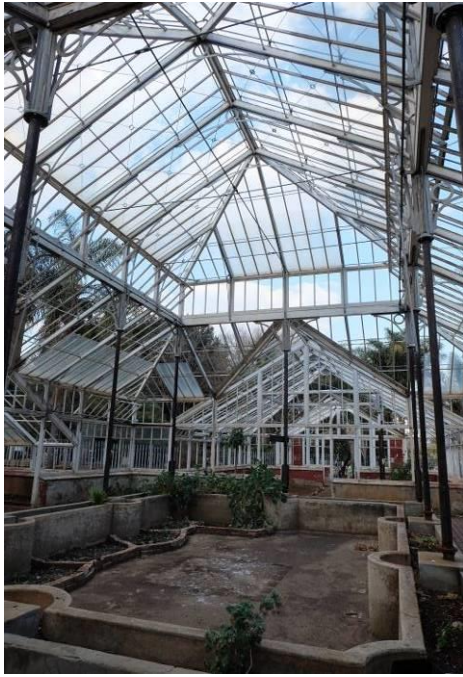
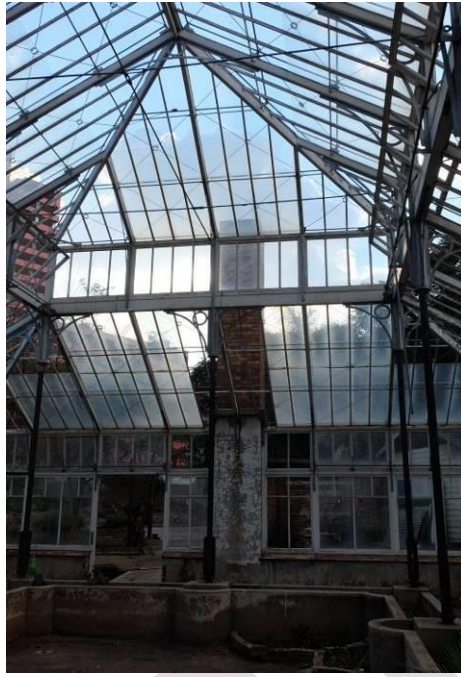
Fig. 47 & 48\_ Interior of current state of Conservatory  
(Source: tsica heritage consultants, 2018)

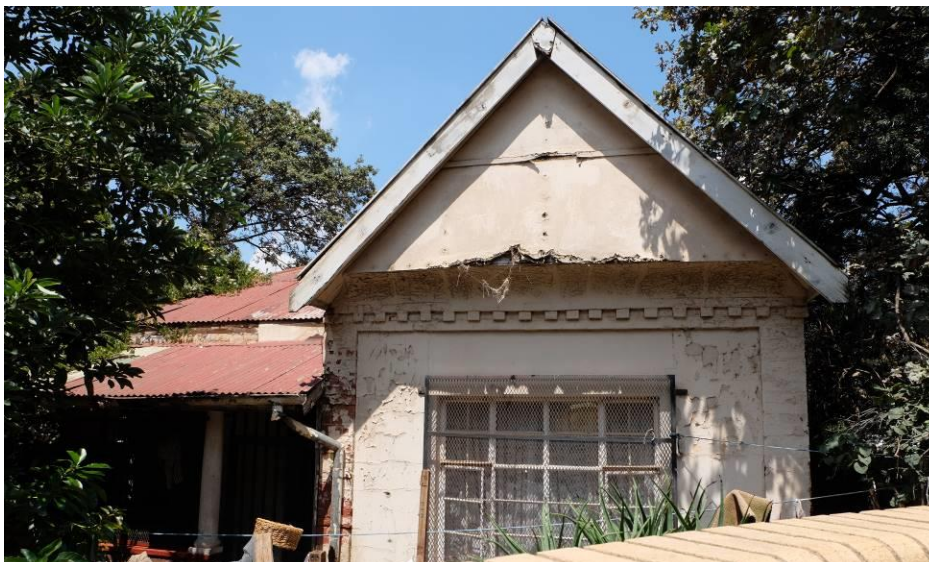
Fig. 53\_Original Park Manager's house along the eastern boundary line of Joubert Park next to the western entrance gate, the building is in a very bad condition and is occupied by illegal residents

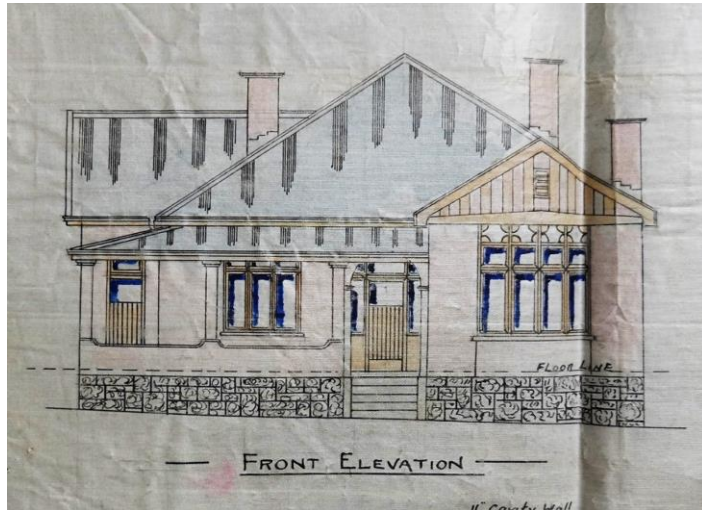
Typical single storey residence from the early 20<sup>th</sup> Century in Berea. The single-sided triangular gable used as architectural design feature and the stoep wrapped around the corner dominated the streetscape of the Victorian time period. The front stairs leading onto the stoep and the main entrance door. The slightly lifted verandah opened up the view towards the street and small front yard. Berea has a number of well-kept examples of the freestanding house designs in the City.

Fig. 54\_Front elevation for single storey residence on Stand 989  
(Source: Plans Department, City of Johannesburg)

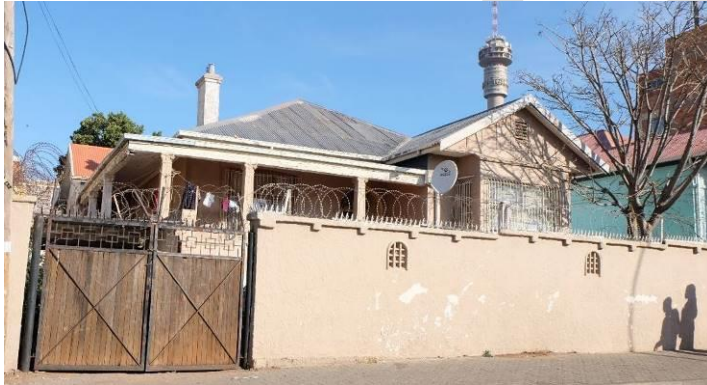
Fig. 55\_South elevation from typical single storey residence from 1911  
(Source: tsica heritage consultants, 2016)

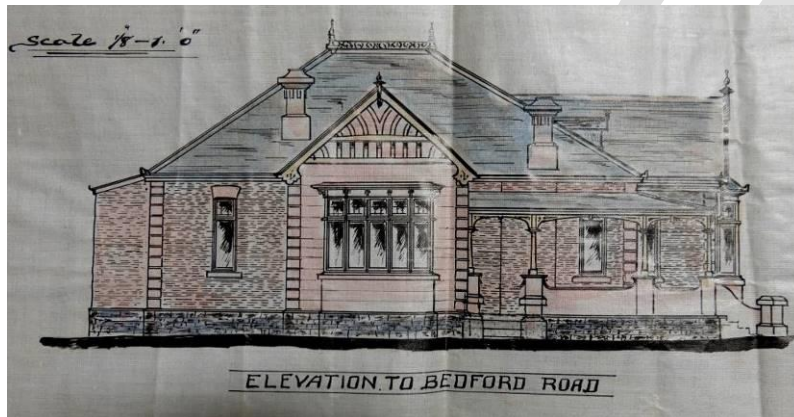
Address	60 Regent Street
Stand No.	1014
Current Zoning	Residential 4
Year of erection	1906
Architect	I. Newcombe
Heritage Significance	Architectural
Proposed SAHRA Grading	3A
<b>Site Description</b>	
<p>The single storey three bedroomed corner residence was designed to accommodate a more affluent family in Yeoville. The floor plan shows a drawing and a breakfast room and two staircases on to the verandah on either side of the streets. The Victorian decorative architectural details are typical for the time and the architect shows a high quality in draughtsmanship with his drawings. More research needs to be done on his work in Johannesburg.</p>

Fig. 56\_Street elevation to Bedford Road with centrally located triangular decorative gable from 1906  
(Source: Plans Department, City of Johannesburg)

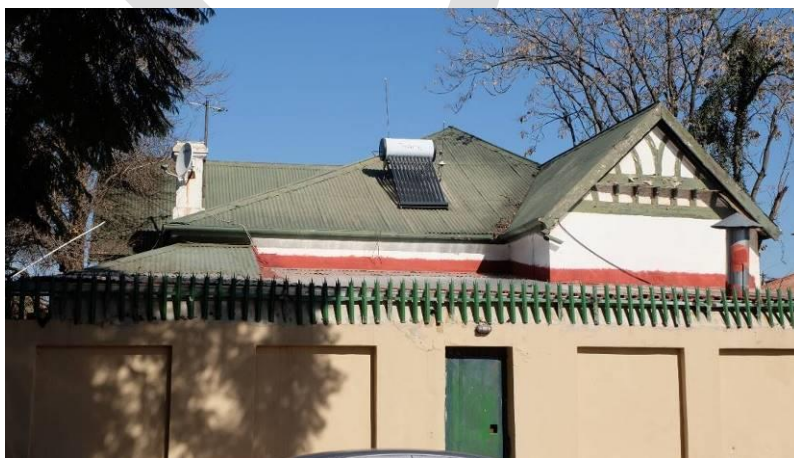
Fig. 57\_Street elevation to Bedford Road with centrally located triangular decorative gable  
(Source: tsica heritage consultants, 2016)

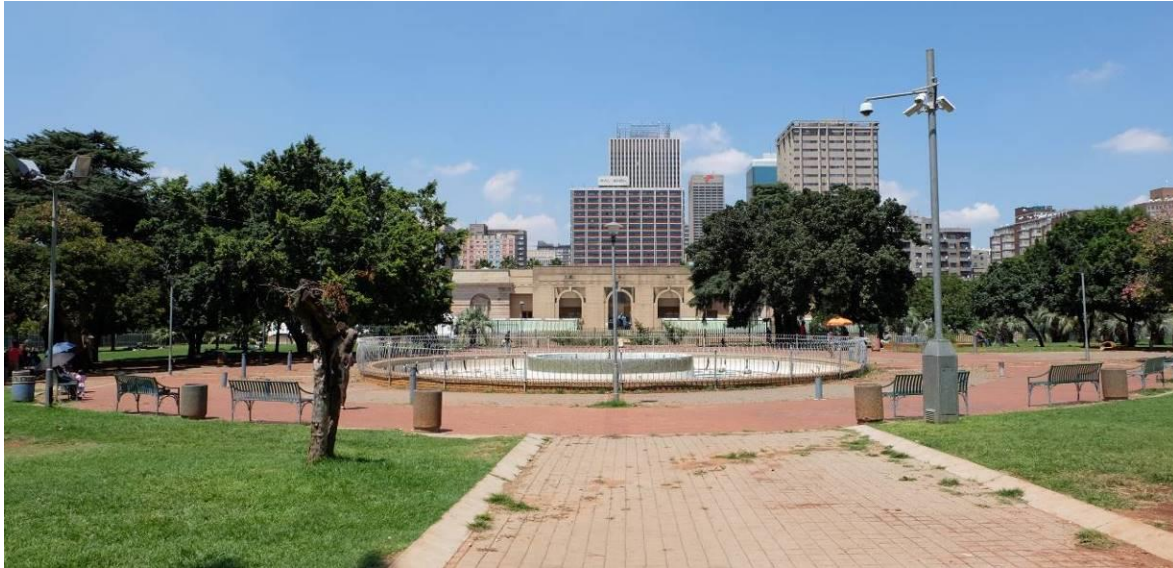
Fig. 58\_Views in southern direction towards the Johannesburg Art Gallery with centrally located fountain and paved walkways from and towards the central fountain area  
(Source: tsica heritage consultants, 2018)

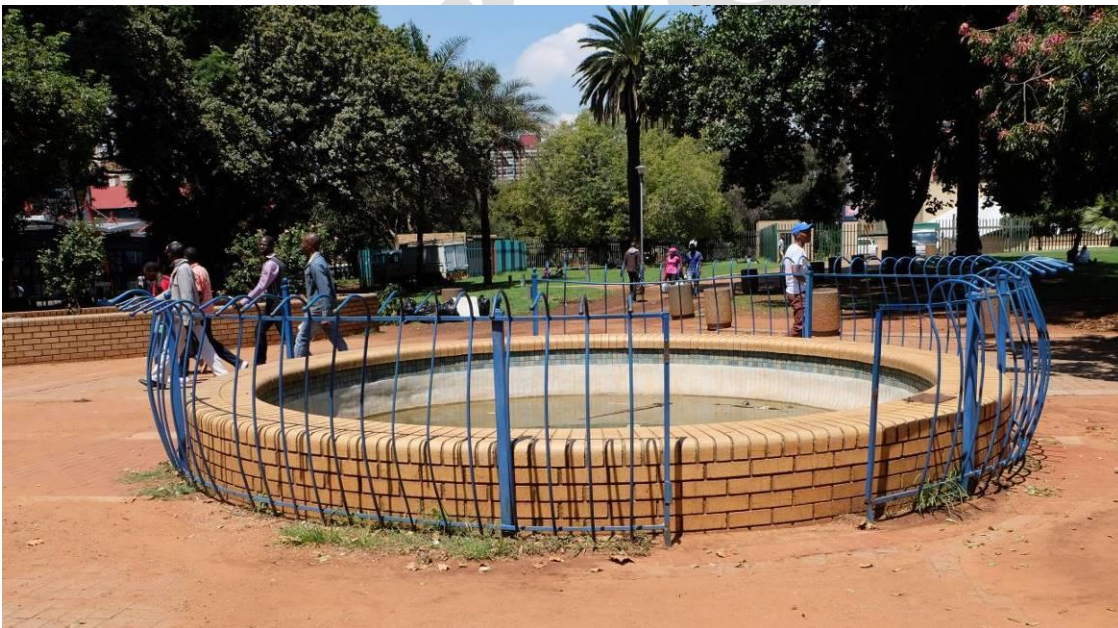
Fig. 59\_Fountain along the walkway towards the eastern and western entrance areas  
(Source: tsica heritage consultants, 2018)

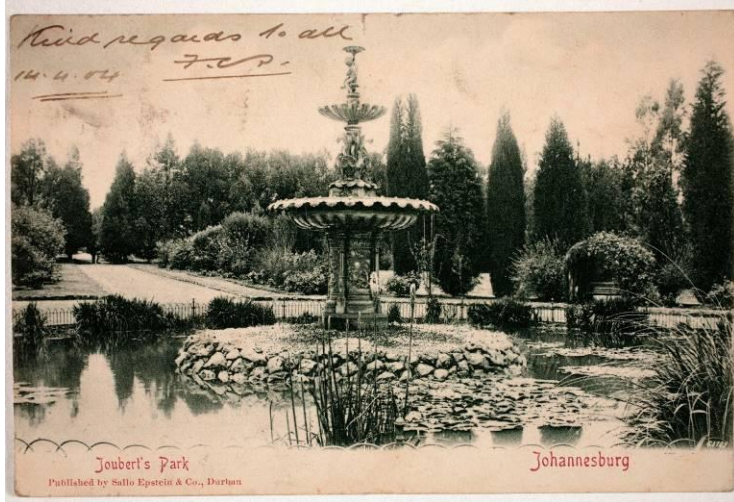
Fig. 65\_Historical postcard of the old central Fountain (1898), not existing anymore  
(Source: JAG Archives)

- The historical location of the central fountain will be maintained and as part of the long-term plan the Central fountain (footprint of the original McFarlane fountain) will be restored
- Areas will be allocated for public art and interactive public installations which can form part of exhibitions within the Johannesburg Art Gallery
- Re-introduction of sculptures within the park as part of the long-term plan to connect the Johannesburg Art Gallery to the park

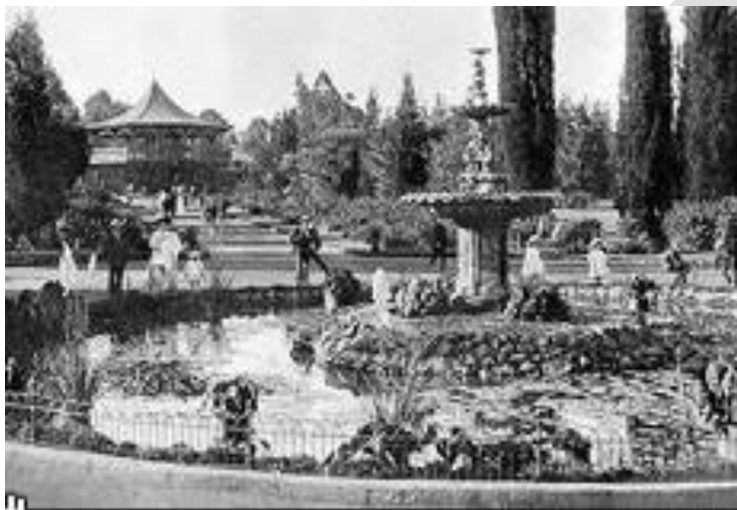
Fig. 66\_Historical image of the old central Fountain (1898) with band stand in the background  
(Source: JAG Archives)
