**Draft Report**

**Heritage Impact Assessment  
&  
Conservation Management Plan**

**for**  
**Joubert Park**  
Erf No. 5105 & Ptn 1 to 3 of Erf 5105, Johannesburg  
September 2018

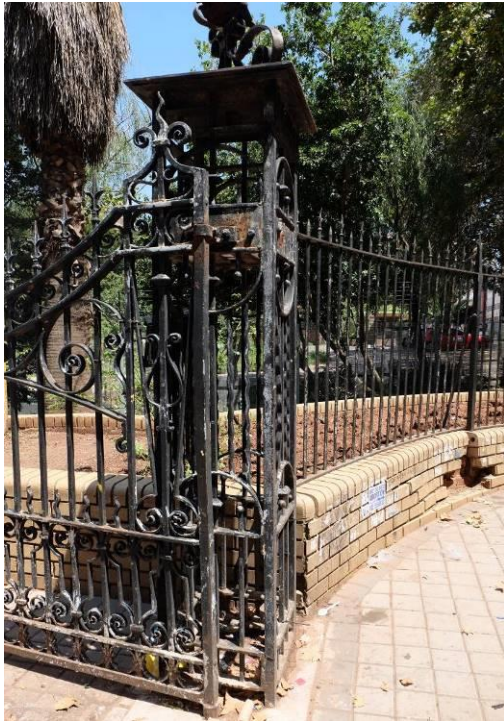
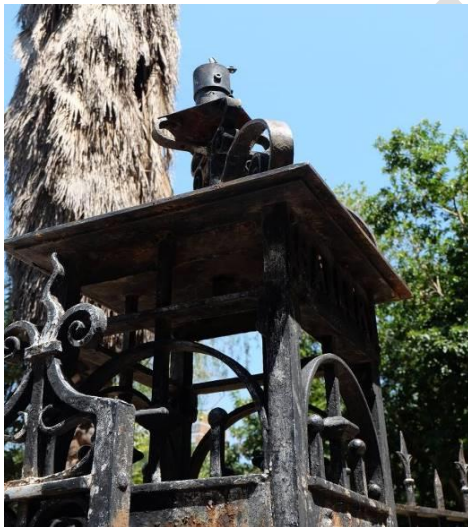
Fig. 67 to 70\_Northern entrance gate with decorative cast iron pillars and gates  
(Source: tsica heritage consultants, 2018)

- Cleaning, restoration and repair of the existing entrance gates, fences and columns
- Creation of a connecting central entrance towards the Johannesburg Art Gallery in a similar style to existing entrances

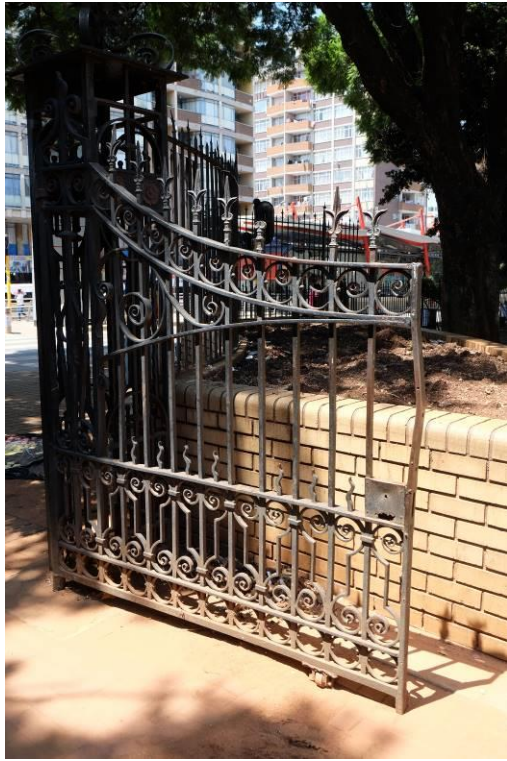
Fig. 71\_Eastern entrance gate with decorative cast iron pillars and gates  
(Source: tsica heritage consultants, 2018)

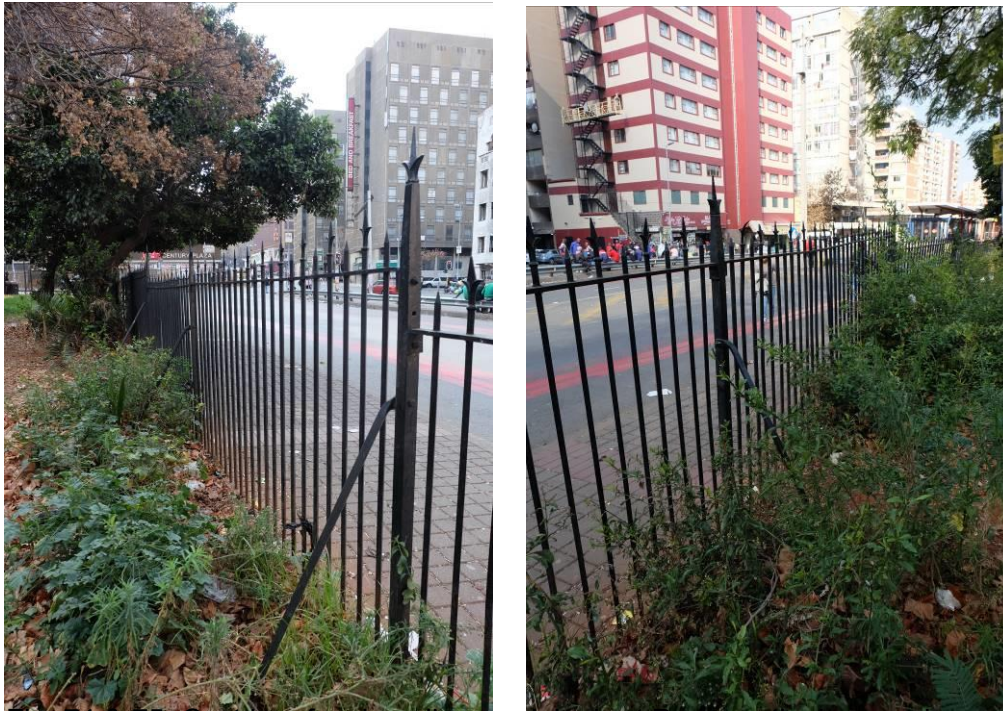
Fig. 74 & 75\_Cast iron fencing all around Joubert Park\_partly damaged or removed  
(Source: tsica heritage consultants, 2018)

<b><i>Heritage Feature</i></b>	<b><i>Nature of Development as Detailed in the Master Plan</i></b>	<b><i>Impact and Recommendation</i></b>
	Repave the existing pathways	maintained
<b>Historical Entrance Gates, Columns and Perimeter Fence</b>	<p><b>Short Term</b> The historical entrance gates and columns be cleaned and stickers, glue etc. be washed off according to the City of Johannesburg Departments of Arts Culture and Heritage Guidelines.</p> <p><b>Medium Term and Long Term</b> Replace broken and missing parts of the historical fence to maintain additional security.</p>	<p>One of the most important and valuable heritage assets of the Park. It is recommended that the gates columns be kept in a pristine condition and be painted regularly in the present paint to avoid rusting.</p> <p>Make good and replace all the broken parts of the fence.</p> <p>Once a locking system for the gates has been put in place, care should be taken to use a system that does not damage the historical gates.</p>

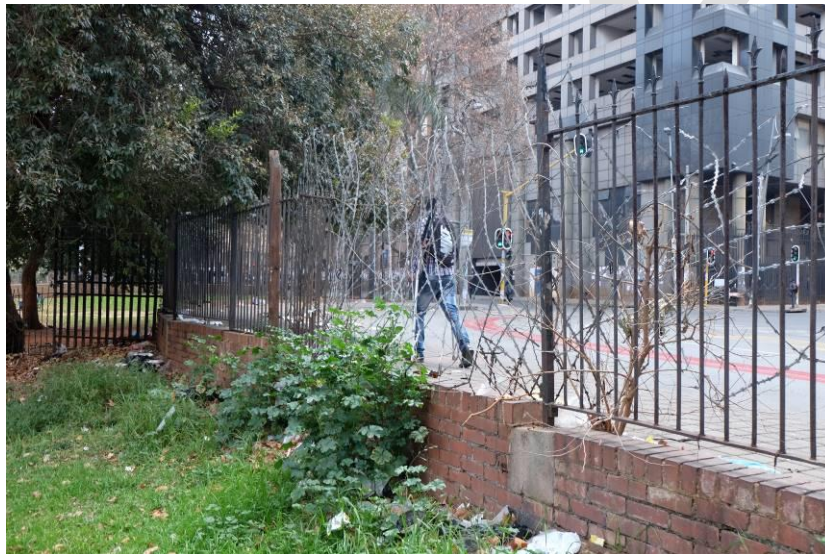
Fig. 76\_Cast iron fencing all around Joubert Park\_partly damaged or removed  
(Source: tsica heritage consultants, 2018)

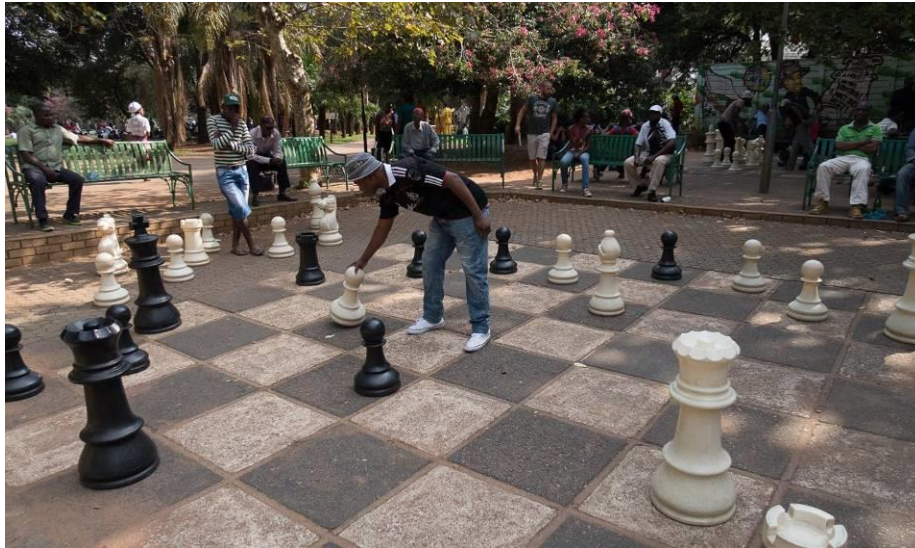
Fig. 77\_Chess area with Giant Chess Pieces in Joubert Park\_chess pieces were removed  
(Source: <http://www.theheritageportal.co.za/article/our-city-fathers-ought-be-protecting-and-defending-joubert-park>)

<b>Heritage Feature</b>	<b>Nature of Development as Detailed in the Master Plan</b>	<b>Impact and Recommendation</b>
		to instil a sense of pride.
<b>Chess Area</b>	<b>Medium to Long Term</b> Chess pieces to be restored and more chess boards to be added. Chess area to be moved as according to the Master Plan.	Impact of moving the chess area will be minimal as it will be moved a few meters towards the bandstand. The chess area is already located in that area.
<b>Children Playground</b>	<b>Short Term</b> All unsafe and broken playground equipment to be removed from the playground with immediate effect. <b>Medium Term to Long Term</b> Revamp the children's play area and introduce more equipment. A second play area is proposed south-east of the Bandstand.	The impact of replacing the equipment is positive and does not affect the historical layout of the Park as the playground will maintain its original position. It is recommended that the playground continues to maintain its position.

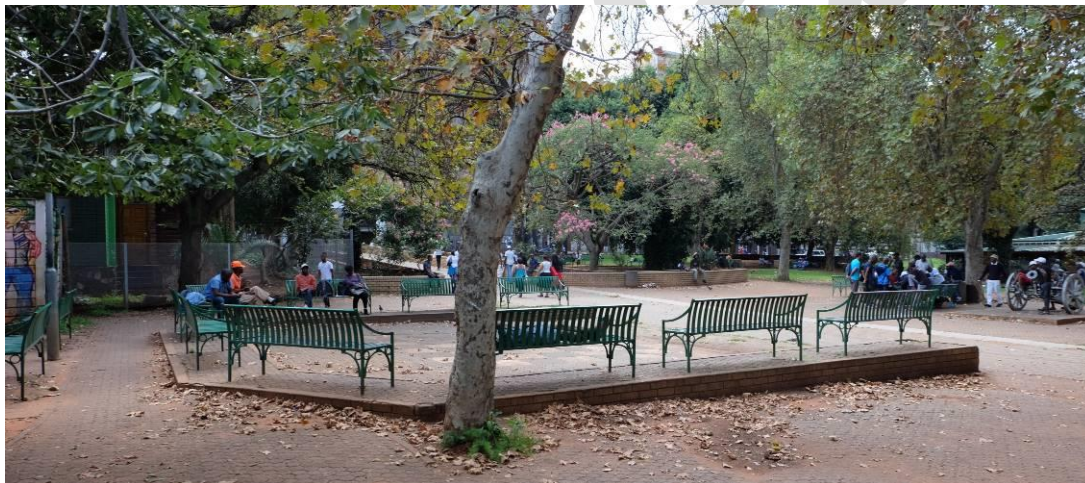
Fig. 78\_Communal areas with benches and chess tables  
(Source: tsica heritage consultants, 2018)

- Cleaning, restoration and repair of existing benches and public chess areas
- Creation and design of durable and not moveable chess furniture
- Giant chess pieces need to be kept safe during night times by security guards

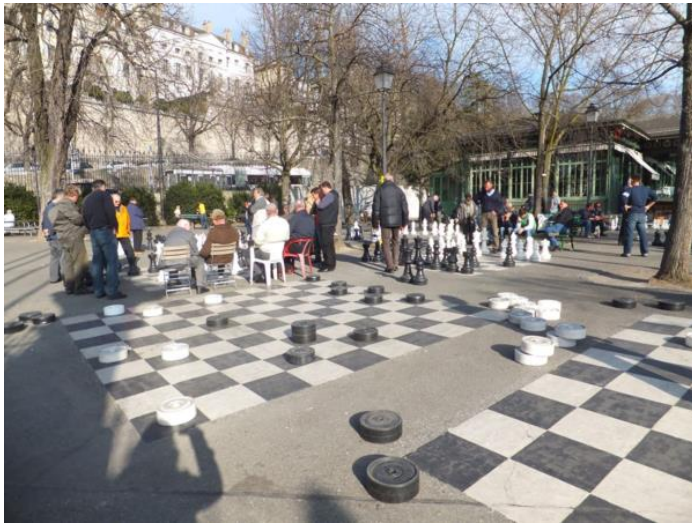
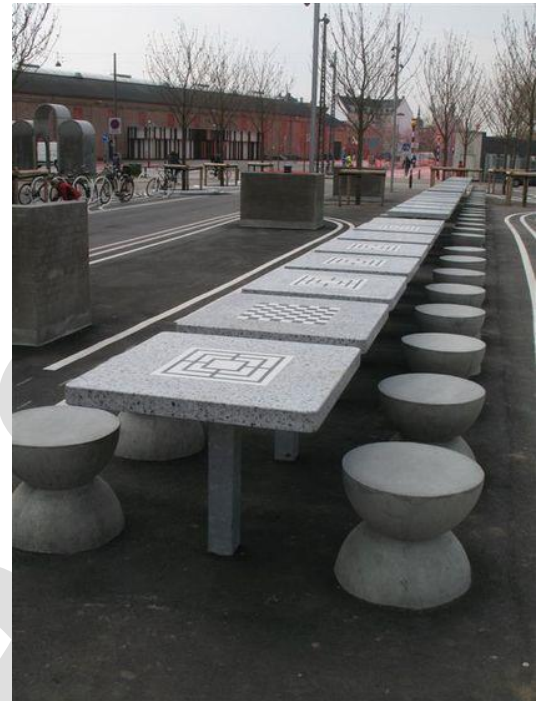
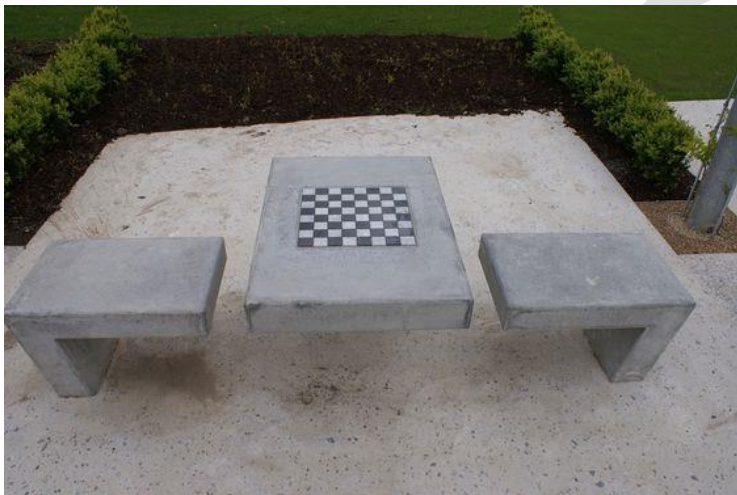
Fig. 79 to 81\_Proposed design for communal play areas with benches and chess tables  
(<https://wiki.openstreetmap.org/wiki/Tag:sport=chess>)

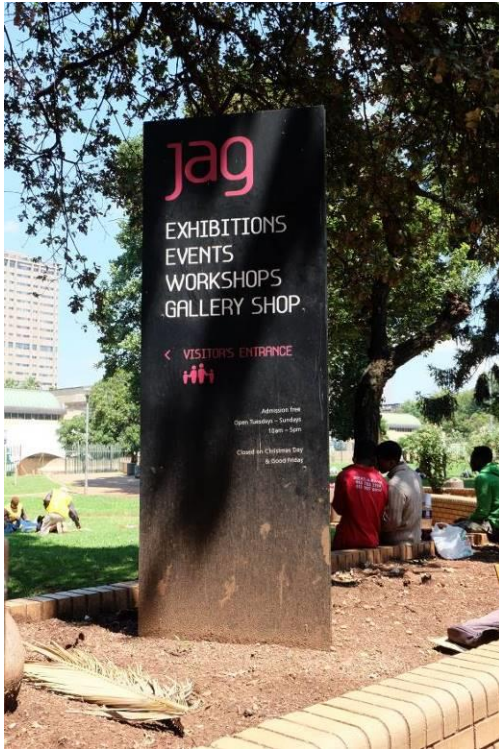
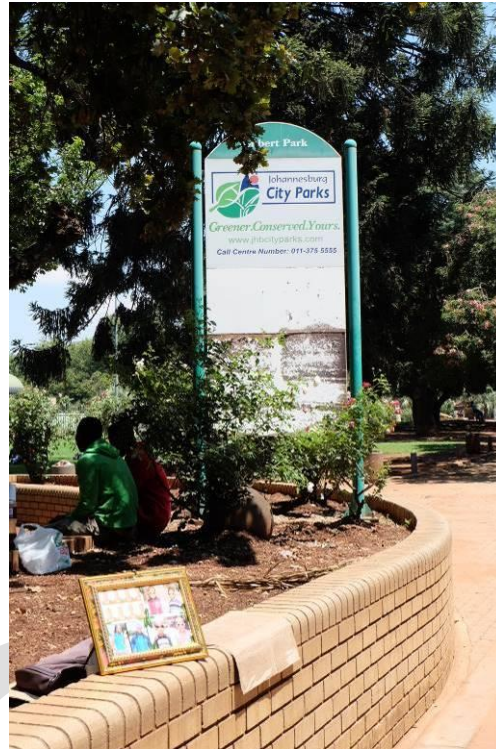
Fig. 82 & 83\_Signages from JAG and City Parks need to be looked at  
(Source: tsica heritage consultants, 2018)

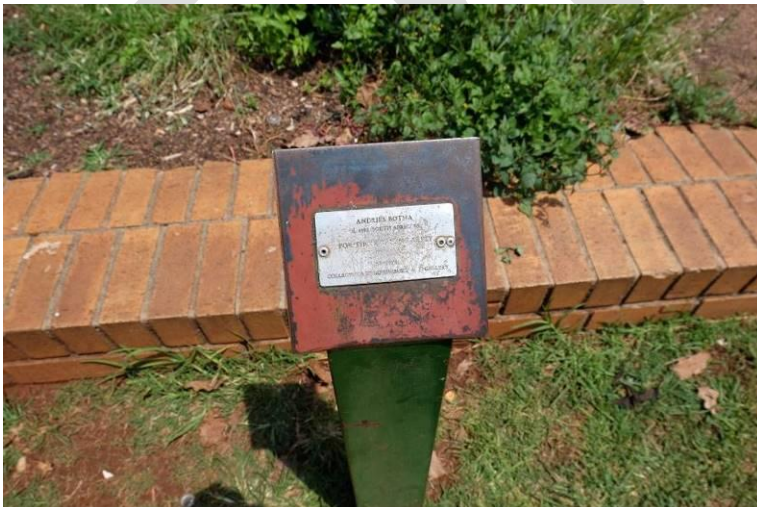
Fig. 84\_Signage for Public art  
(Source: tsica heritage consultants, 2018)

- Should inform the visitor of the history of the park and make them feel welcome
- Branding for the park as a safe communal space and visitors attraction
- Cooperation with the Johannesburg Art Gallery to create a common signage for Park and the Gallery
- Recommendations for blue plaques for and within the Park

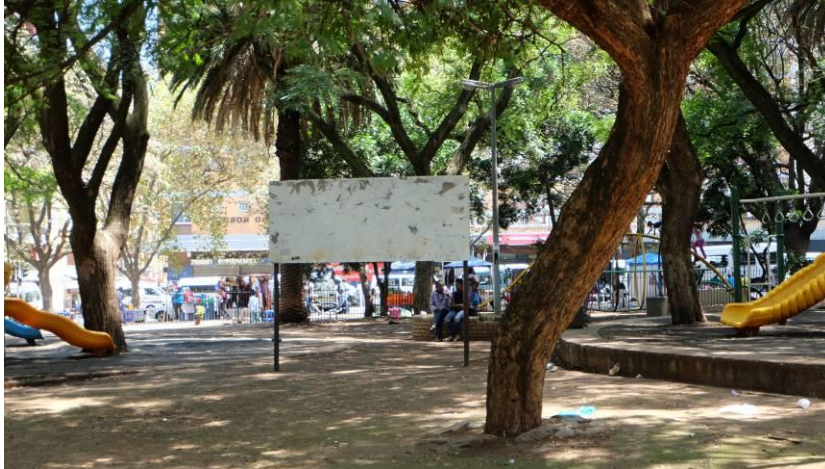
Fig. 85\_ Information boards at playground area  
(Source: tsica heritage consultants, 2018)

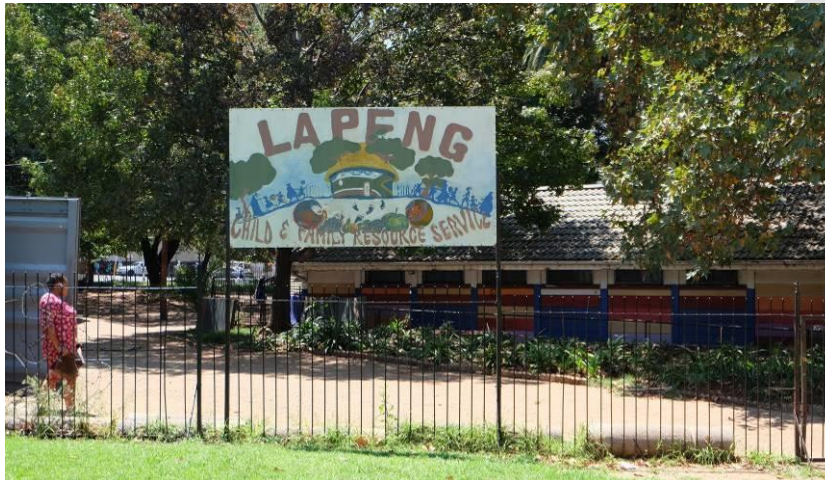
Fig. 86\_ Information boards for Creche  
(Source: tsica heritage consultants, 2018)

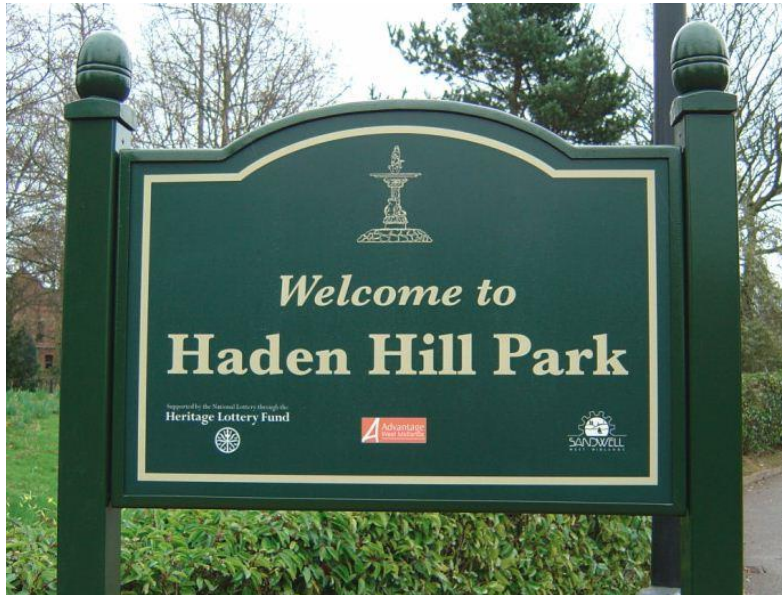
Fig.88\_Welcoming board and informative signage should have same design

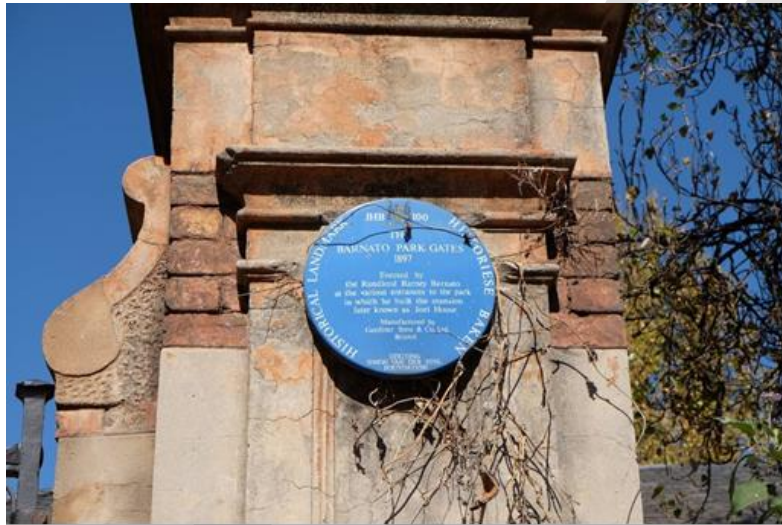
Fig.89\_Blue plaque on the Barnato Park Gates from 1897\_same suggested for Joubert Park

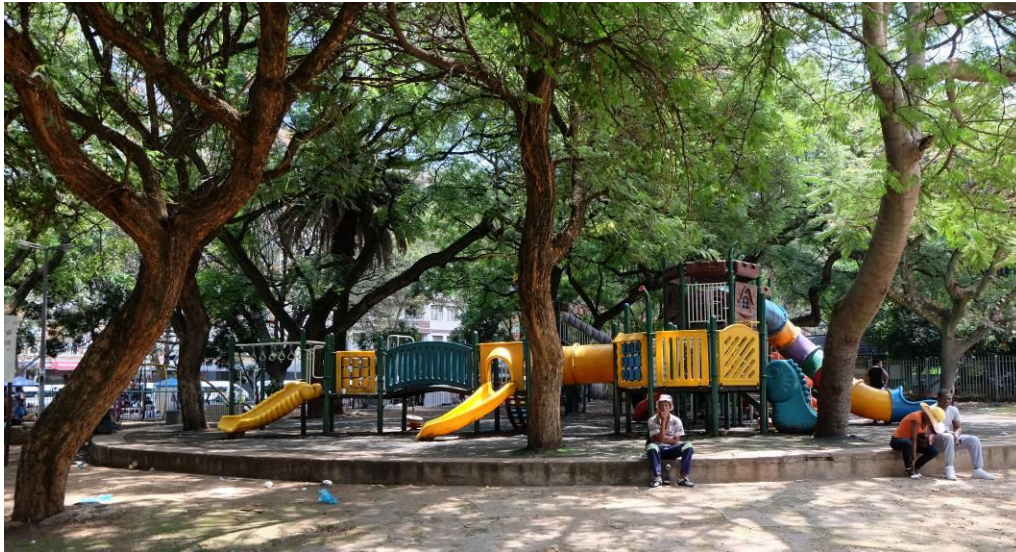
Fig. 90\_ Current state of children's playground area located along the western boundary line of the Park

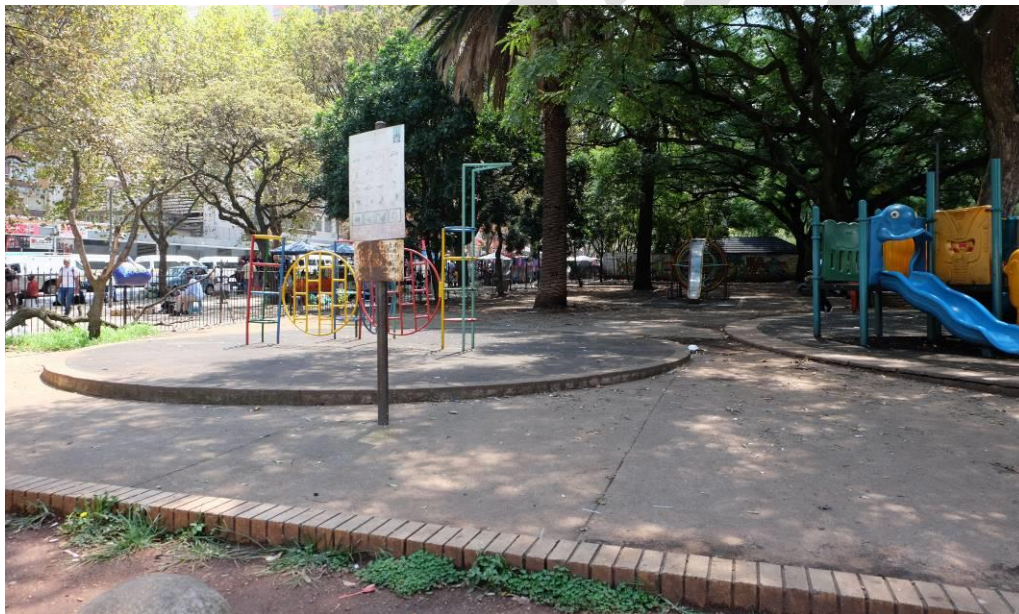
Fig. 91\_ Current state of children's playground area located along the western boundary line of the Park
