# HARNESSING HERITAGE TO EMPOWER PEOPLE IN THE WAKE OF DISASTER

The rescue restoration of the  
historic town centre of Wupperthal Mission Station  
Cedarberg, South Africa  
2019-2021

Graham Jacobs

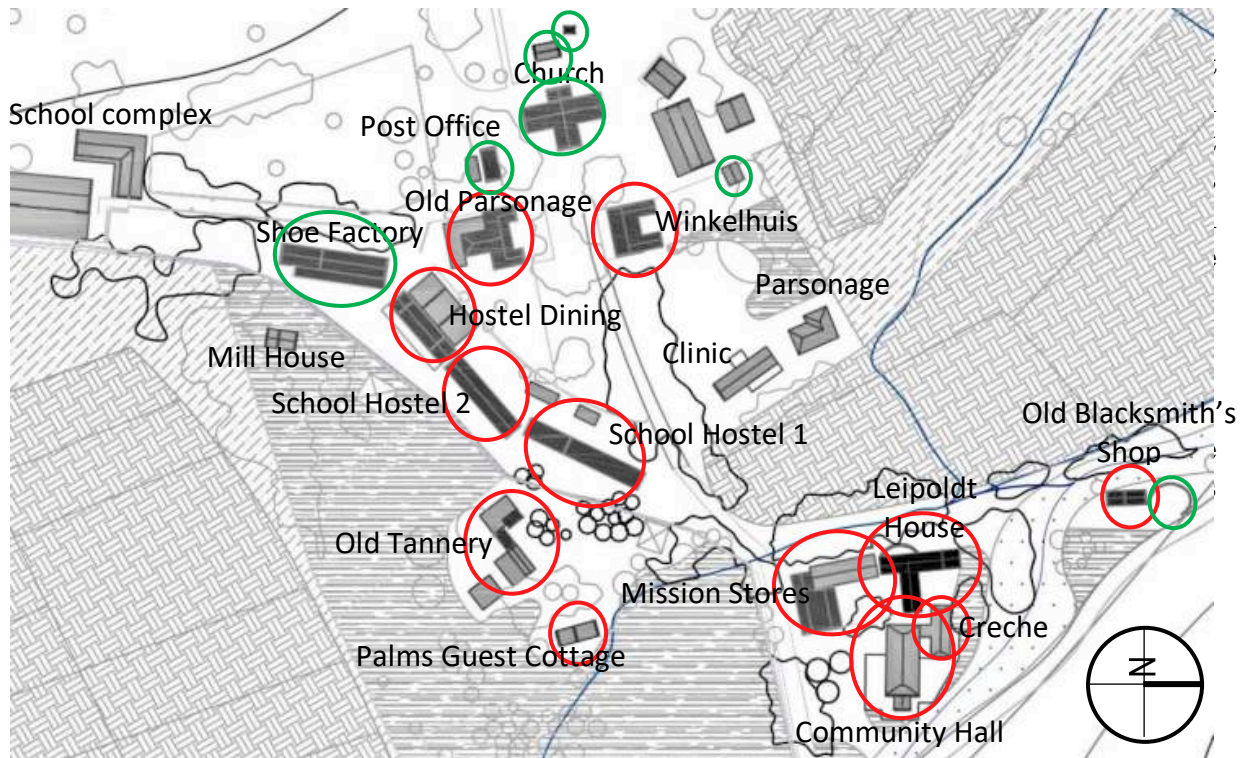
**FIGURE 2:** *Site plan of the Wupperthal town centre with buildings gutted by fire circled in red. Other buildings where significant refurbishments were done are circled in green. The church and shoe factory were miraculously not burned. (Base diagram; TV3 Architects & Planners).*

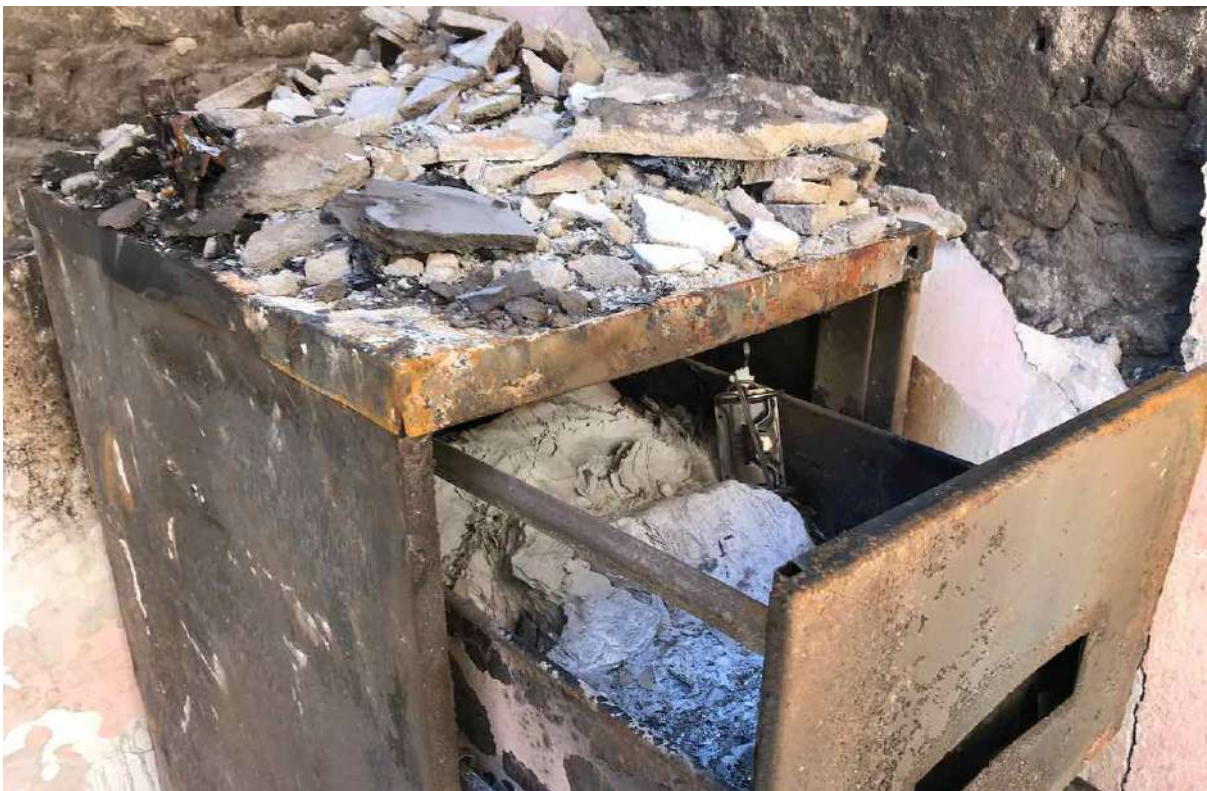
**FIGURE 5:** *Most of the town's records were lost in the fire. That included drawings, photographs, title deeds, survey diagrams and other historic and historical records that would otherwise have been useful for informing the reconstruction process. (Image: ARCON, 24 January 2019).*

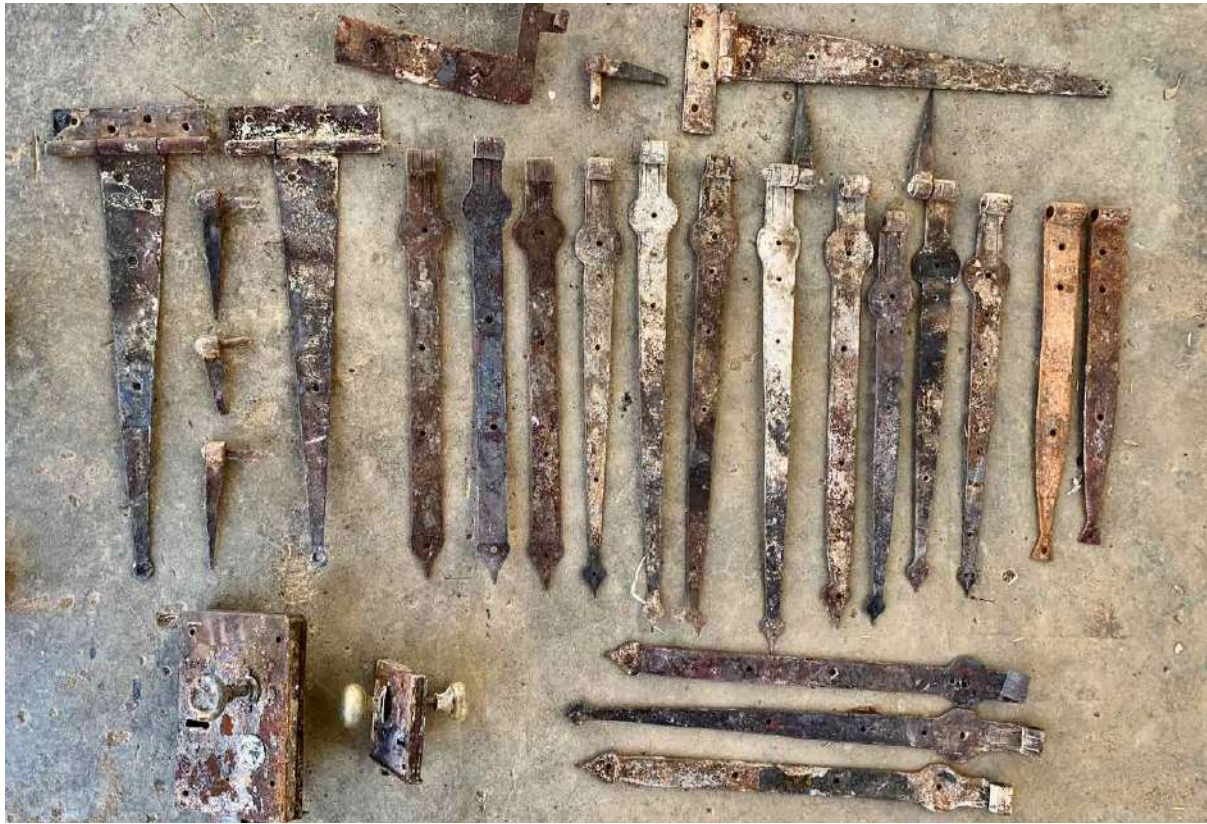
**FIGURE 7:** *Examples of historic ironmongery recovered after the fire. These included a large 19<sup>th</sup> C front door lock (bottom left). Most were recovered from the ashes and rubble of the Winkelhuis; and most, including the badly damaged and heat-seized door locks, were able to be reconditioned and reinstalled during the restoration project. (Image: ARCON, 24 January 2019).*

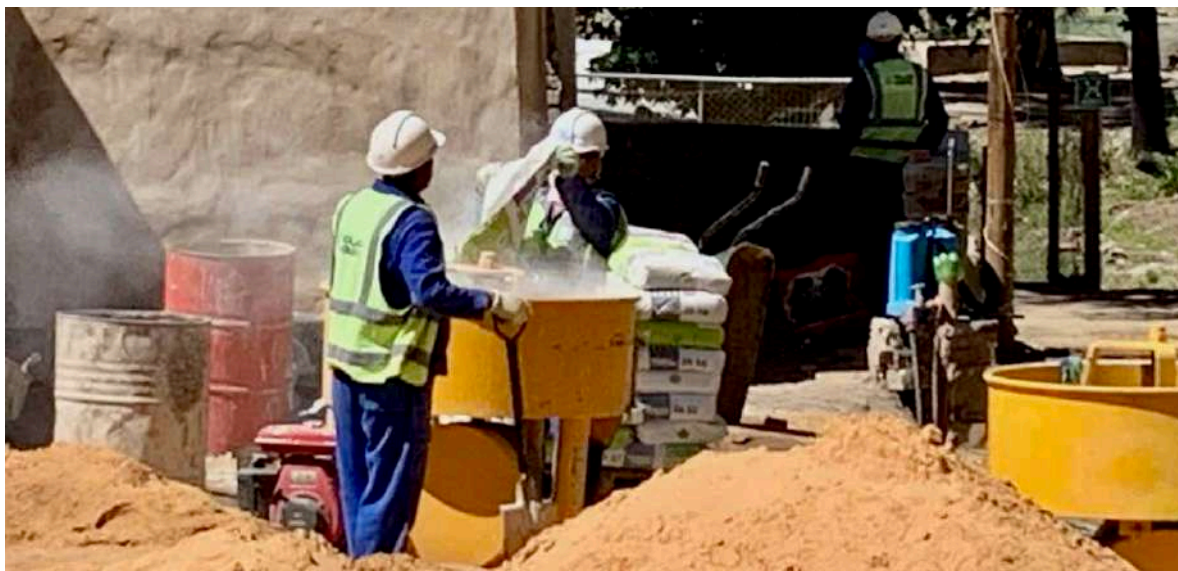
**FIGURE 9: Pan mixers in action preparing lime/sand mortars and renders.** *The sand used was Malmesbury sand which is coarser and therefore preferred over finer Cape Flats silica sands for work on historic buildings. (Image: ARCON, 25 October 2019).*

The contract had a special condition that pan mixers were to be used for the mixing of lime/sand mortars and renders. That was to ensure that the ingredients would be properly mixed to avoid possible future adhesion problems and weak spots. Improperly mixed and poorly prepared and cured lime mortars and renders have been one of the main problems behind the unfair reputation that lime products have acquired in the construction industry in South Africa. One unexpected drawback of using lime was discovering during the first winter months when temperatures in the Cederberg occasionally plunged to below freezing point. Lime stops hardening below 5° C which consequently did slow operations during the coldest days. From then onwards, the contractor was instructed to keep a maximum/minimum thermometer in the site office and daily temperatures were recorded and included in the contractor's monthly reports.

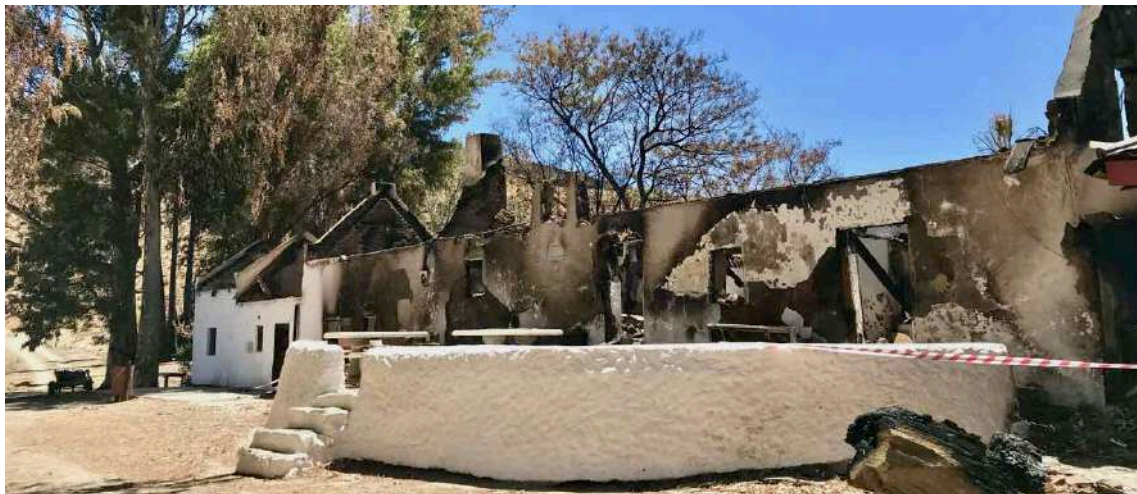
**FIGURE 10A:** *Exterior of Leipoldt House after the fire. This building is most probably the original Rietmond farmhouse, pre-dating the arrival of the Rhenish missionaries by about 30 years. The uncharacteristic semicircular stoep appears to have been used as a podium from which open air services were conducted before the church was completed, explaining its non-traditional shape. (Image: ARCON, 25 October 2019).*

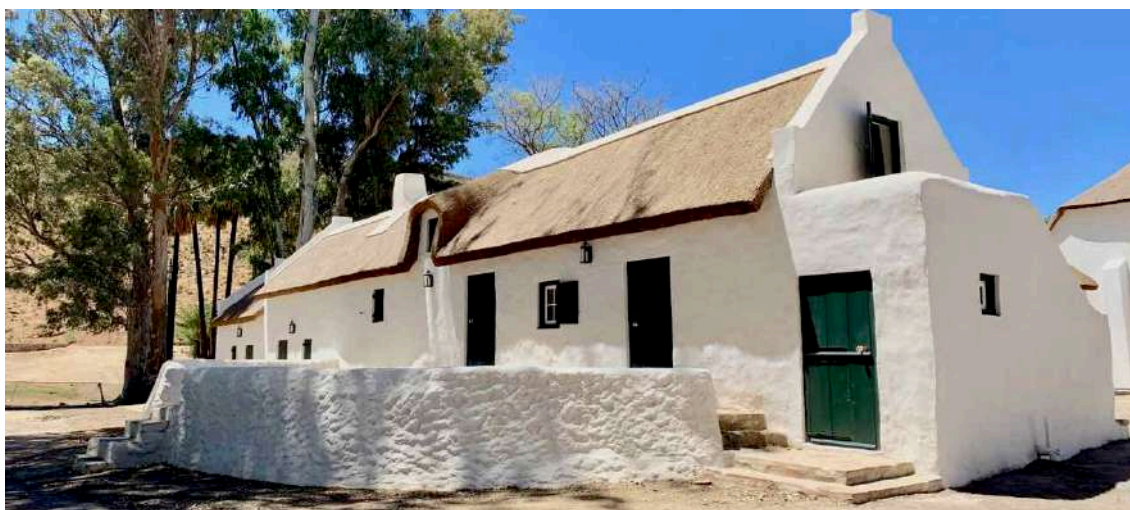
**FIGURE 10B:** *Exterior of Leipoldt House after restoration. (Image: ARCON, 27 Nov 2020).*

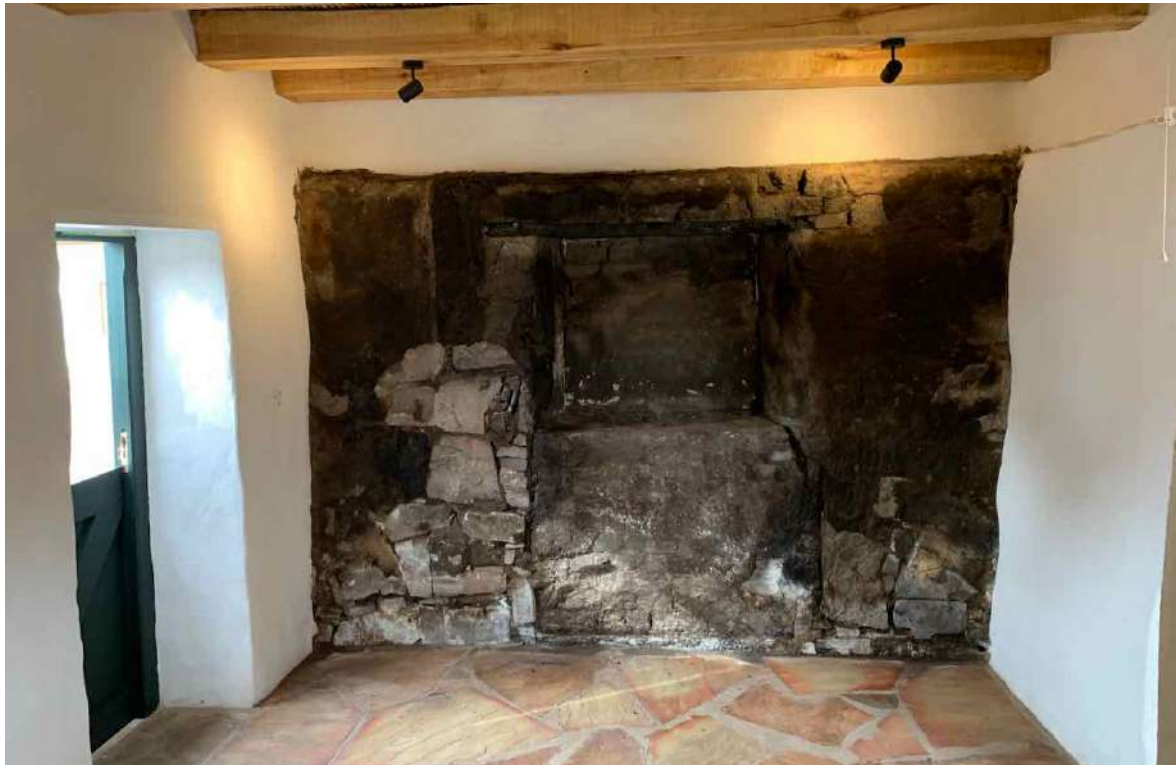
**FIGURE 10E: Leipoldt House memorial wall:** It was decided that one of the end walls in Leipoldt House should be retained in the condition in which it was found after the fire to commemorate the disaster. This was considered especially relevant as this part of the building is scheduled to become the town's museum. (Image: ARCON, 8 June 2021).

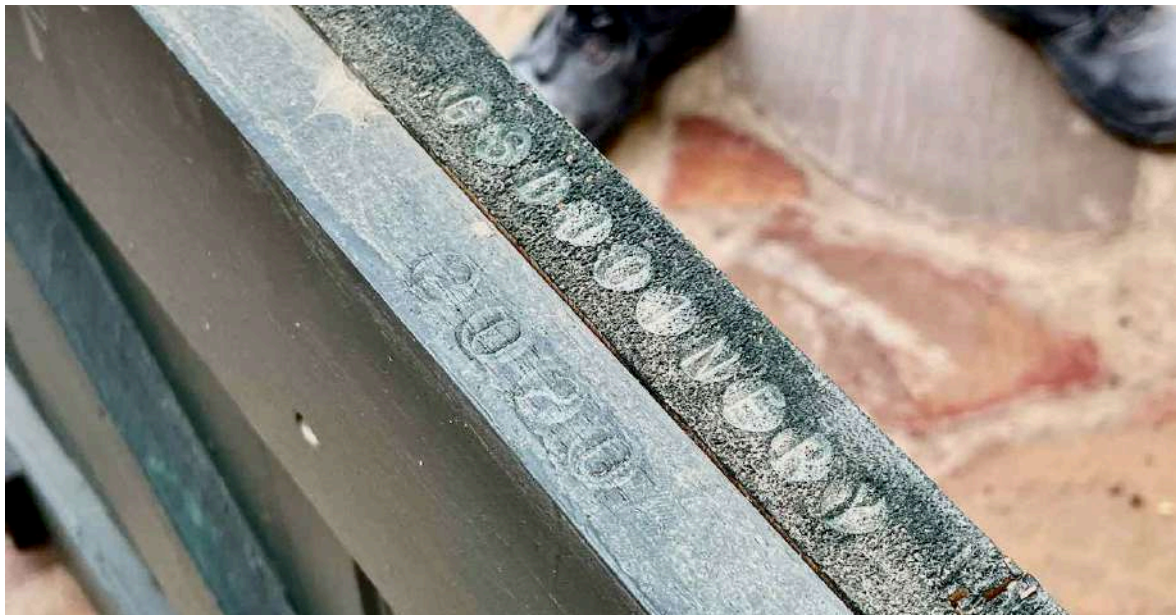
**FIGURE 10F: Carpenter's marks:** All new joinery in Leipoldt House and other buildings was stamped with the name of the joiner and date of fabrication in inconspicuous places as a record for future researchers: all in the tradition of historic carpenter's marks incised into their work through the ages, and consistent with similar early practices in the town (see **Figure 16C**) (Image: ARCON, 8 June 2021).

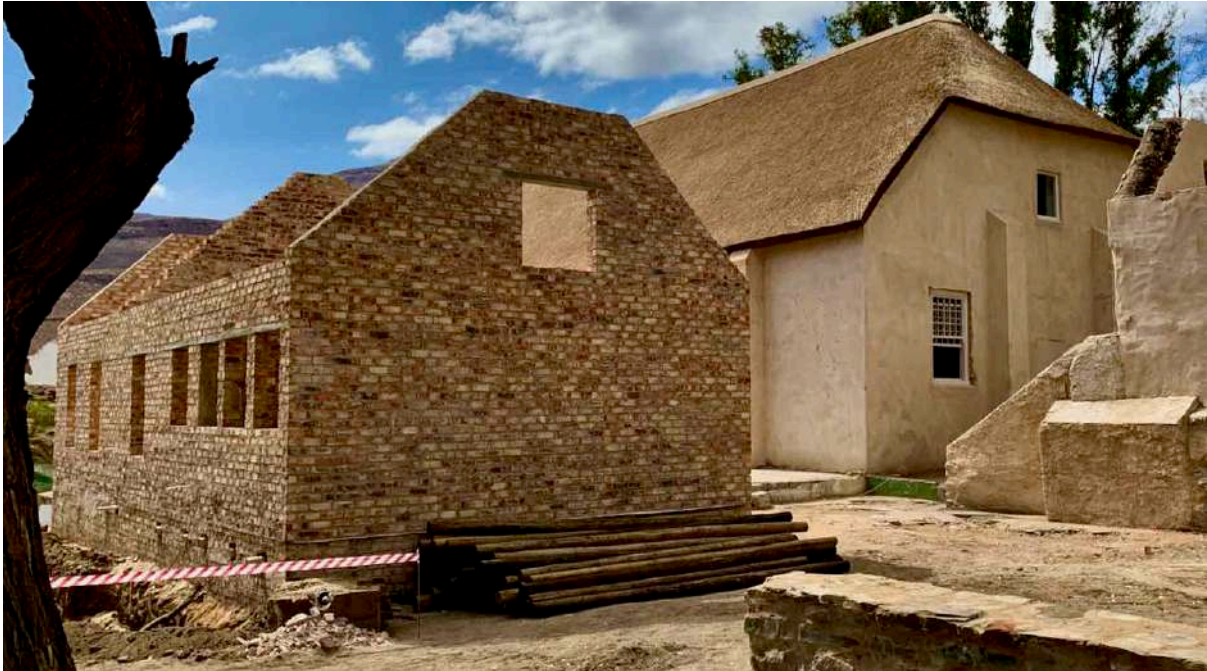
**FIGURE 12A:** *The Creche Building under reconstruction (left) to accommodate new toilets and office space for the Community Hall.* (Image: ARCON, 21 January 2020).

The Creche building, constructed in c1980 with the Community Hall, was so badly damaged by the fire that the remains had to be demolished down to foundation level. The Moravian Church then decided to relocate the creche and requested that the building be reconstructed to accommodate new toilets and an office for the restored hall.

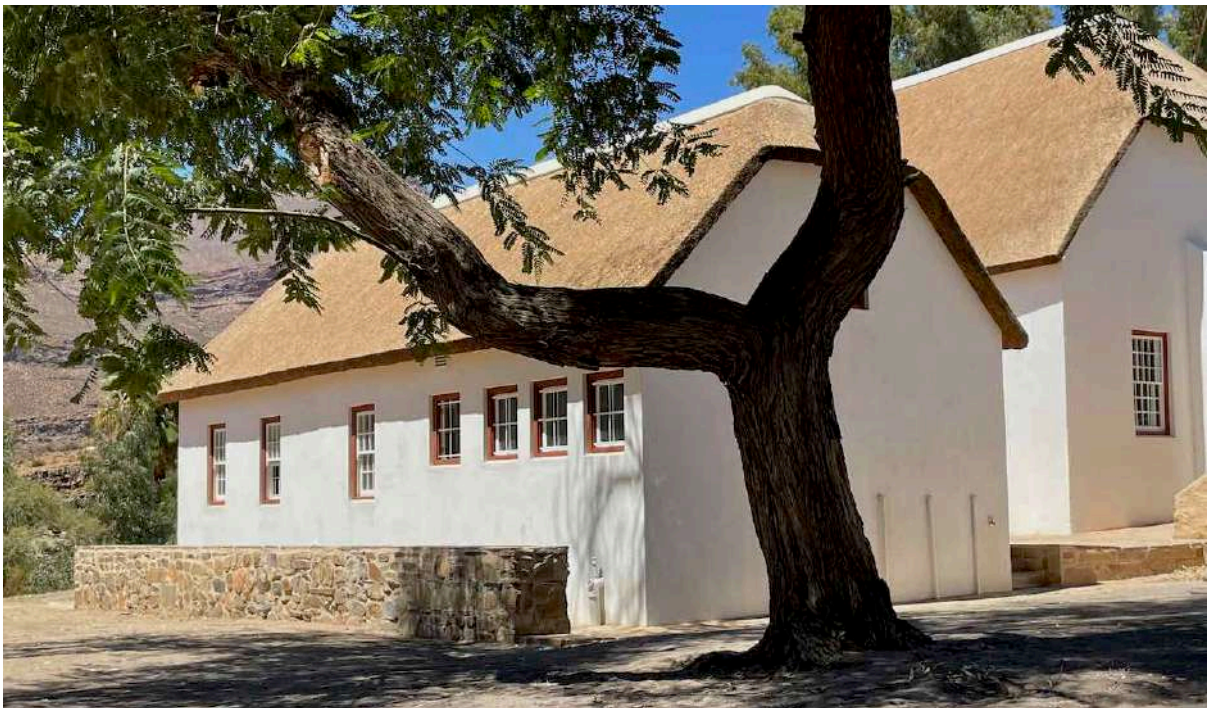
**FIGURE 12B:** *The Creche Building completed.* (Image: ARCON, 23 February 2021).

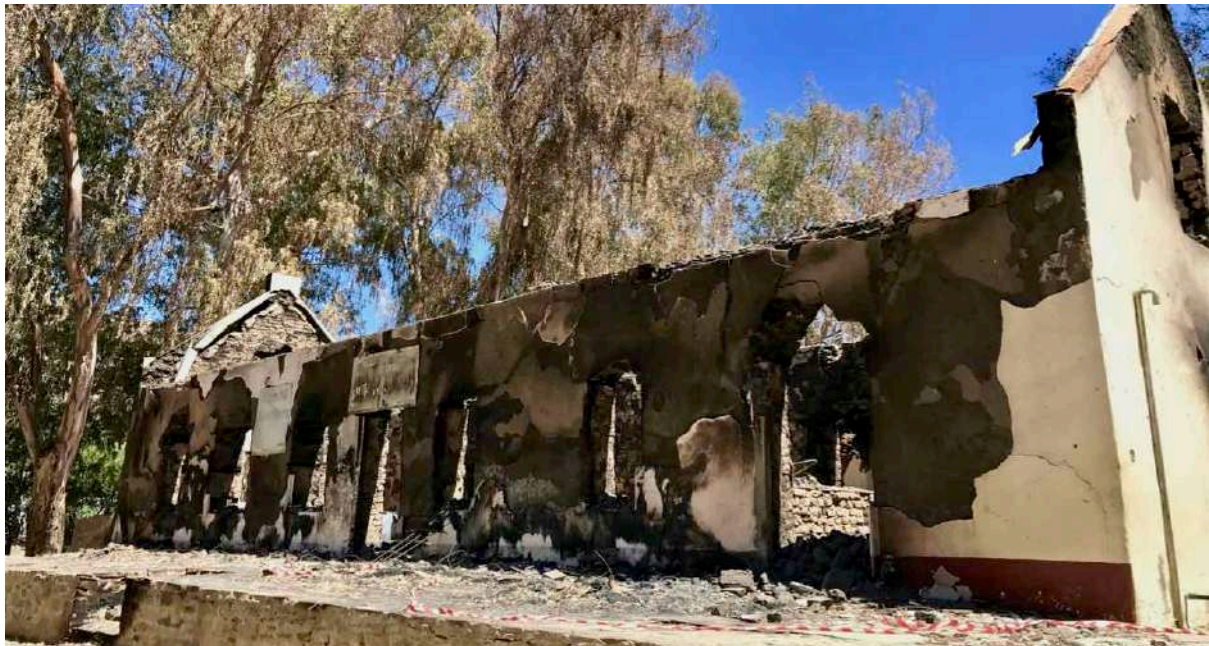
The Mission Stores, one of the oldest buildings constructed or enlarged by the Rhenish missionaries, originally housed the first school in Wupperthal. Fransen records the building as having sash windows stylistically dating back to c1830 with much internal timberwork of the same period. All of this was, most unfortunately, lost in the fire. At the request of the Moravian Church, it was decided to restore the building to include a restaurant and kitchen as an opportunity for promoting local business and job creation.

**FIGURE 13A:** *The Mission Stores Building after the fire.* (Image: ARCON, 24 January 2019).

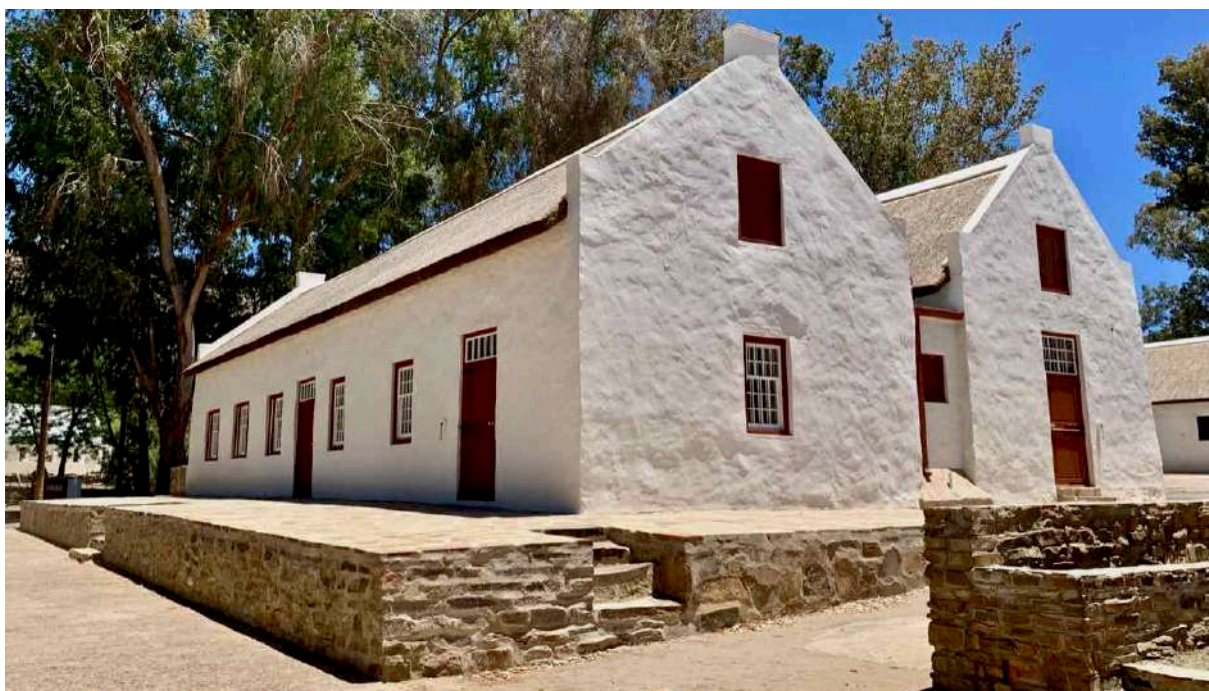
**FIGURE 13B:** *The Mission Stores Building restored to include a restaurant and catering kitchen.* (Image: ARCON, 9 March 2021).

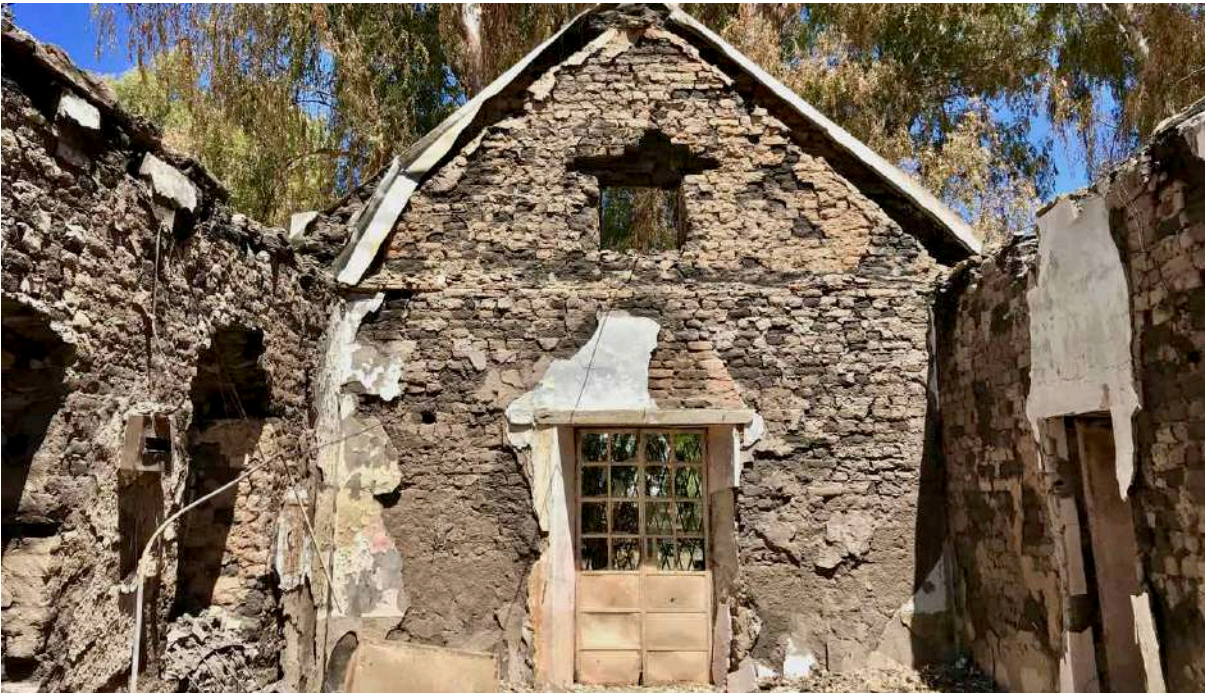
**FIGURE 13C:** *Part of the Mission Stores interior after the fire.* (Image: ARCON, 9 March 2021).

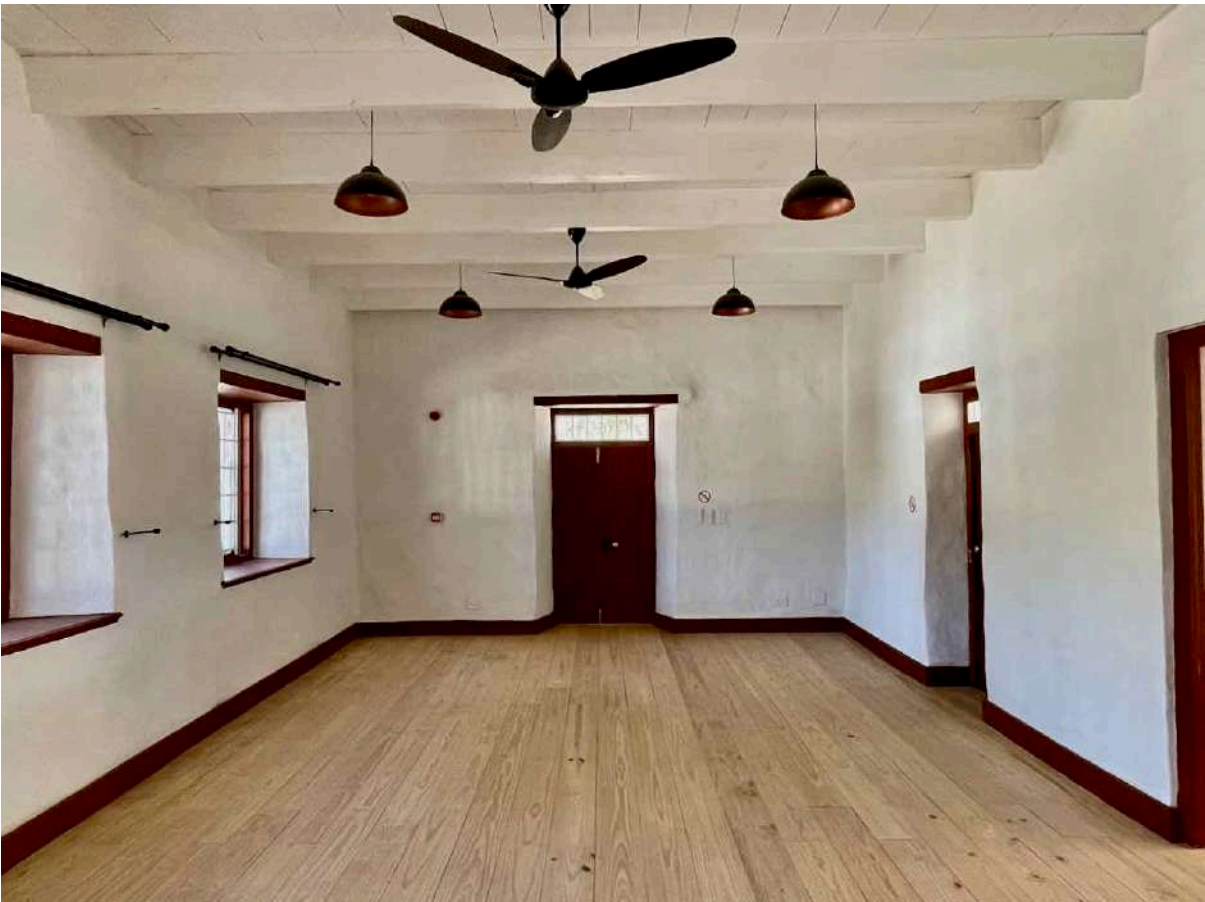
**FIGURE 13D:** *The same view of the Mission Stores interior after restoration, now intended for use as restaurant space opening onto a small terrace.* (Image: ARCON, 18 May 2021).

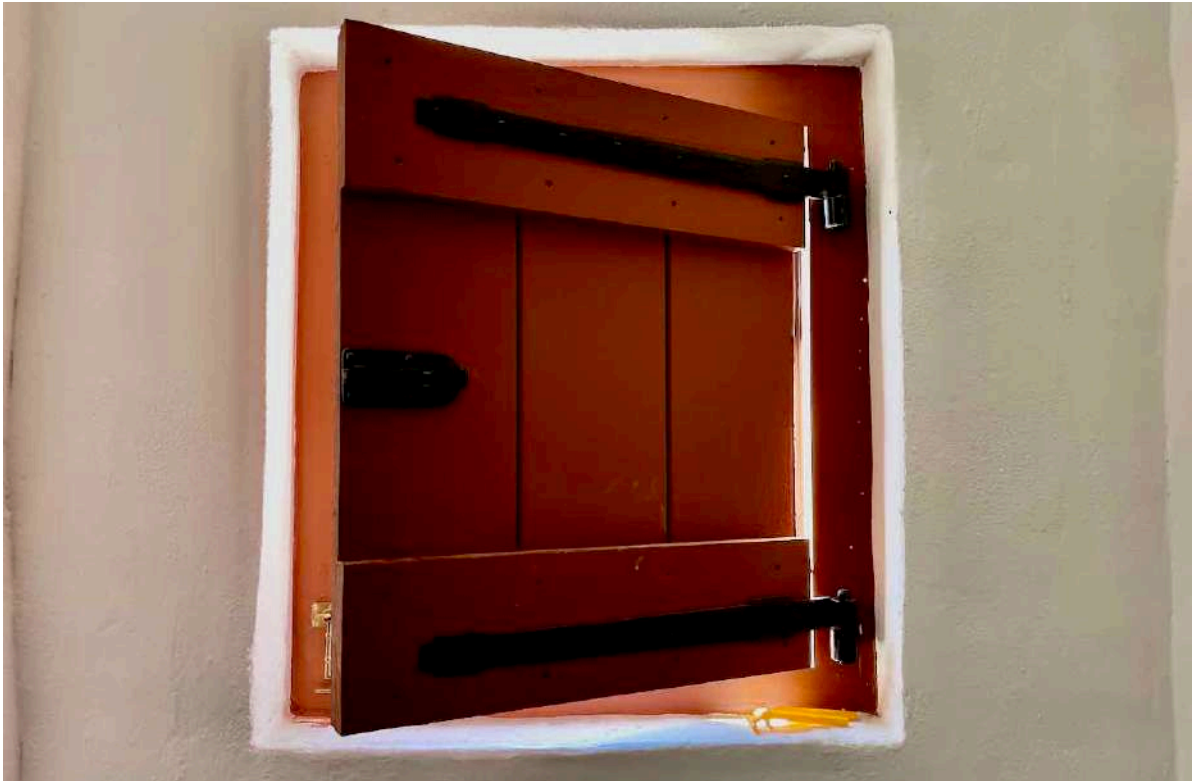
**FIGURE 13E:** *Example of old wrought iron strap hinges recovered after the fire, refurbished and reinstalled in the Mission Stores building. (Image: ARCON, 7 April 2021).*

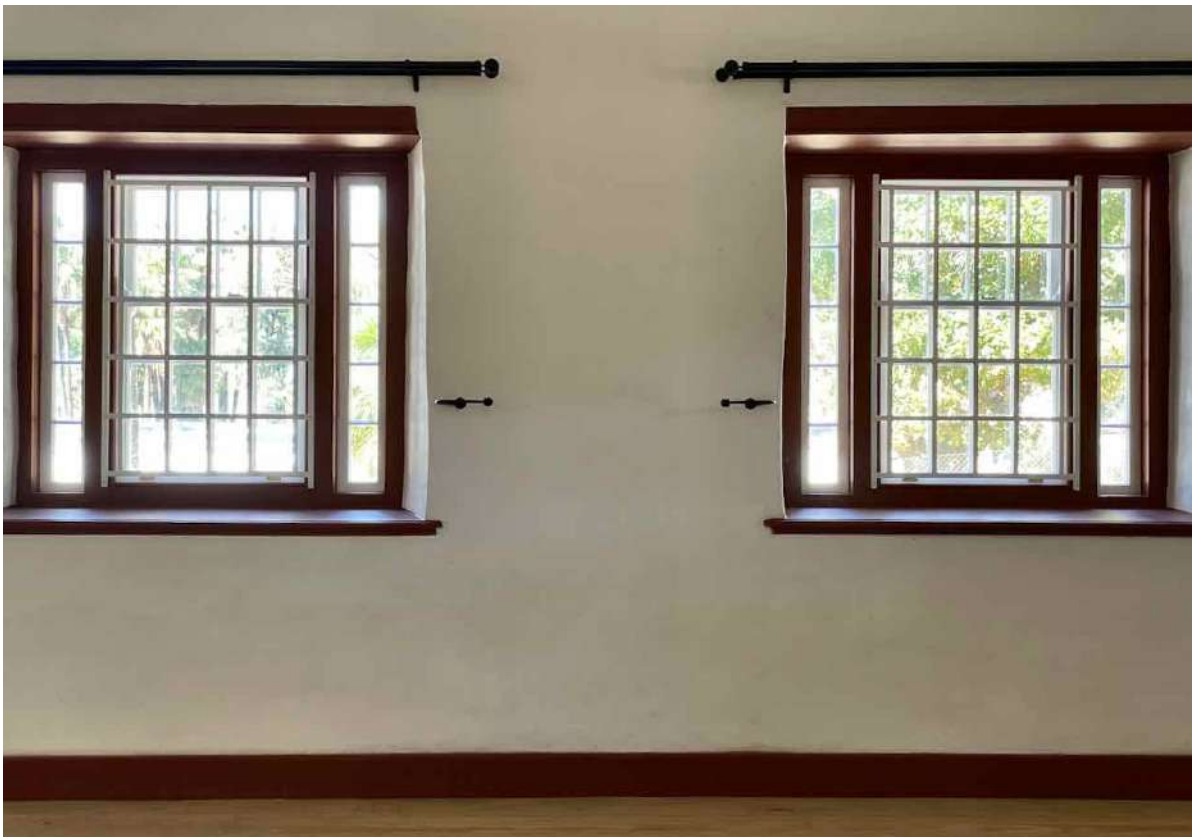
**FIGURE 13F:** *Replacement windows in the Mission Stores after restoration. It is suspected that the additional glazing on the sides was to provide extra light for pupils when the building was still a school in the 1830's. (Image: ARCON, 7 April 2021).*

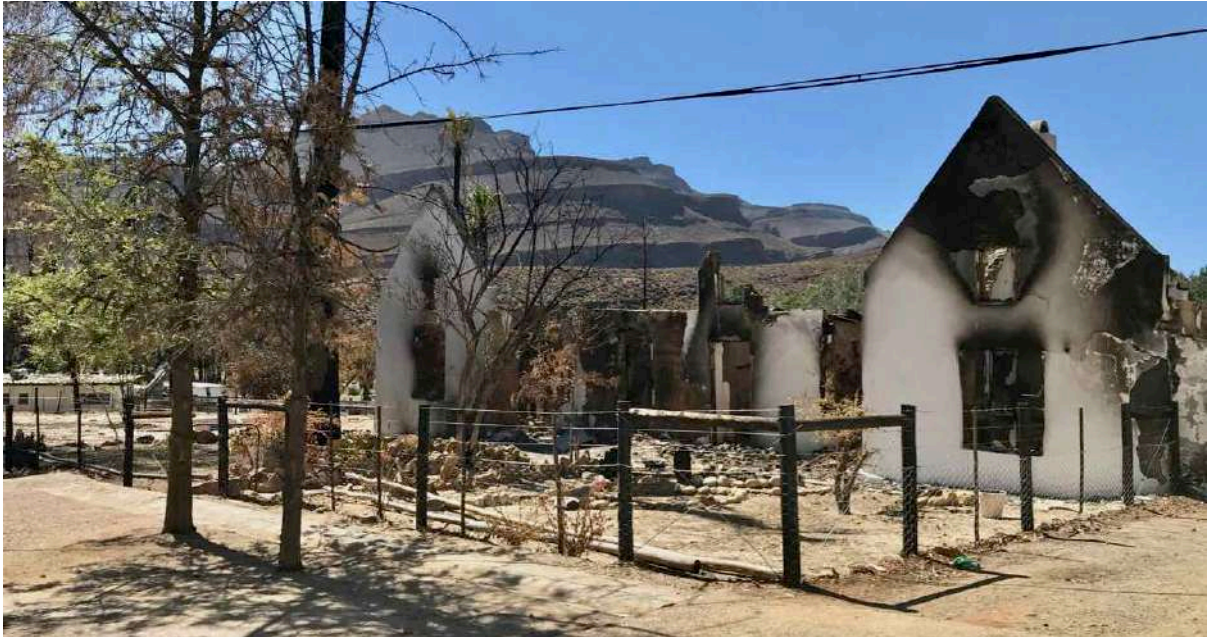
**FIGURE 14A:** *The Parsonage after the fire.* (Image: ARCON, 24 January 2019).

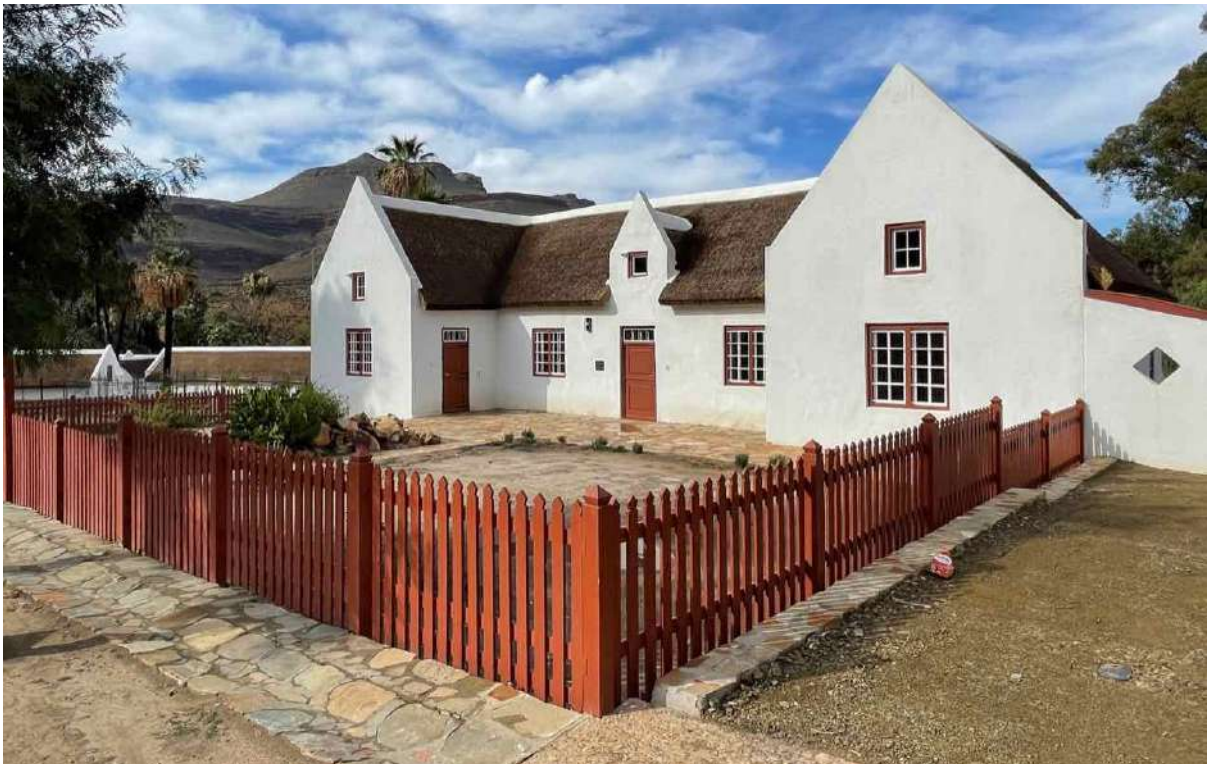
**FIGURE 14B:** *The Parsonage after restoration.* The palisade fence was copied from remains that survived the fire in front of the Winkelhuis opposite. (Image: ARCON, 8 June 2021).

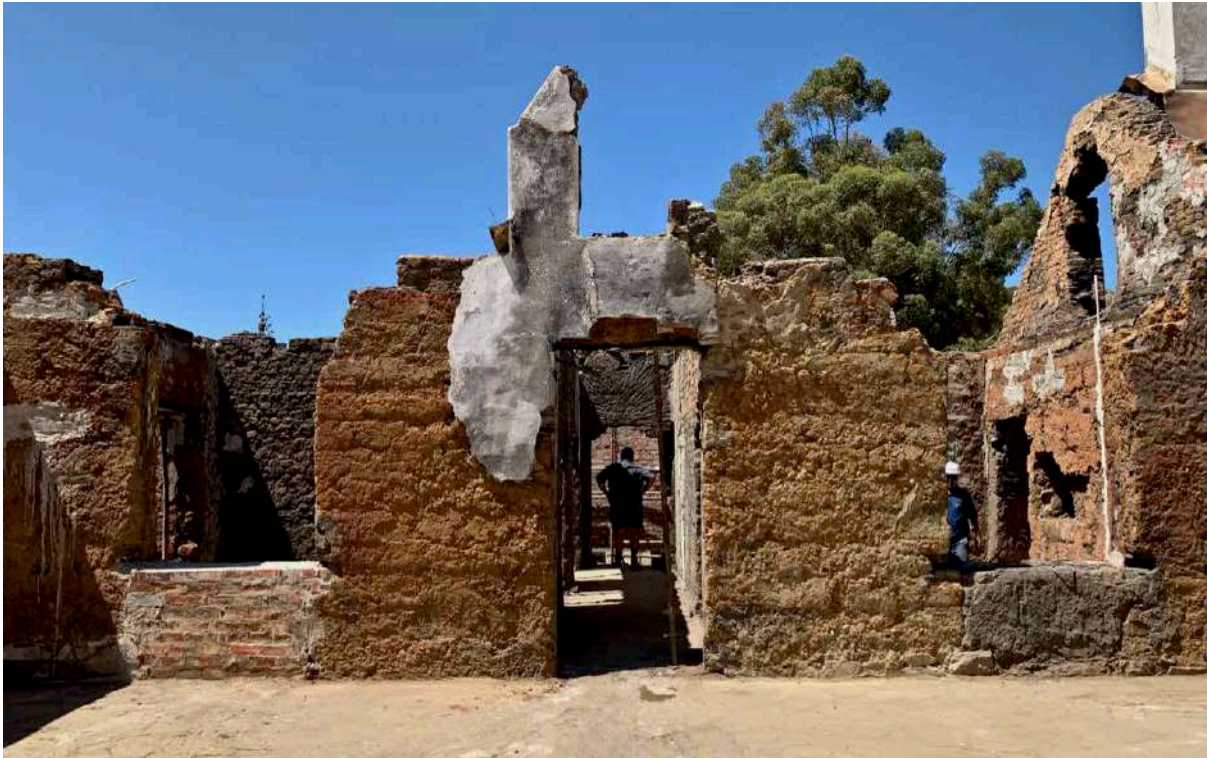
**FIGURE 14C:** *The front façade of the Parsonage after the fire debris had been cleared. The rammed earth construction of the central portion of the facade is clearly evident in the horizontal wall striations. (Image: ARCON, 30 January 2020).*

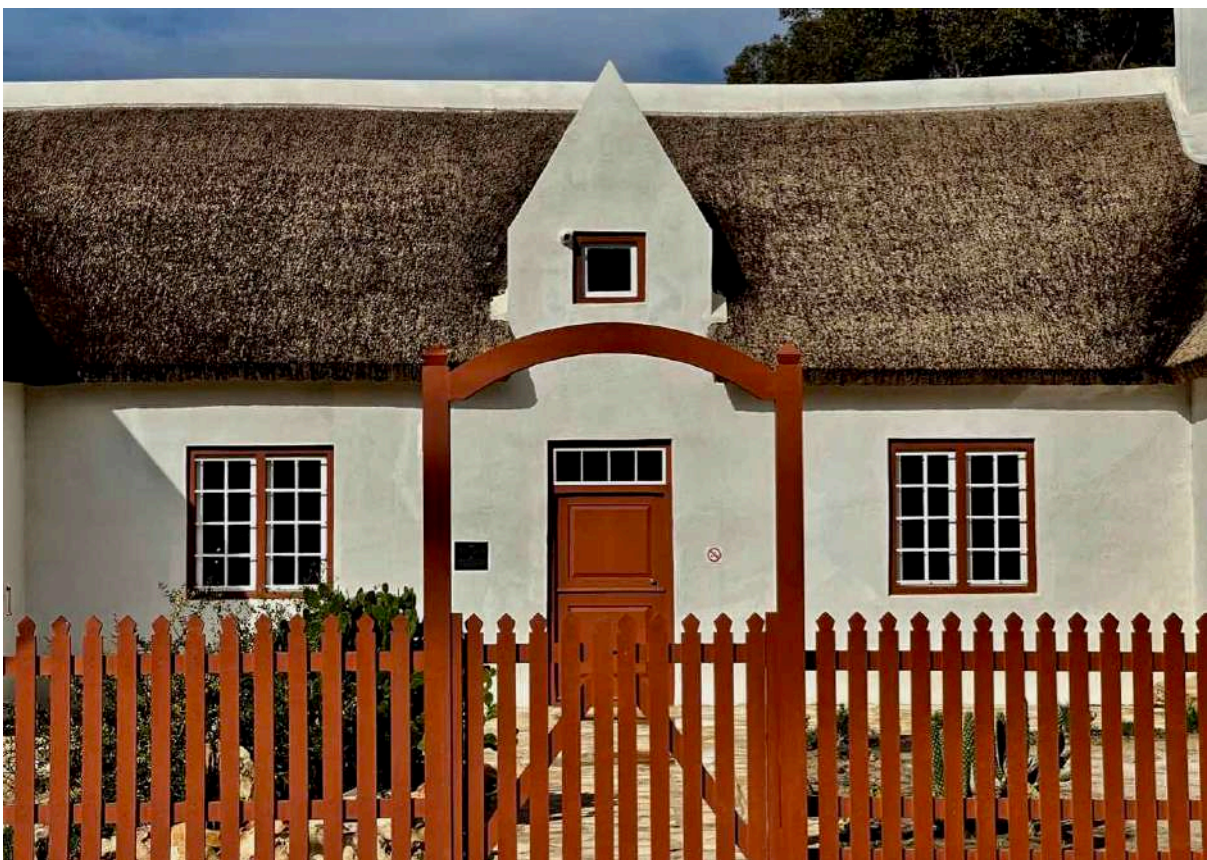
**FIGURE 14D:** *The front façade of the Parsonage after restoration. (Image: ARCON, 8 June 2021).*

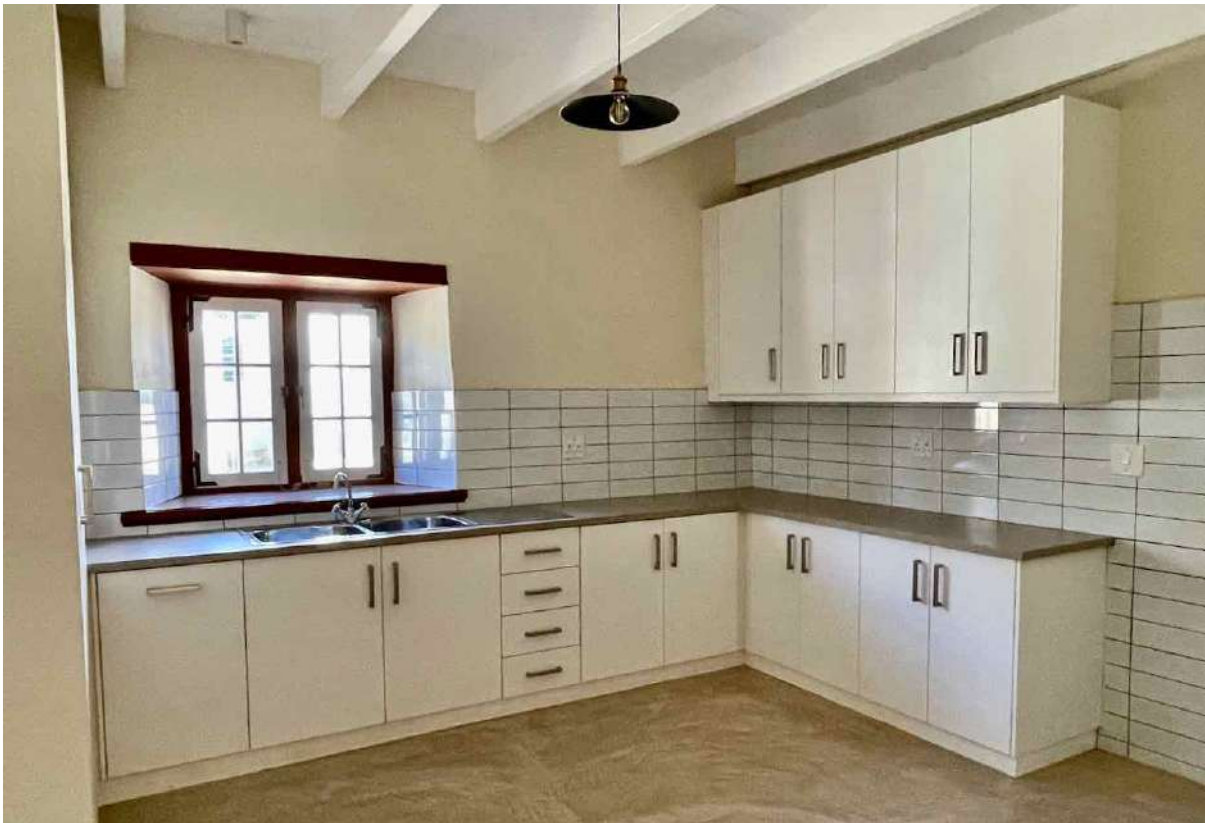
**FIGURE 14E:** *The new simple, yet contemporarily styled Parsonage kitchen installed in the Parsonage as part of the reconstruction works. (Image: ARCON, 7 April 2021).*

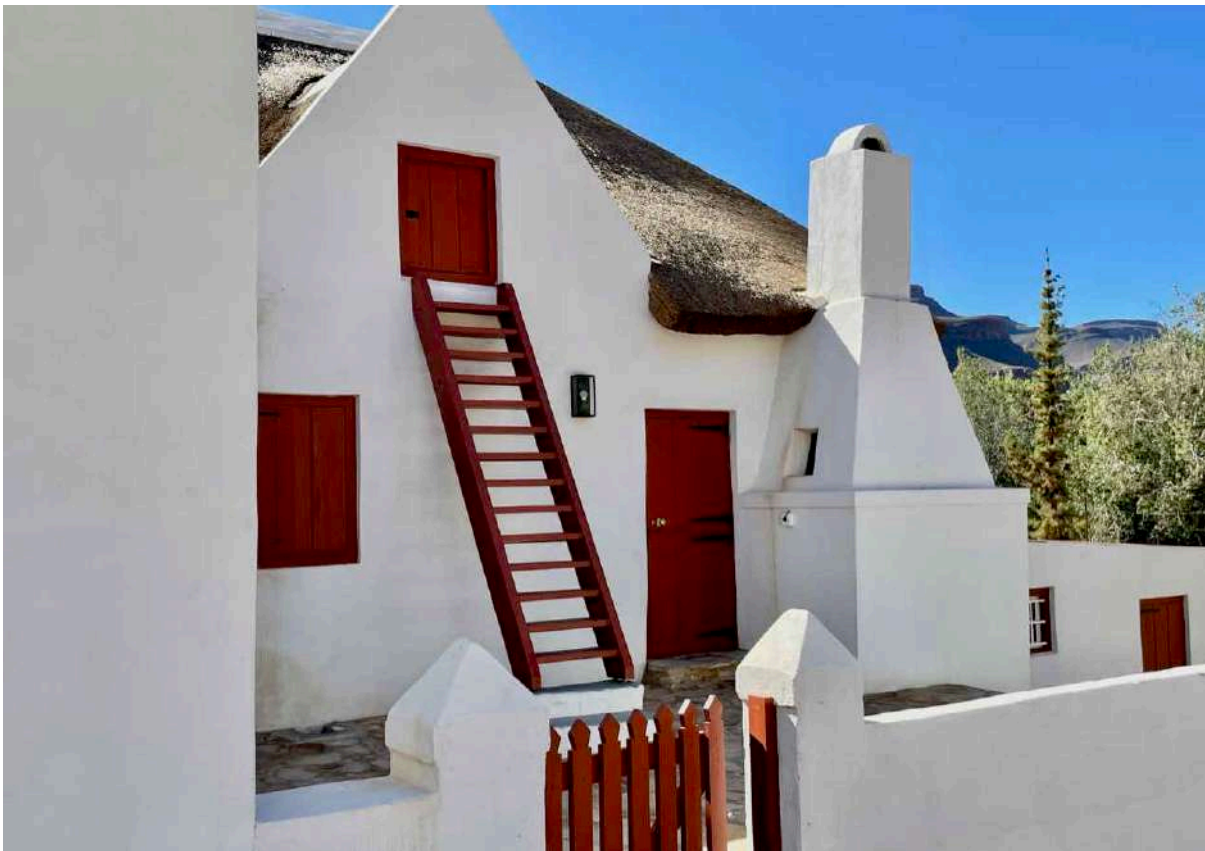
**FIGURE 14F:** *The west side of the Parsonage after restoration. (Image: ARCON, 23 March 2021).*

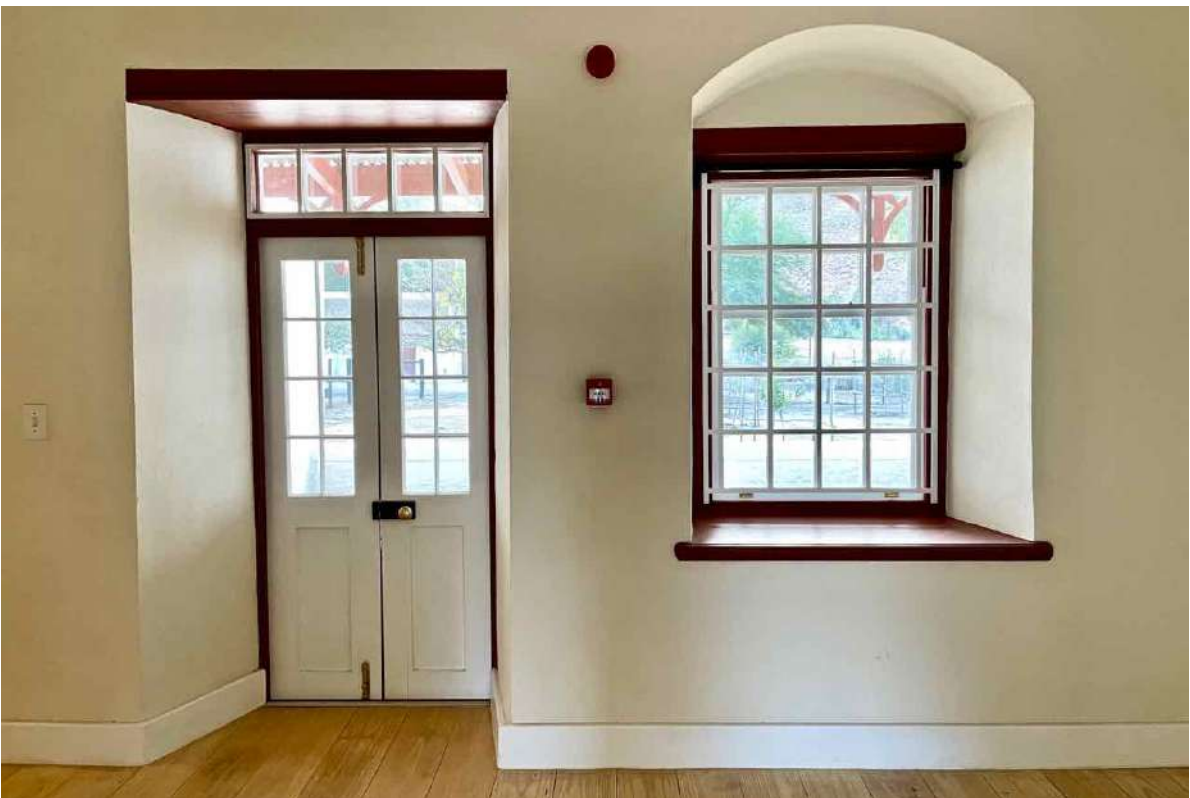
**FIGURE 15D:** *The same view as Figure 15C after restoration.* (Image: ARCON, 16 October 2020).

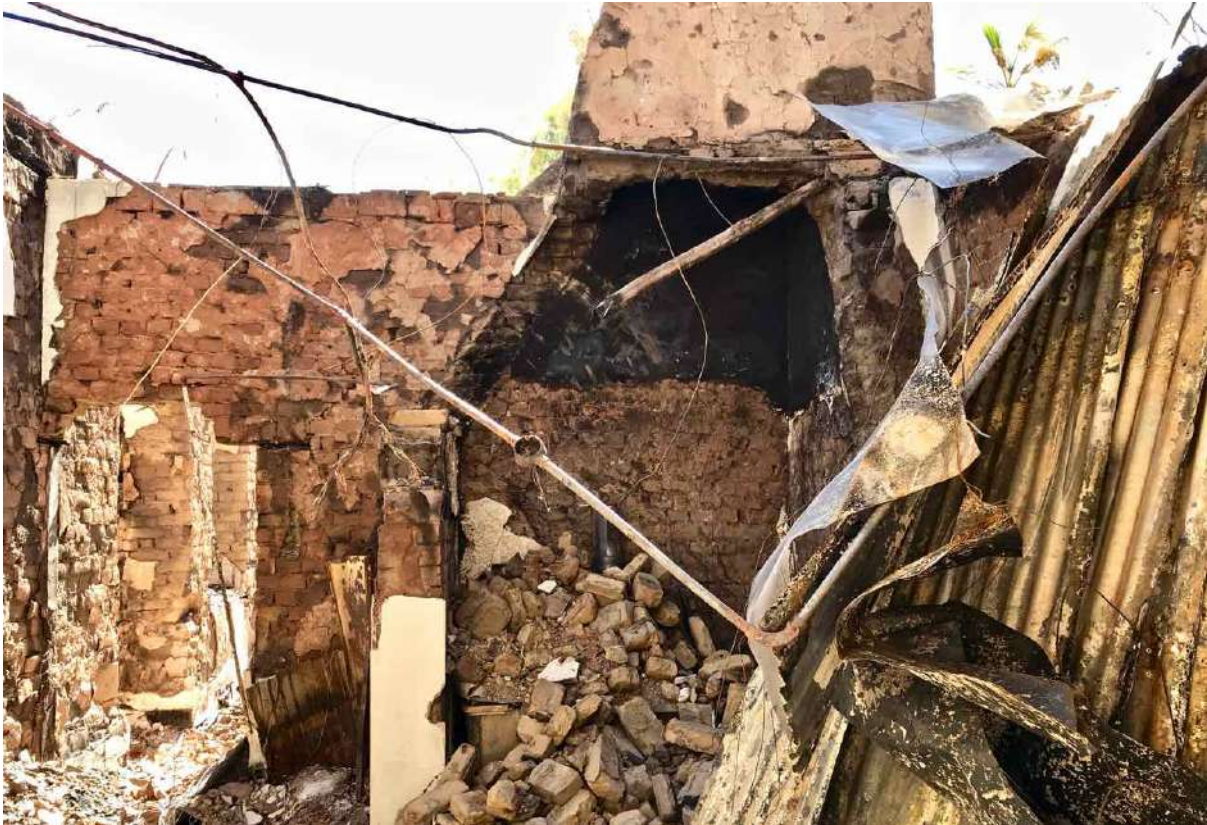
**FIGURE 15E:** *Collapsed kitchen hearth in the Winkelhuis after the fire. All intact bricks were recovered and re-used in its reconstruction. (Image: ARCON, 24 January 2019).*
