# HARNESSING HERITAGE TO EMPOWER PEOPLE IN THE WAKE OF DISASTER

The rescue restoration of the  
historic town centre of Wupperthal Mission Station  
Cedarberg, South Africa  
2019-2021

Graham Jacobs

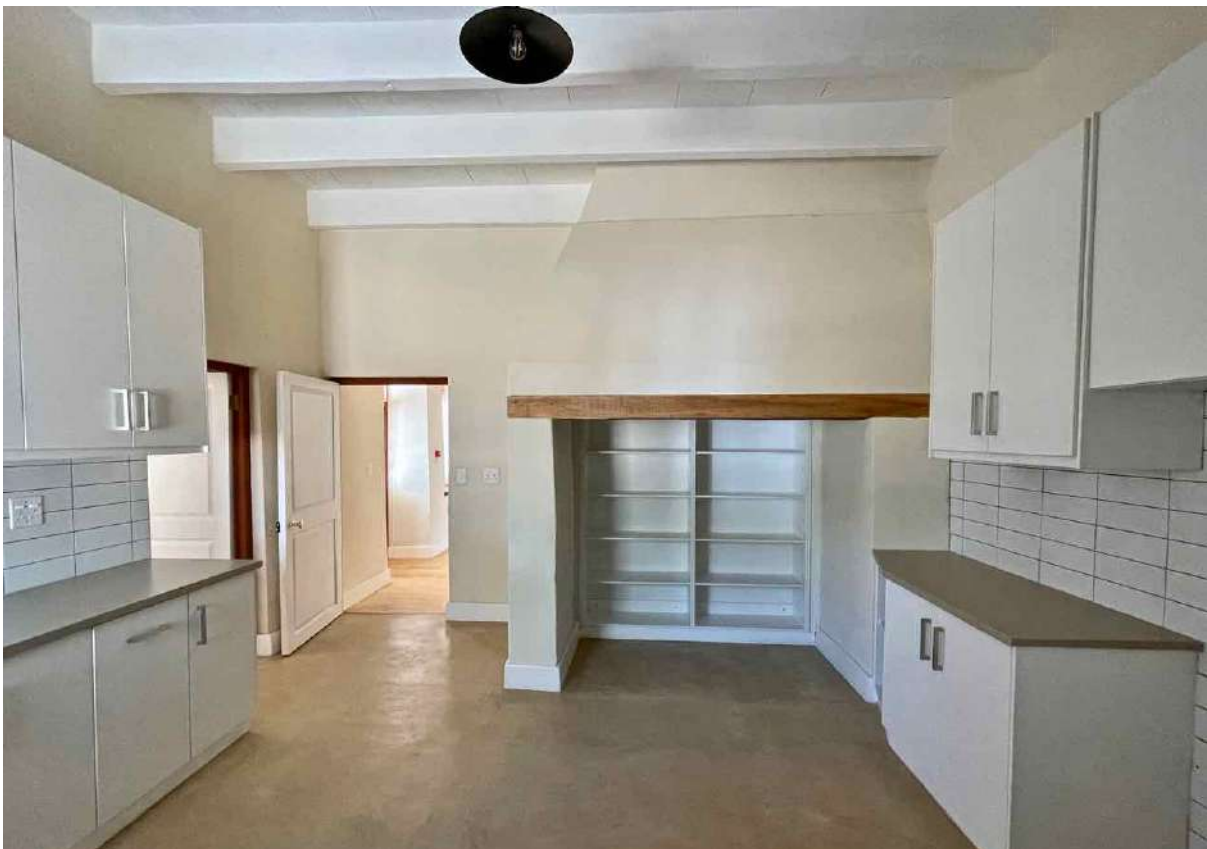
**FIGURE 15D:** *New simple, contemporarily styled kitchen with reconstructed hearth converted to a pantry. (Image: ARCON, 24 January 2019).*

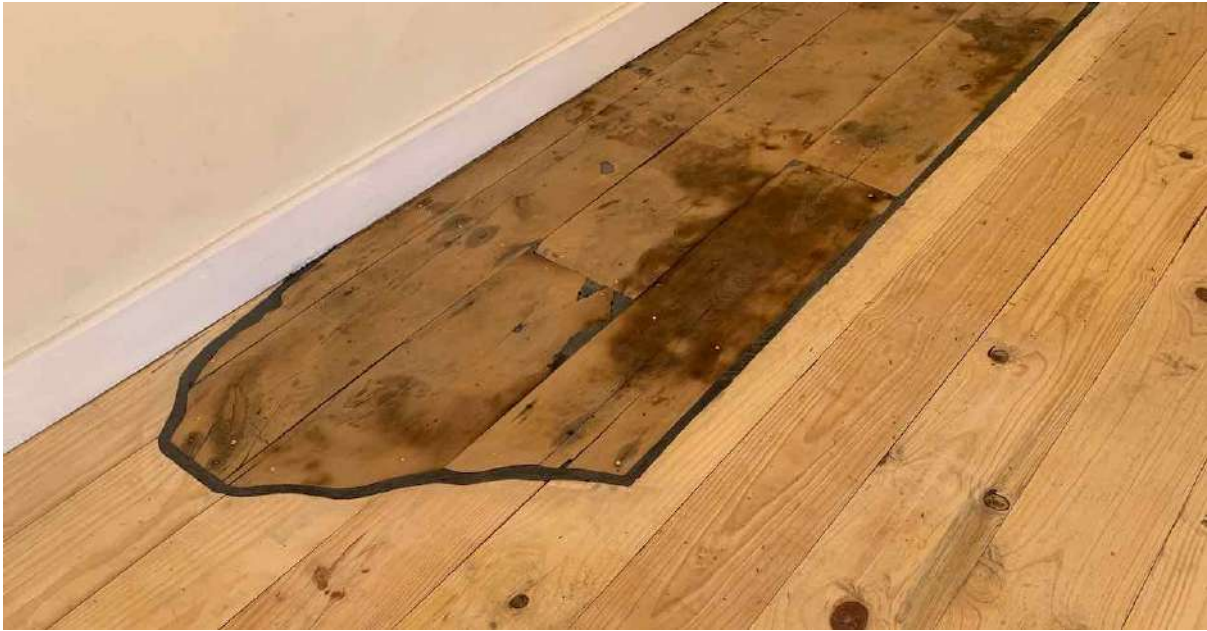
**FIGURE 15E:** *Remnant of cedarwood flooring recovered after the fire and set into the new floor in the same position where it had been recovered. An interpretative plaque explaining the significance of these floorboards has been placed on the wall above. Out of all the buildings damaged in the fire, this is the only area where some cedarwood flooring survived. (Image: ARCON, 27 November 2020).*

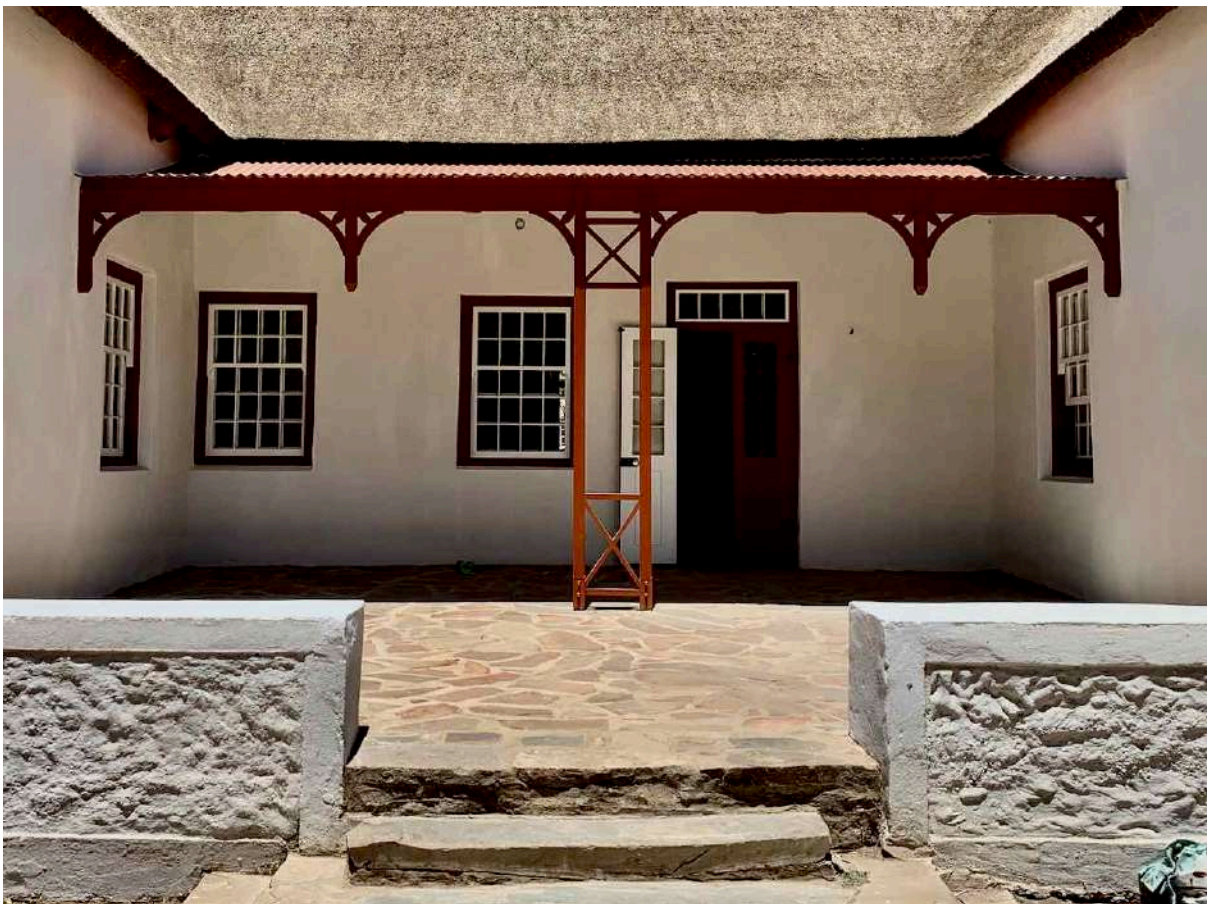
**FIGURE 15F:** *Rear veranda of the Winkelhuis with reconstructed canopy based on a photograph that the author, by pure coincidence, took on a casual visit to Wupperthal about 4 months before the fire. That photograph proved to be the only known record of the rear façade of the house with its canopy. (Image: ARCON, 27 November 2020).*

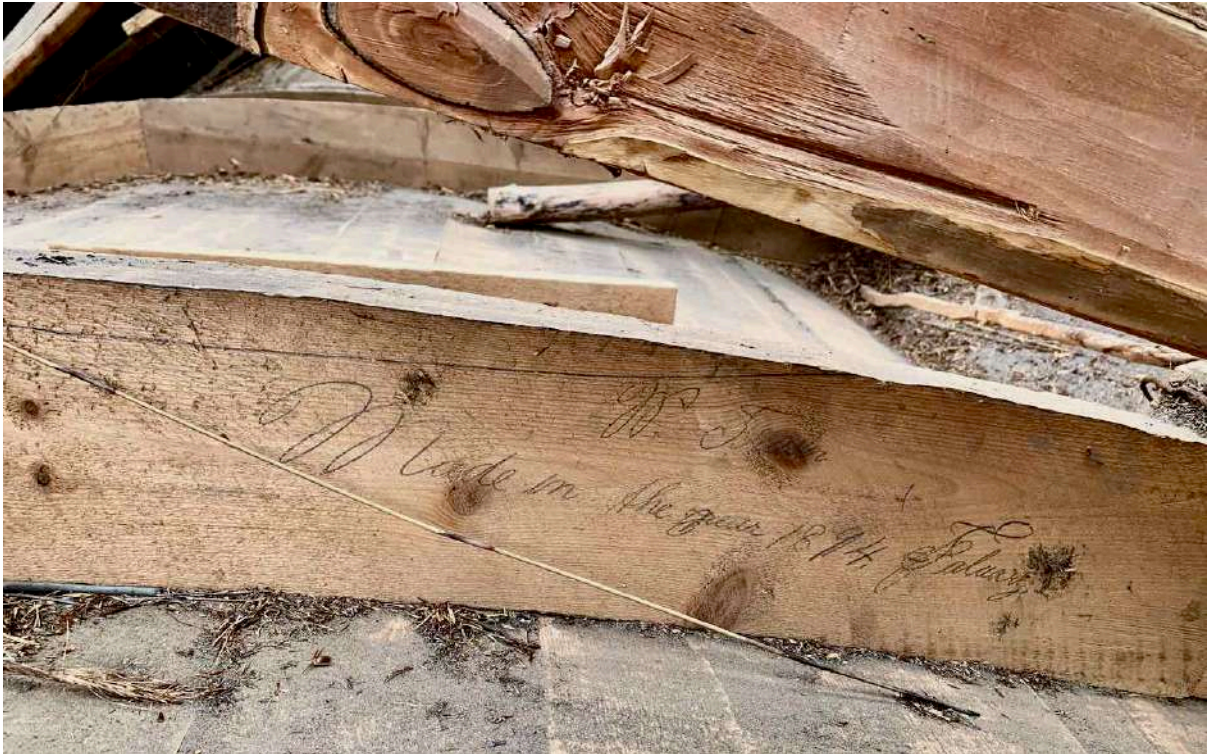
**FIGURE 16C:** *Carpenter's signature on one of the saucer vault ribs record that the ceiling was added in 1894. This practice has been revived at Leipoldt House and other new joinery forming part of the restoration process. (Figure 10F). (Image: ARCON, 1 Nov. 2019).*

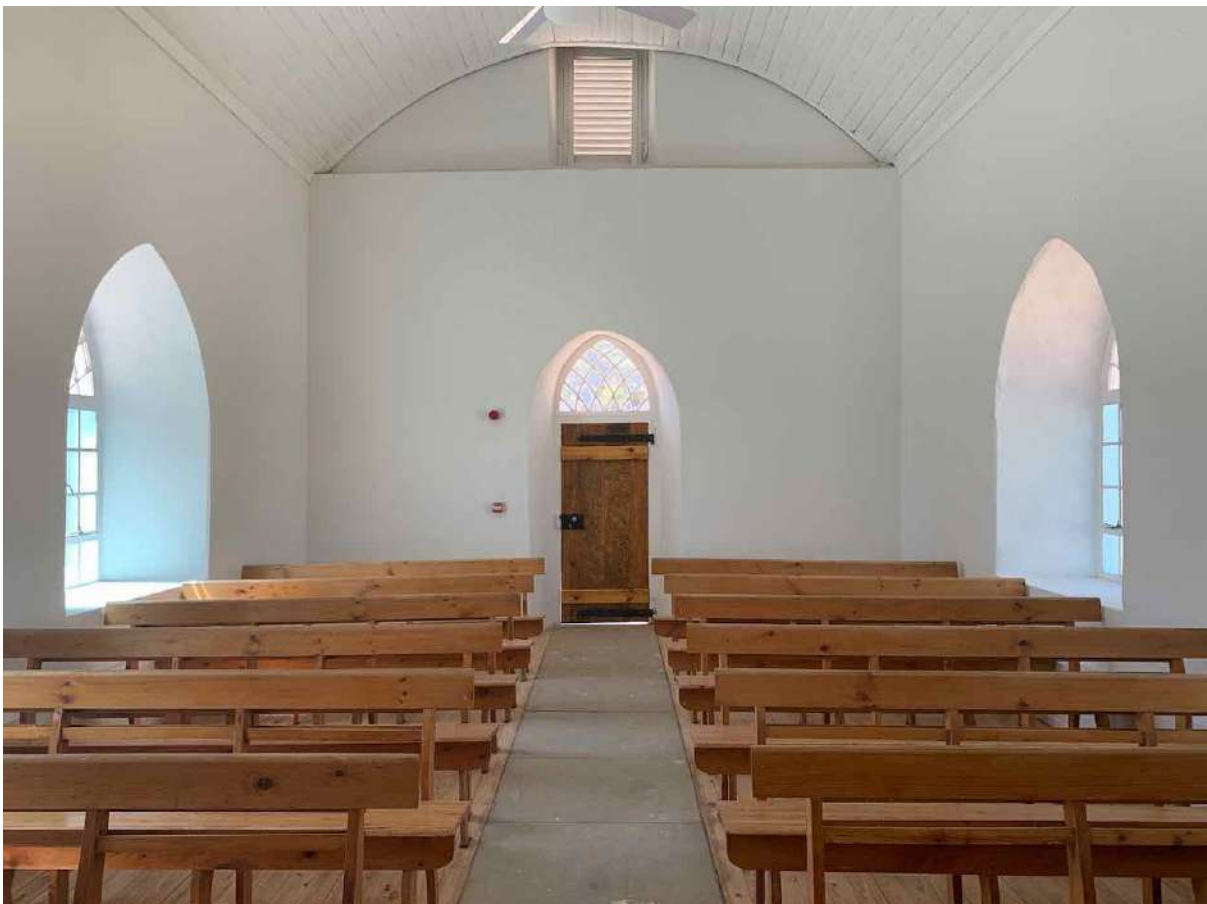
**FIGURE 16D:** *The simple Church interior with saucer vault ceiling and freshly painted walls. (Image: ARCON, 14 Jan 2021).*

The church building, inaugurated in 1835 by the Rhenish missionaries, was found to have a structurally poor roof. The Foundation therefore generously decided to broaden the project brief, leading to the entire re-roofing of the building despite it not having sustained fire damage. Carpenter's marks on one of the ceiling ribs (**Figure 16C**) show the ceiling to have been a later addition. It was found that the original installation had involved the cutting away of diagonal trusses between the nave and transept, presumably because those trusses would have extended below the new vault line. That resulted in a badly weakened roof at the intersection between nave and transept, and was on the point of collapse. The roof consequently had to be strengthened with new trusses placed between the old, effectively becoming a new roof structure. The building was then fully re-thatched.

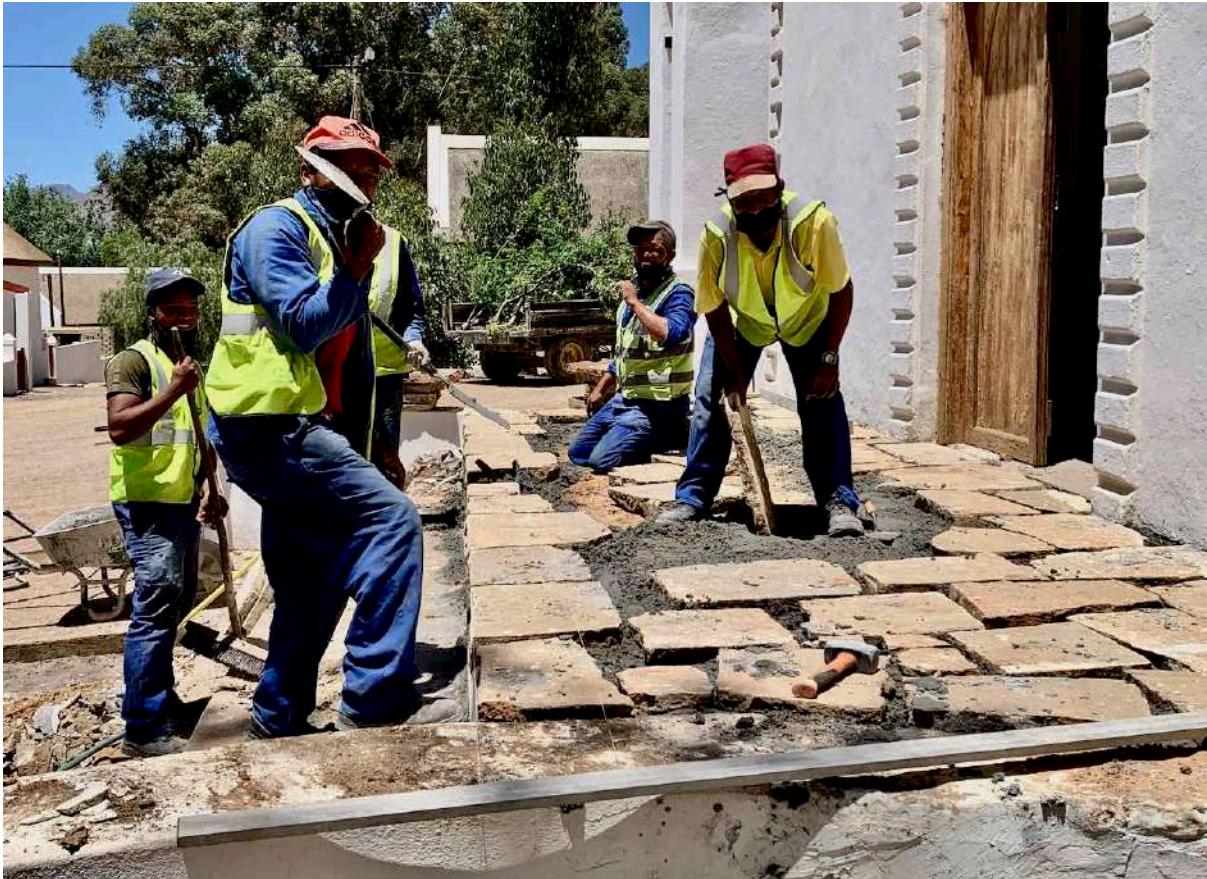
**FIGURE 16E:** *Workers re-laying the stone flags in front of the church. The grey mortar is lime mixed with local dark grey river sand and not cement. (Image: ARCON, 27 November 2020).*

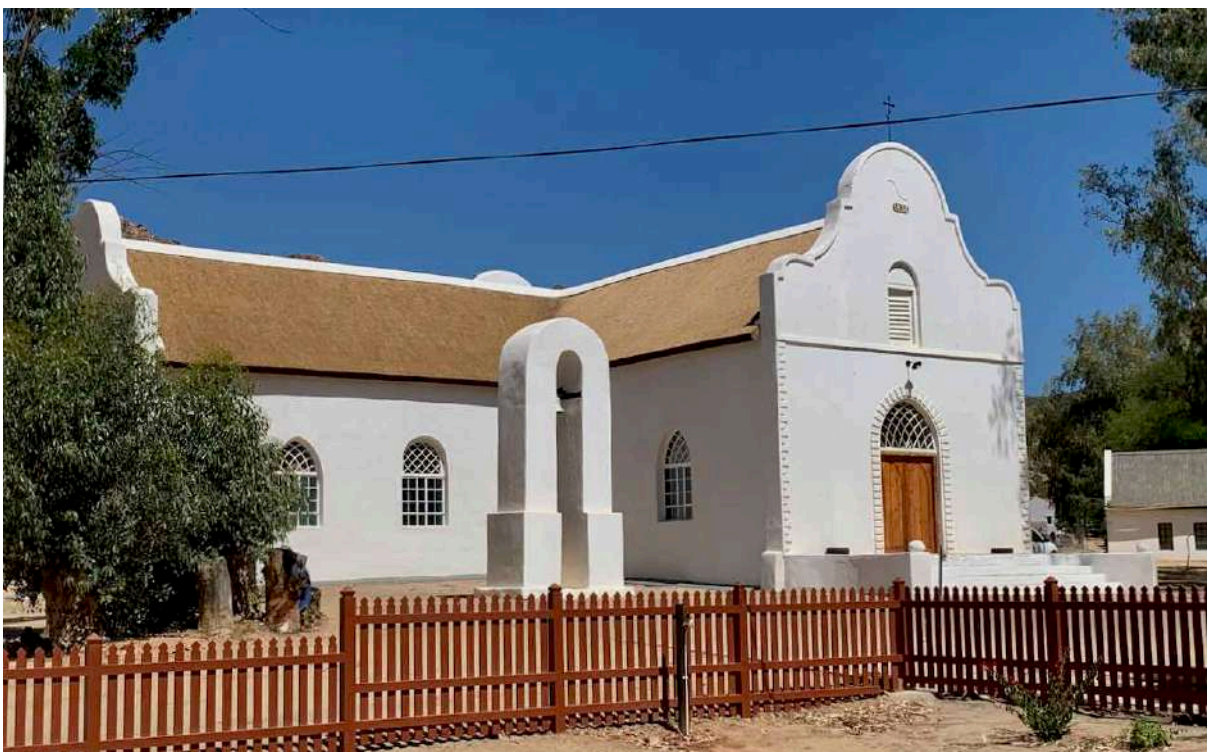
**FIGURE 16F:** *The church building after completion of the new roof and repainting with a propriety breathable wall coating. (Image: ARCON, 14 January 2021).*

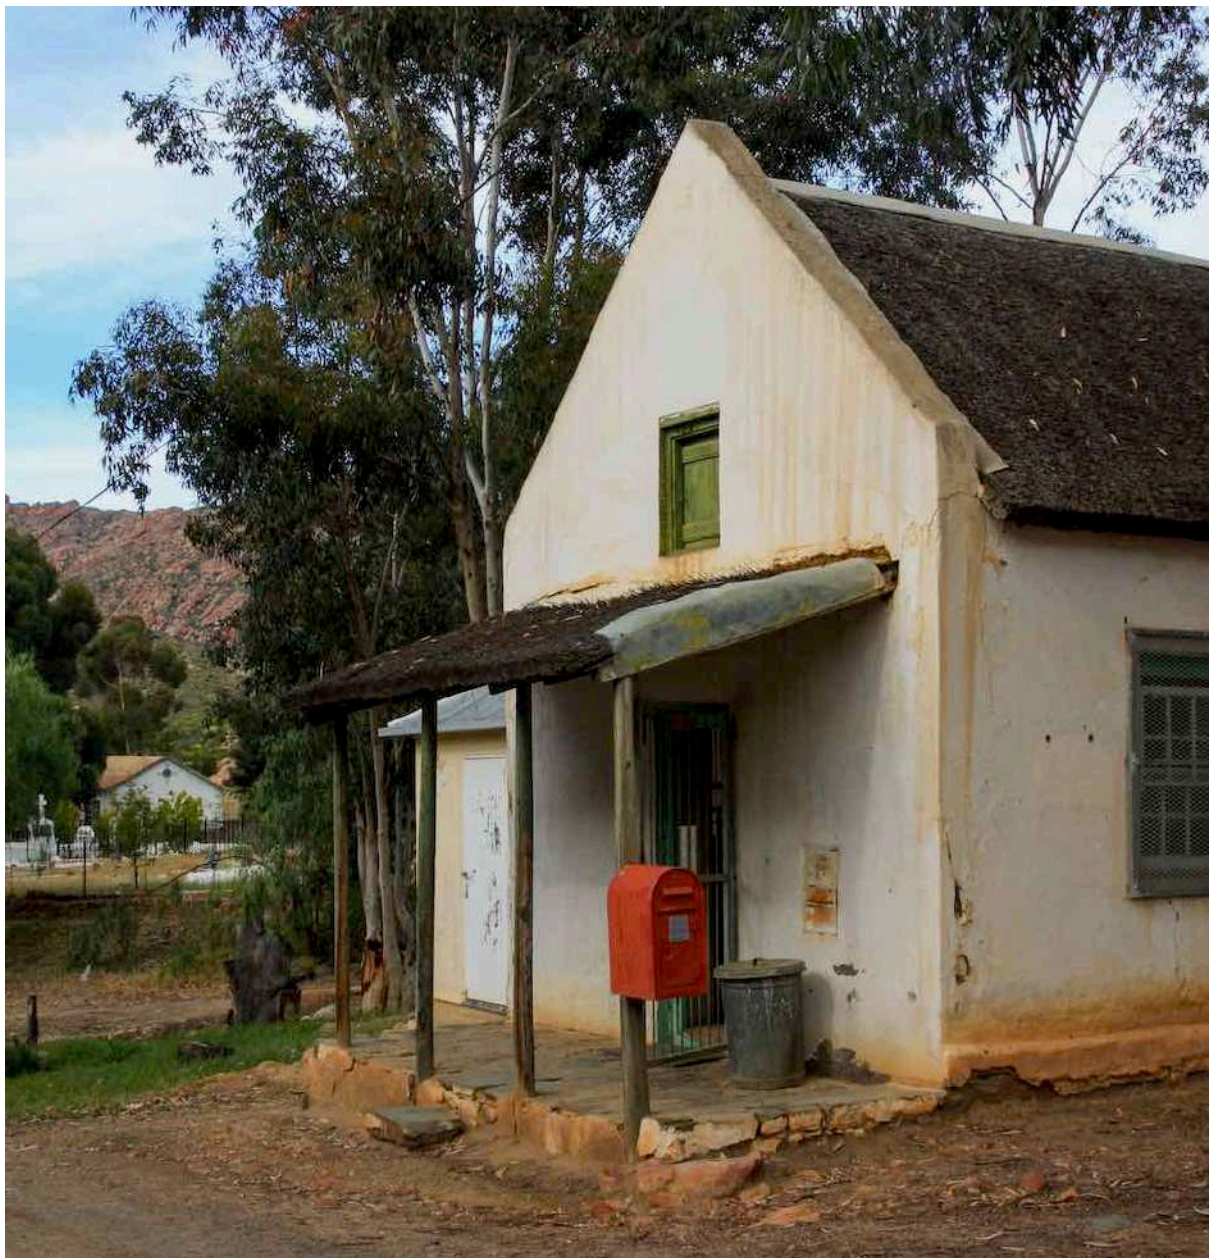
**FIGURE 17A:** *The Post Office Building before the fire.* (Image: Gabriel Fagan Architects, 22 September 2009).

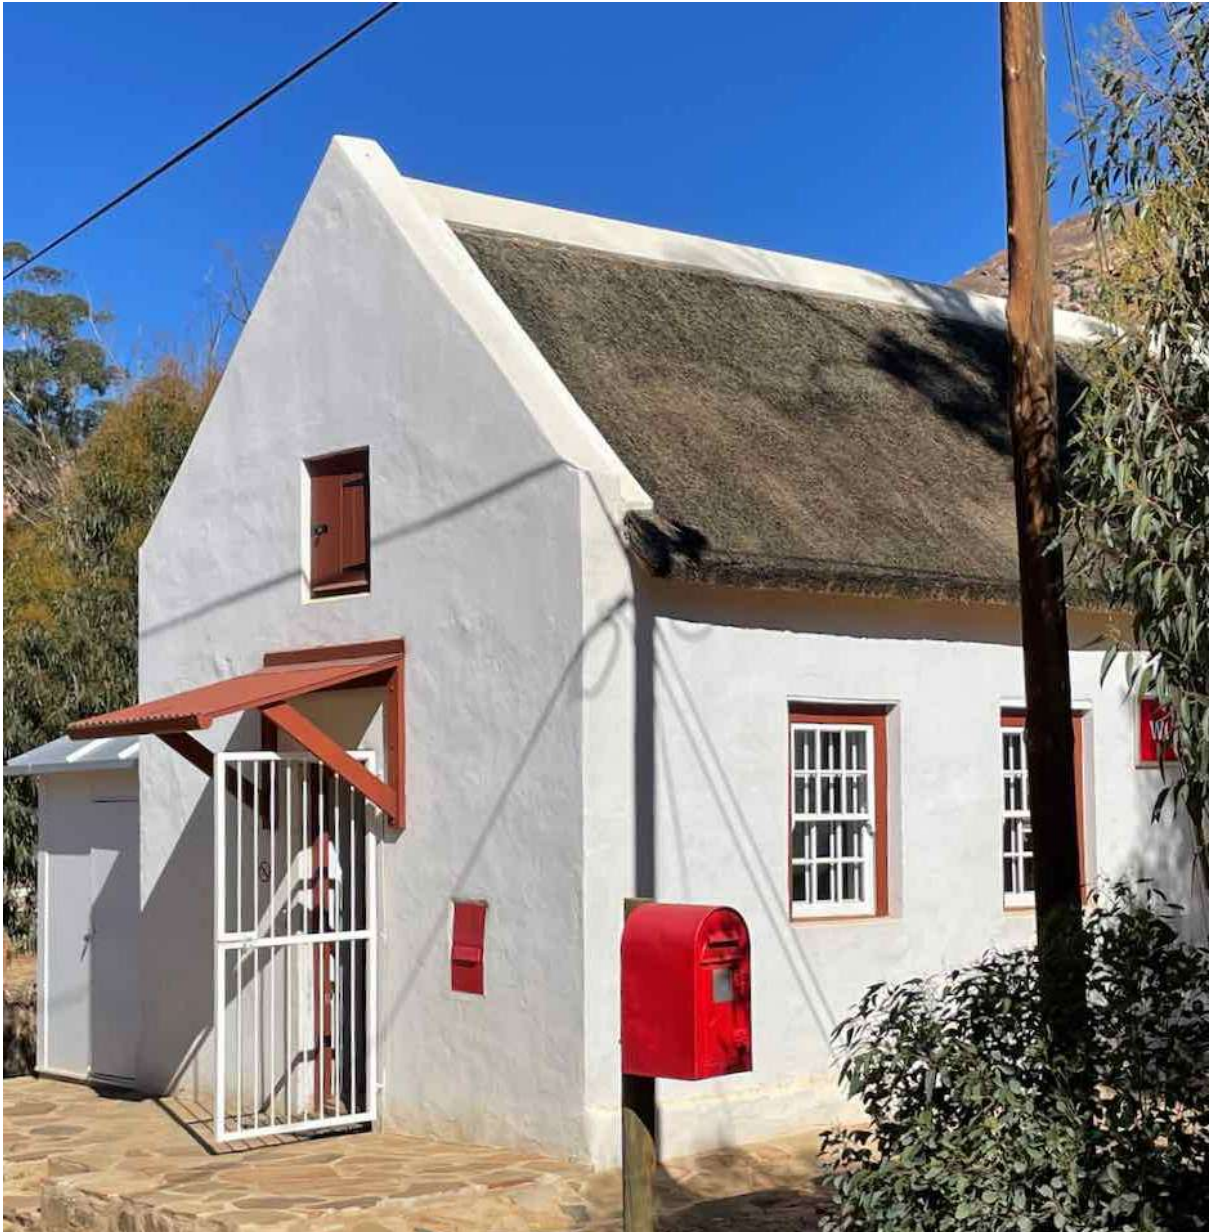
The date of the Post Office building is not known but suspected to date back to the earlier half of the 20<sup>th</sup> C. The building was left almost completely undamaged by the fire apart from its thatched front entrance canopy which had totally burned away. Fortunately, the main thatch roof had not caught fire. The building was, however, in need of maintenance. That included requiring attention to extensive cracks in its walls. It was therefore decided to repair the cracks, repaint the building and construct a new canopy. This new canopy is a smaller cantilevered corrugated iron roofed structure and not thatch. Another thatch version would have deteriorated faster, considering its shallow pitch.

**FIGURE 17B:** *The Post Office Building after refurbishment including new paving on the front stoep using locally sourced sandstone laid by local labour. A smaller corrugated iron front entrance canopy replaced the previous burned out thatch canopy which had been pitched too shallow to withstand the weather for long. (Image: ARCON, 18 May 2021).*

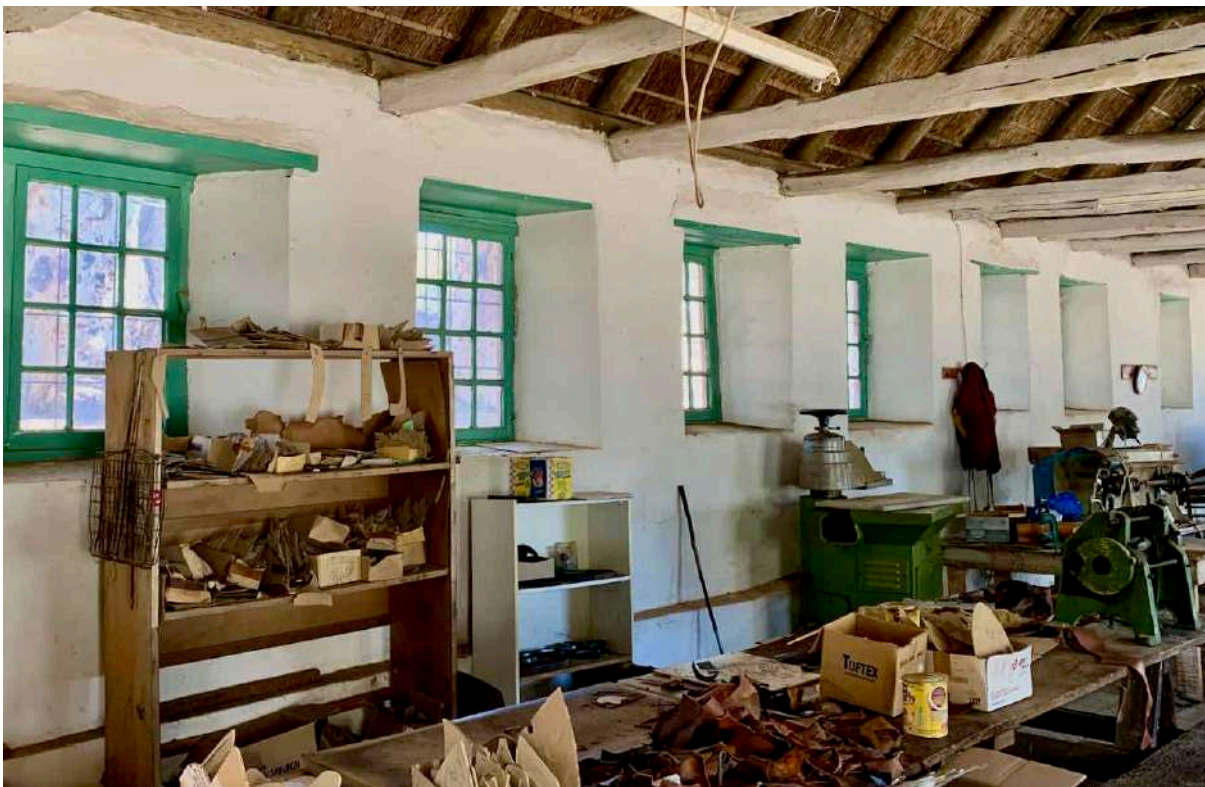
**FIGURE 18A:** *Interior of the Shoe Factory before refurbishment with surviving original casement windows; now in all likelihood the oldest surviving casement windows in the settlement since the fire. (Image: ARCON, 17 March 2020).*

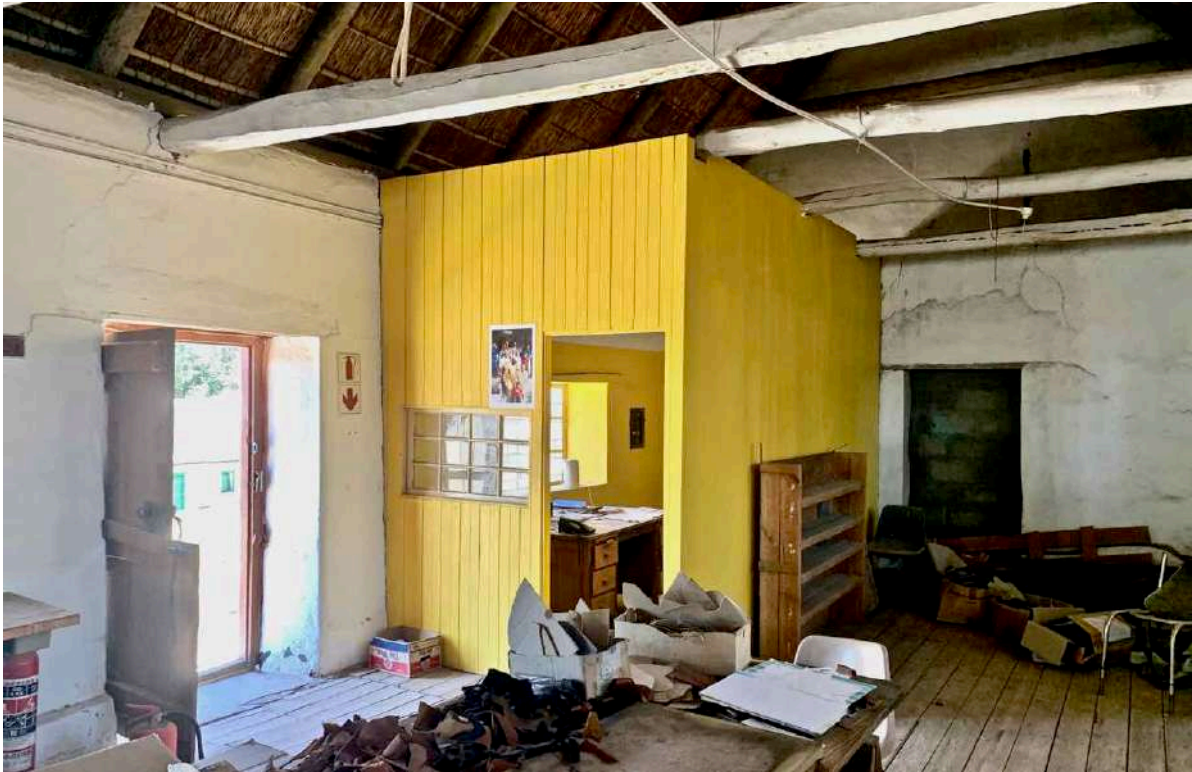
**FIGURE 18B:** *Interior of the Shoe Factory before refurbishment.* (Image: ARCON, 17 March 2020).

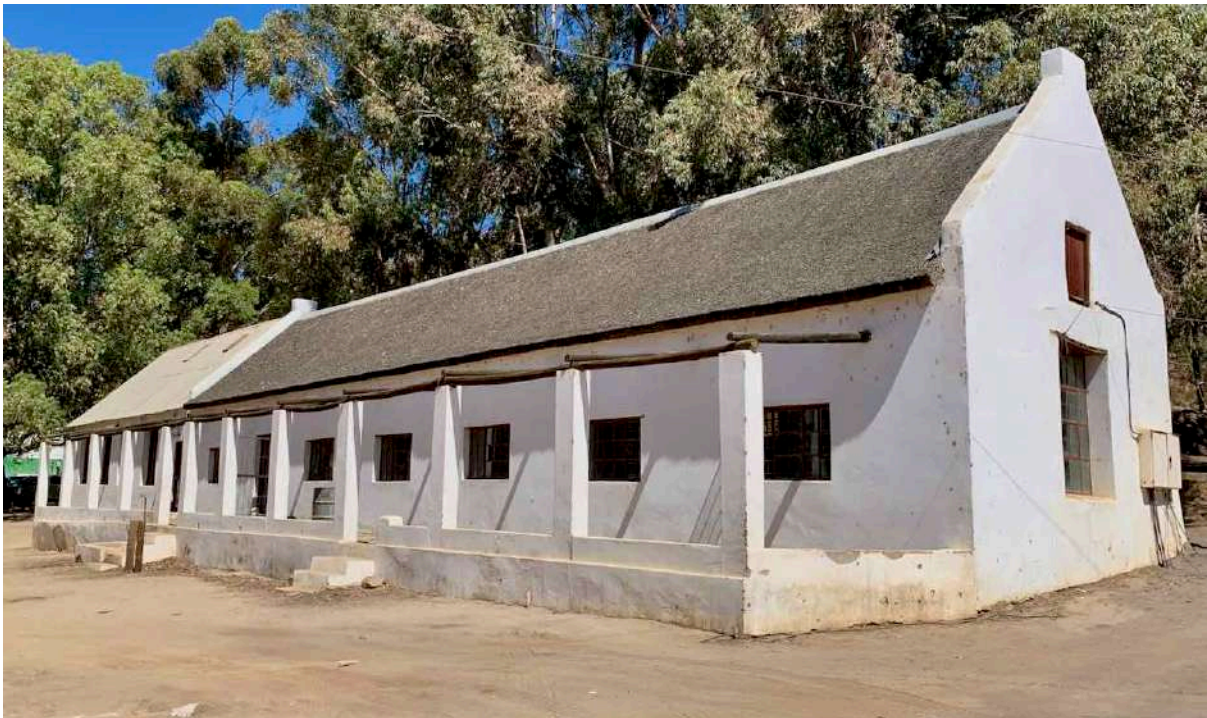
**FIGURE 18D:** *Exterior of the shoe factory prior to refurbishment. It had been re-thatched by the Moravian Church a few years previously. The extension on the far left was then used as the town library and had a corrugated iron roof. (Image: ARCON, 17 March 2020).*

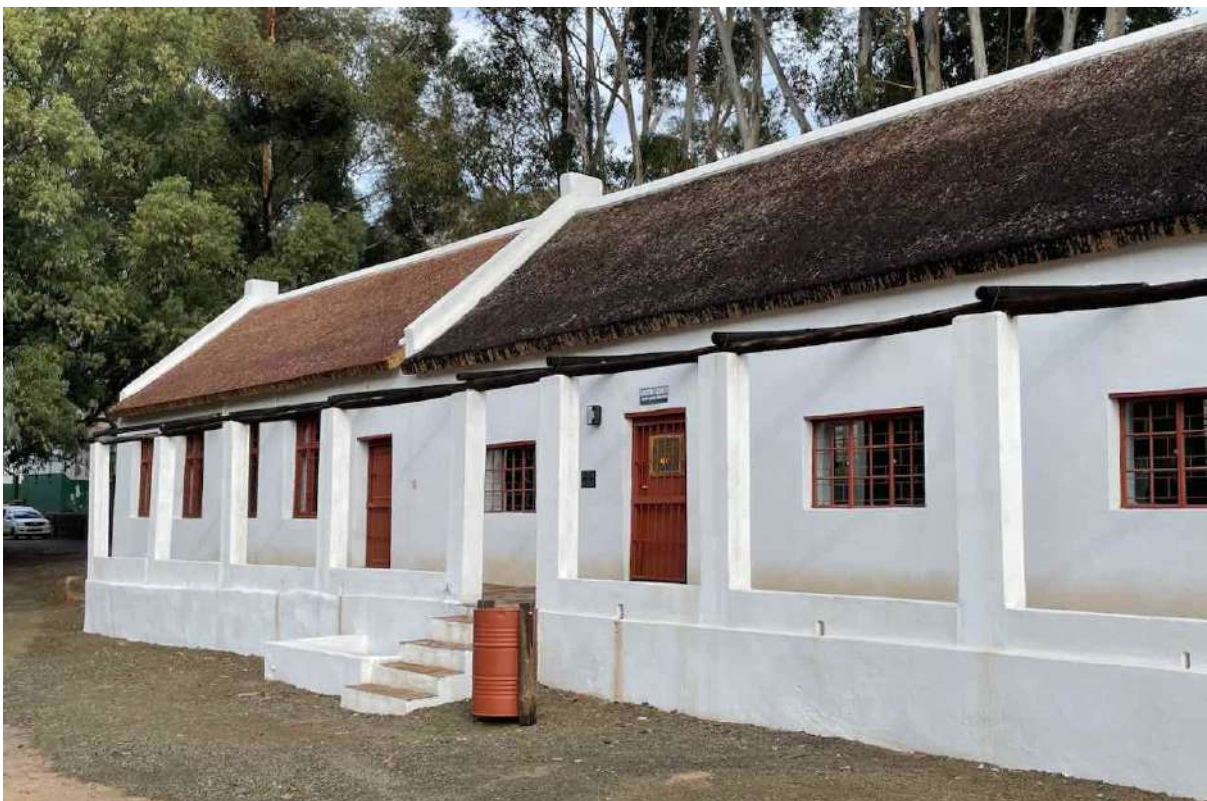
**FIGURE 18E:** *Exterior of the Shoe Factory after refurbishment. The extension on the far left was provided with a thatched roof to match the roofscape of the rest of the town centre. The interior was refurbished to provide a shop for the factory. The steel windows were retained. (Image: ARCON, 8 June 2021).*

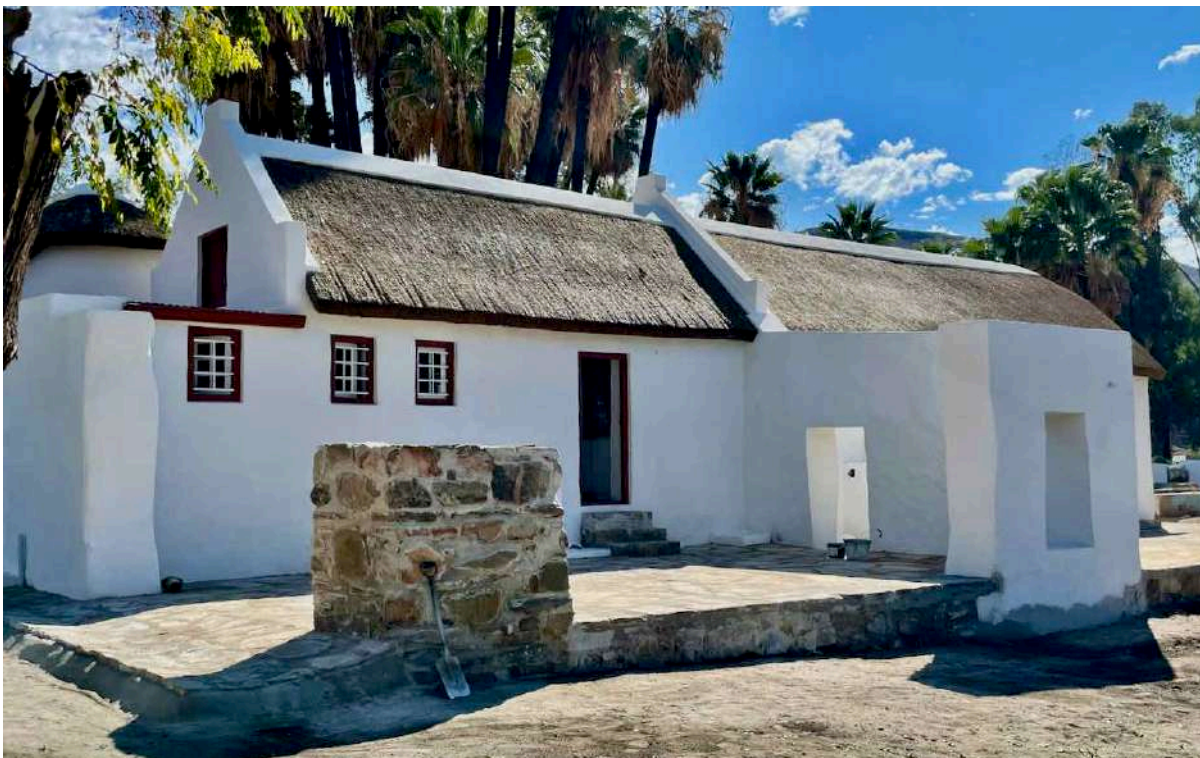
**FIGURE 19E:** *View of the back of the tannery after restoration for use as guest accommodation. The new stone structure in the foreground is a braai. Most of the concrete bases in Figure 19D were retained under the new stoep. (Image: ARCON, 4 May 2021).*

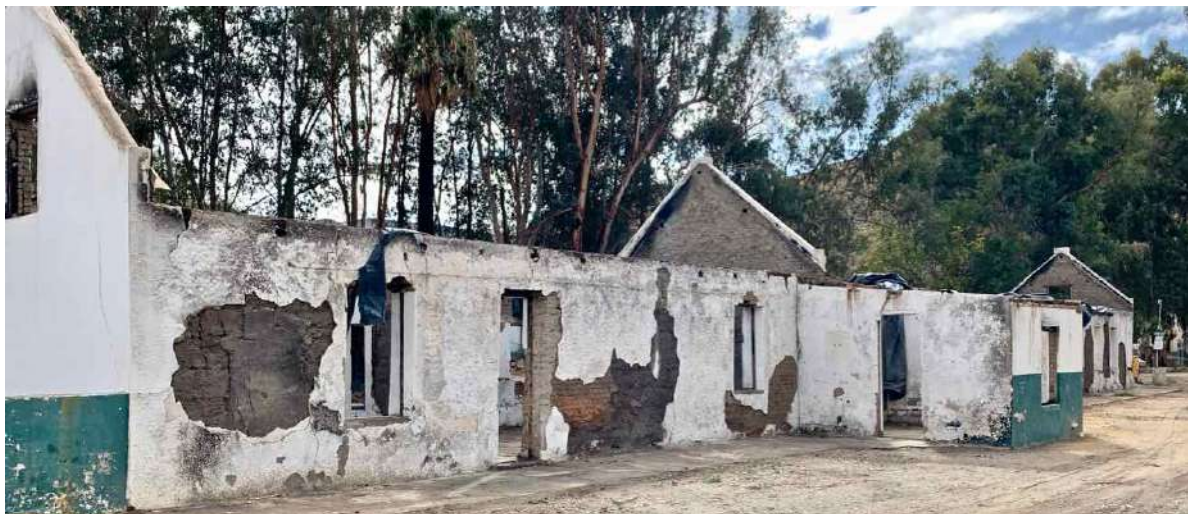
**FIGURE 20A:** *The northernmost of the two school hostels after the fire.* (Image: ARCON, 24 January 2019).

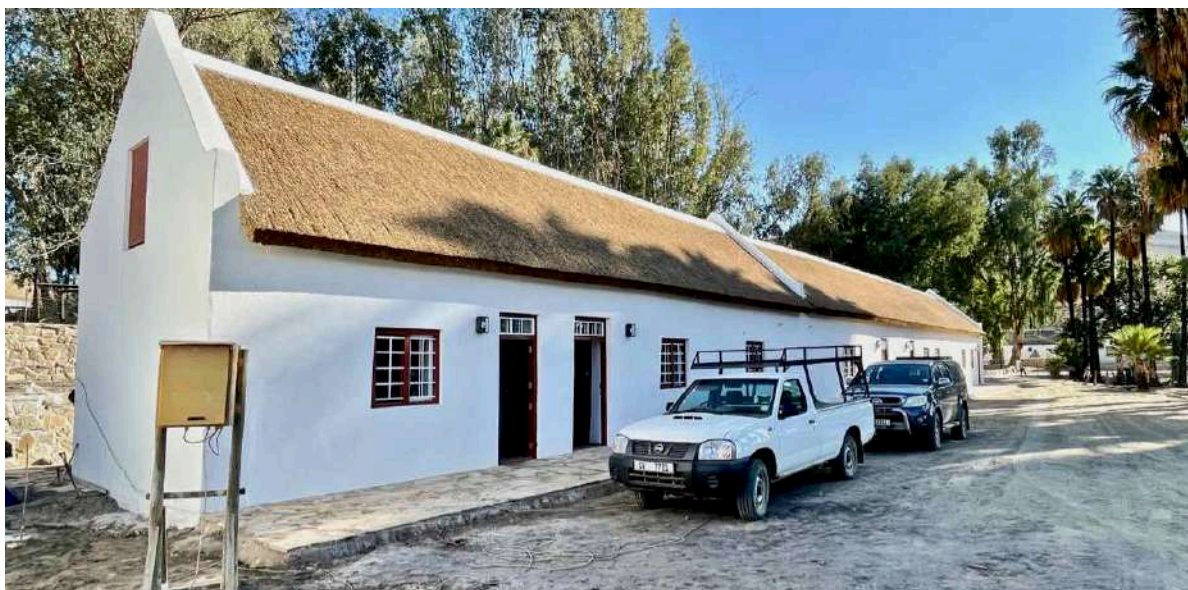
**FIGURE 20B:** *The northernmost of the two school hostels with restoration nearing completion.* New casement windows were installed in the openings of the burned out 20<sup>th</sup> C false sash windows which had, in turn, probably replaced the original windows, possibly similar to the surviving casement windows in the Shoe Factory (**Figure 17A**) except that the latter are single casements and not double casements as installed here. (Image: ARCON, 4 May 2021).

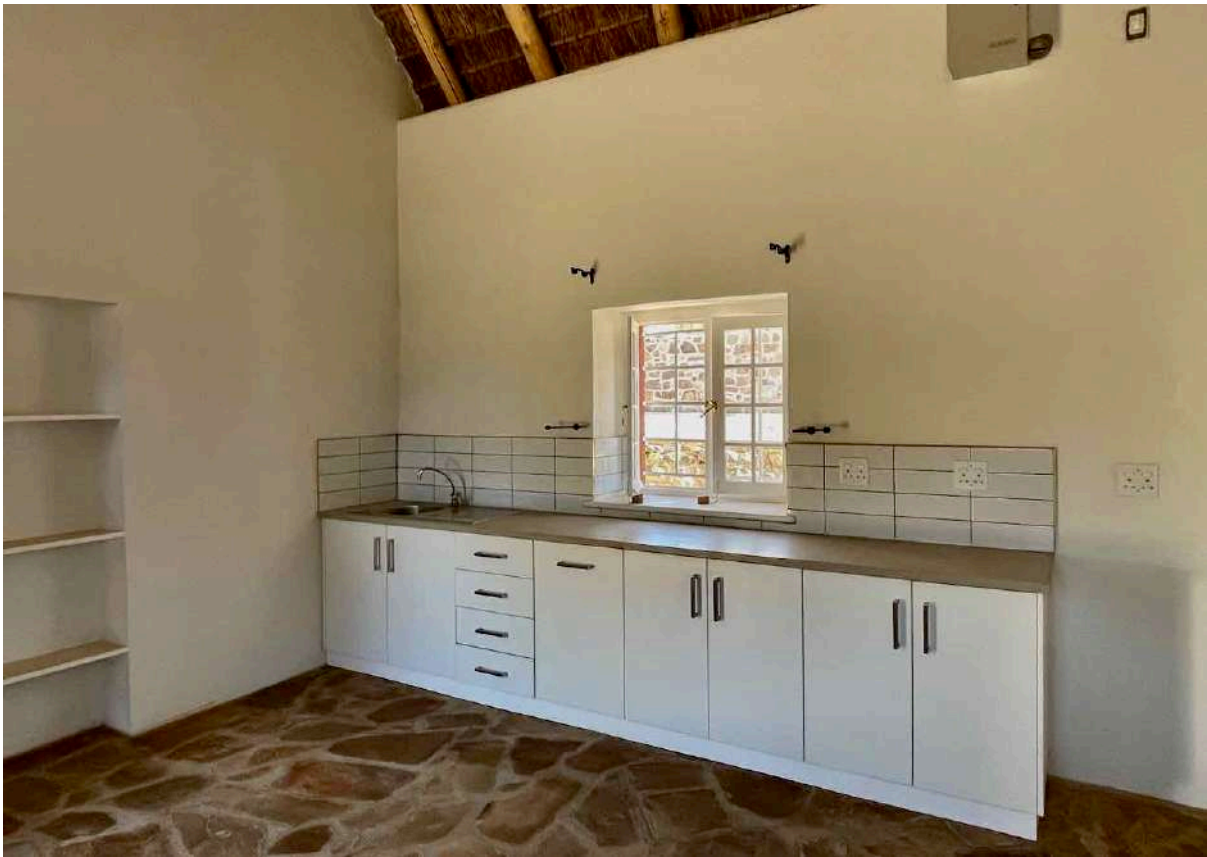
**FIGURE 20E:** *Kitchenette in one of the guest flatlets. Door openings that were bricked in were left recessed as a record of that opening, and to double as shelf space. (Image: ARCON, 4 May 2021).*

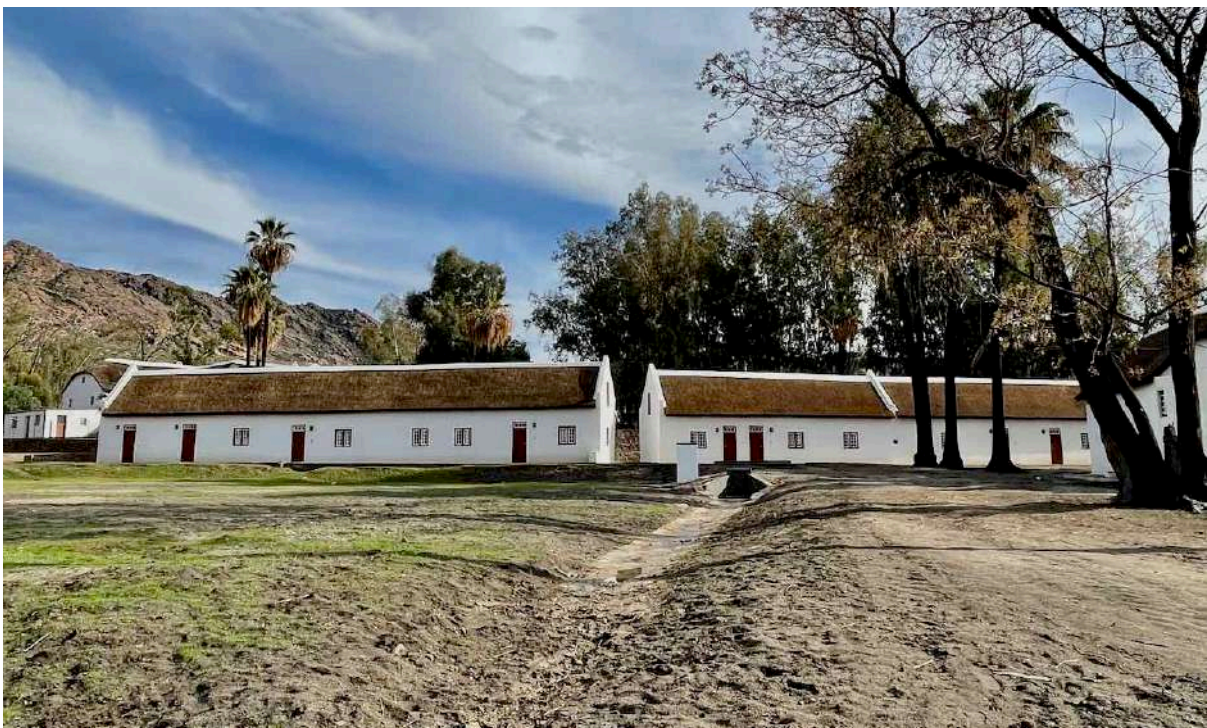
**FIGURE 20F:** *View of both restored hostel buildings, now repurposed as guest accommodation for the village. The channel and outfall in the center of this image is part of a new stormwater system installed by the Foundation to control flood waters which had previously been a problem, after heavy rains. (Image: ARCON, 4 May 2021).*

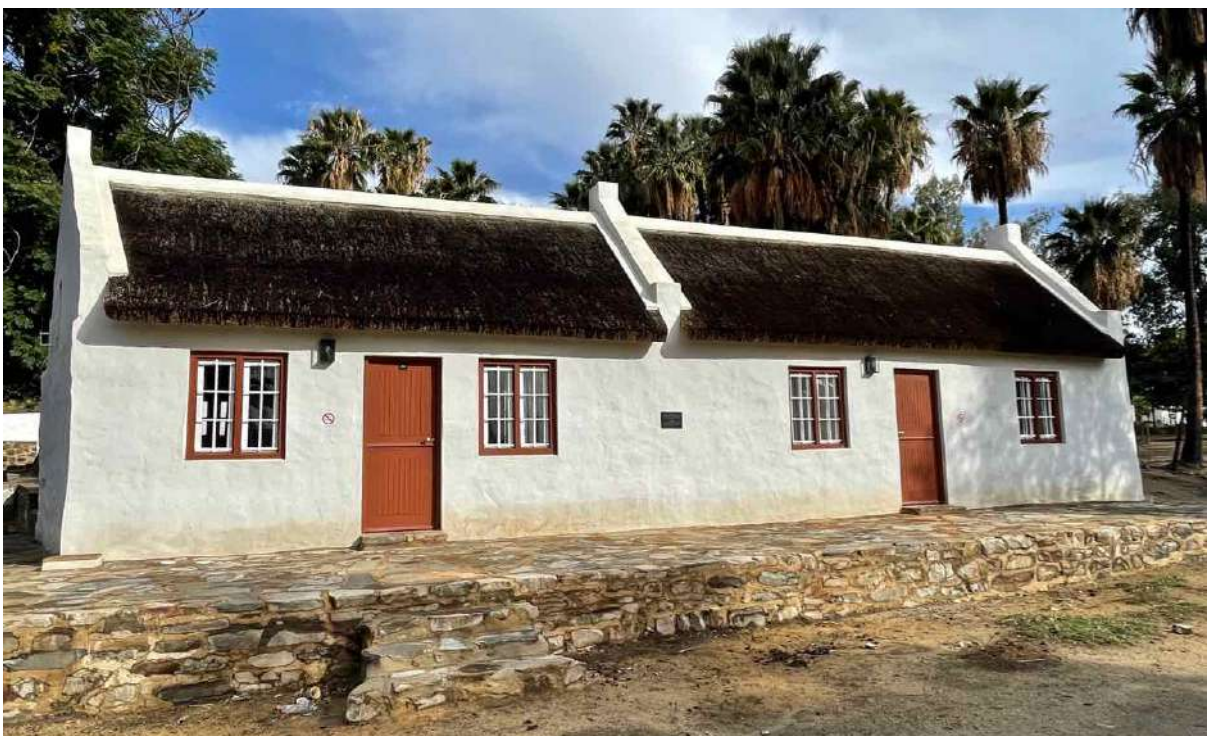
**FIGURE 21B:** *The Palms Guest House after restoration.* (Image: ARCON, 24 January 2019).

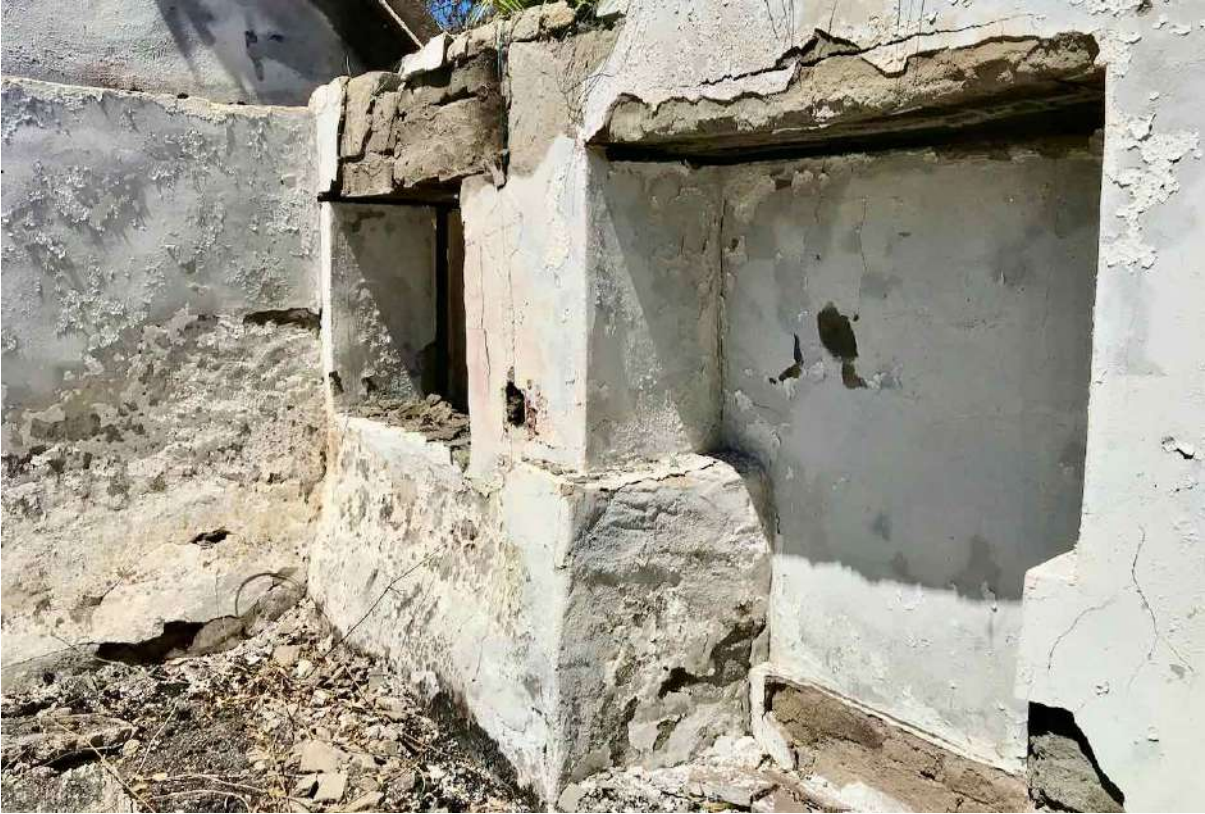
**FIGURE 21C:** *A portion of the gutted interior of the Palms Guest House after the fire.* (Image: ARCON, 24 January 2019).

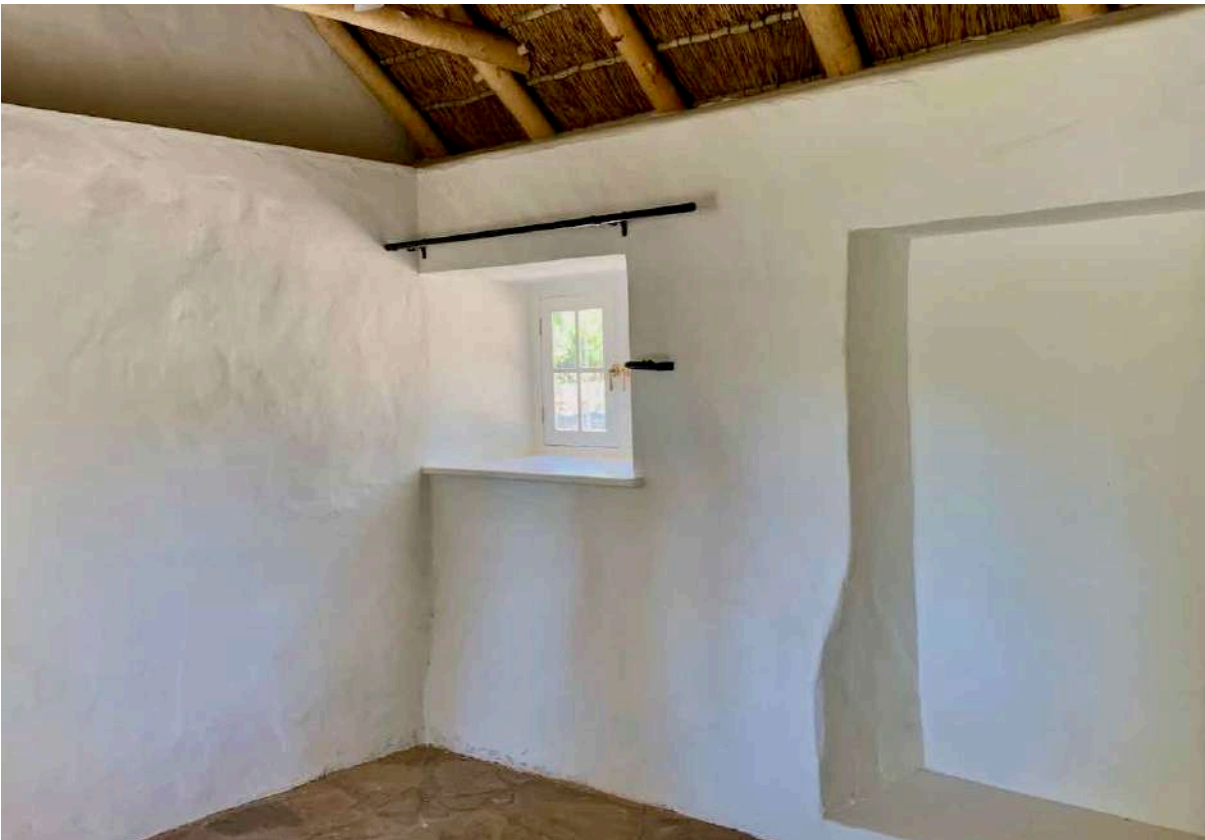
**FIGURE 21D:** *The same part of the interior after restoration.* (Image: ARCON, 10 November 2020).

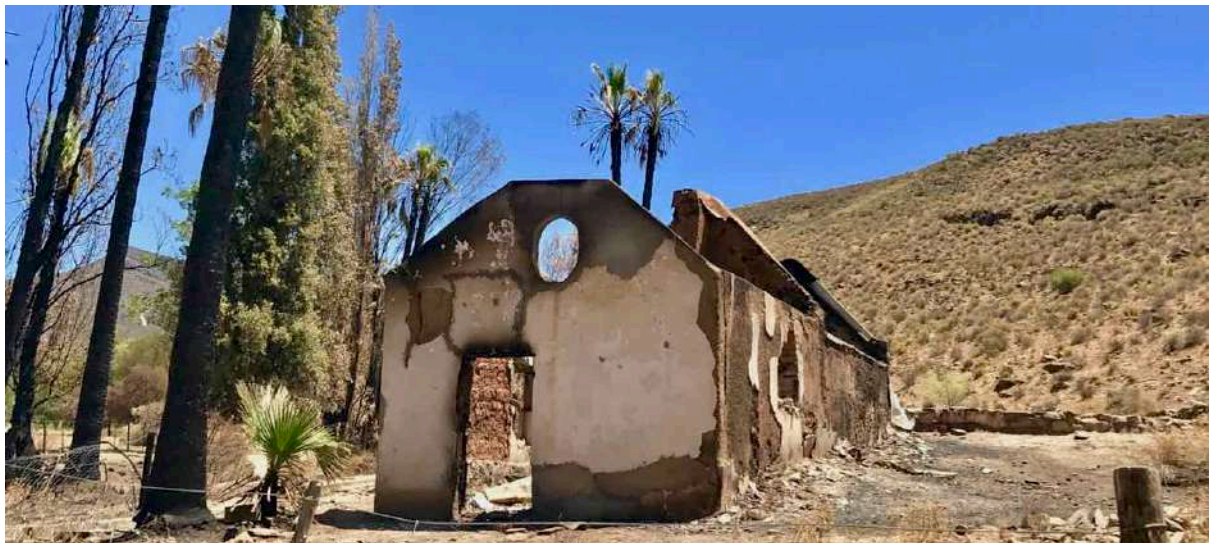
**FIGURE 22A:** *The gutted Blacksmith's Shop after the fire.* (Image: ARCON, 24 January 2019).
