# HARNESSING HERITAGE TO EMPOWER PEOPLE IN THE WAKE OF DISASTER

The rescue restoration of the  
historic town centre of Wupperthal Mission Station  
Cedarberg, South Africa  
2019-2021

Graham Jacobs

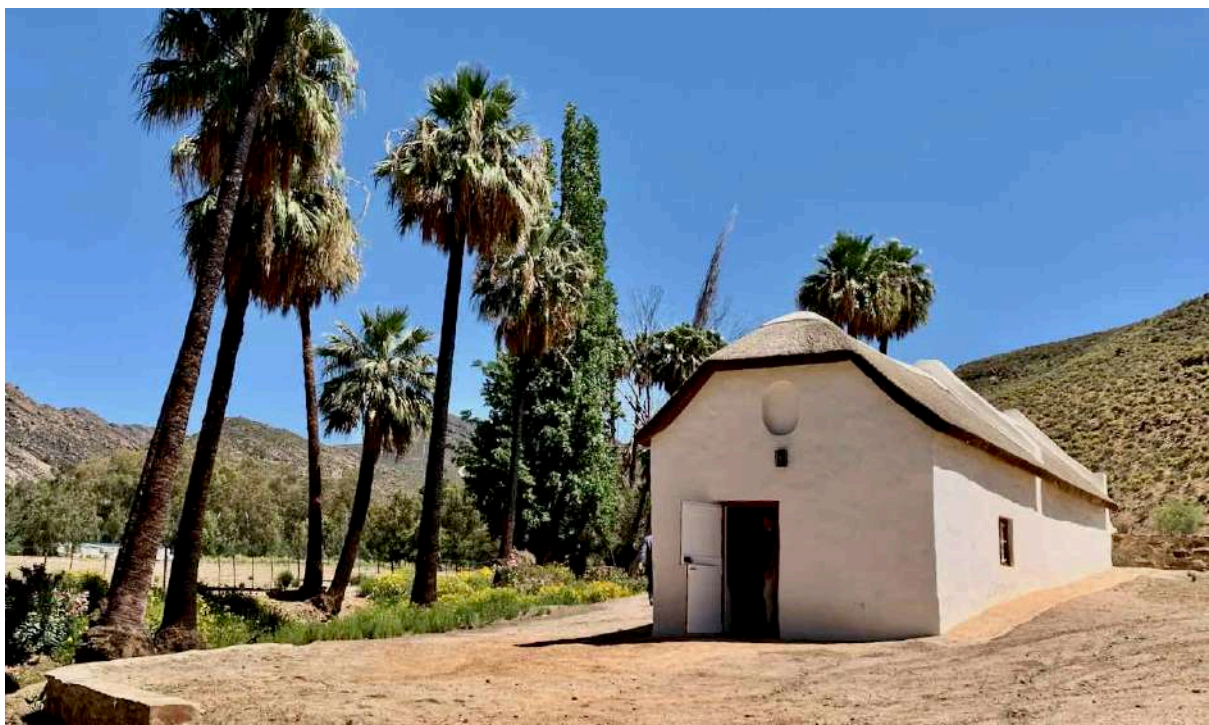
**FIGURE 22B:** *The Blacksmith's Shop after restoration.* (Image: ARCON, 10 November 2020).

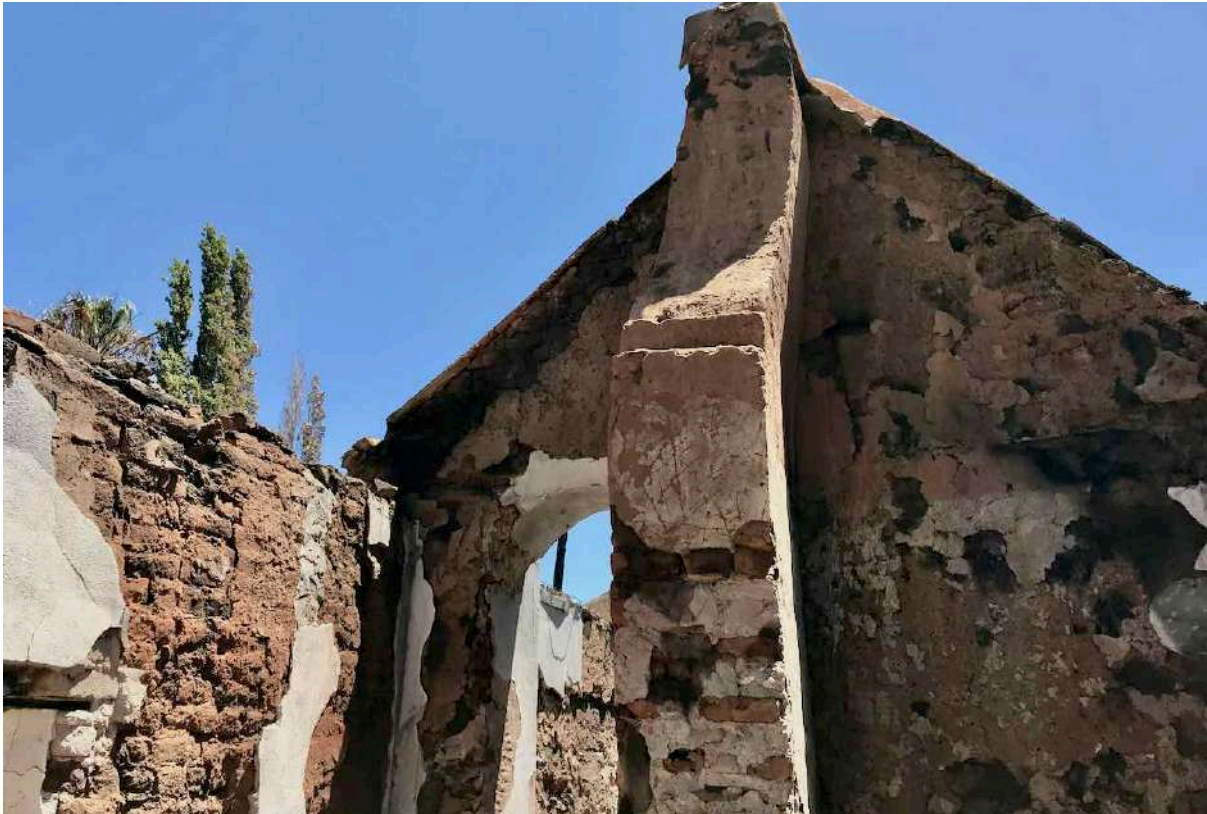
**FIGURE 22C:** *The remains of the forge flue after the fire.* (Image: ARCON, 24 January 2019).

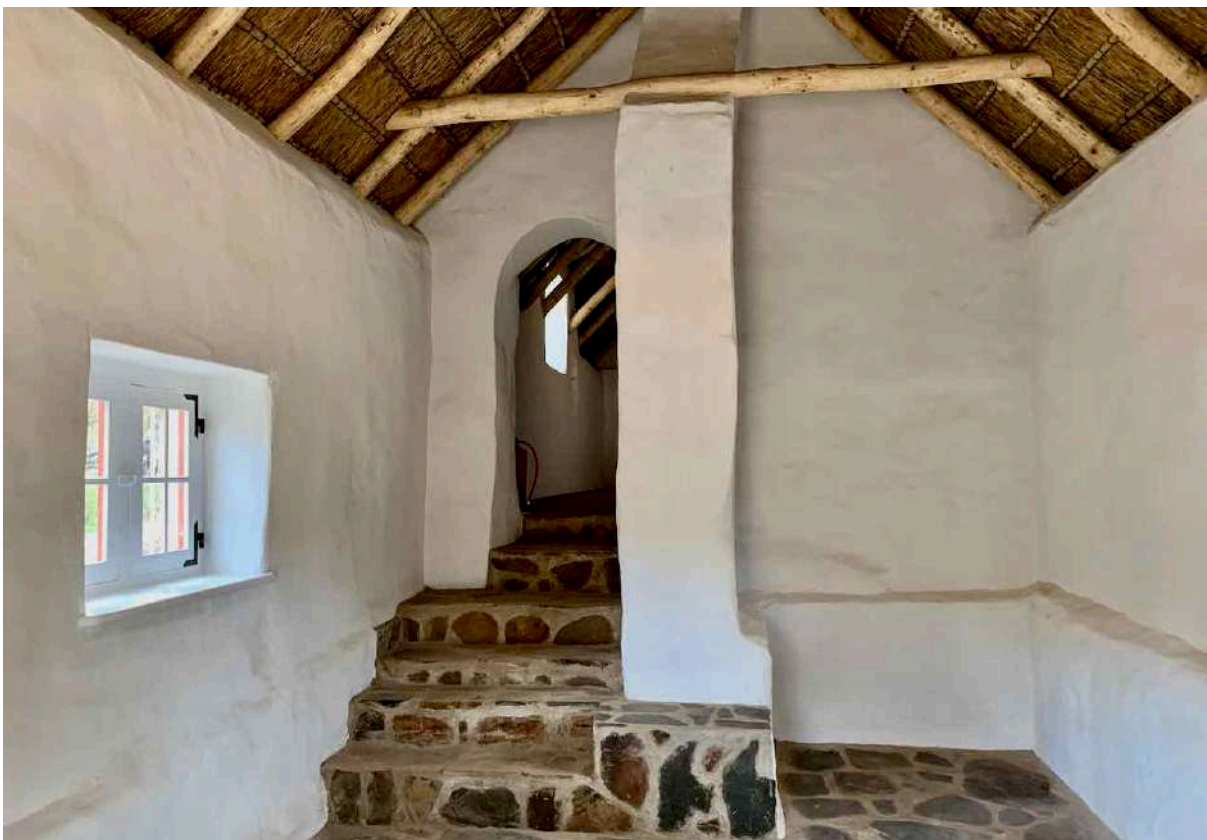
**FIGURE 22D:** *The forge area after restoration.* The forge was not reconstructed as the building is earmarked to be the new information centre for the town. The extra floor area was needed for office space. (Image: ARCON, 9 July 2020).

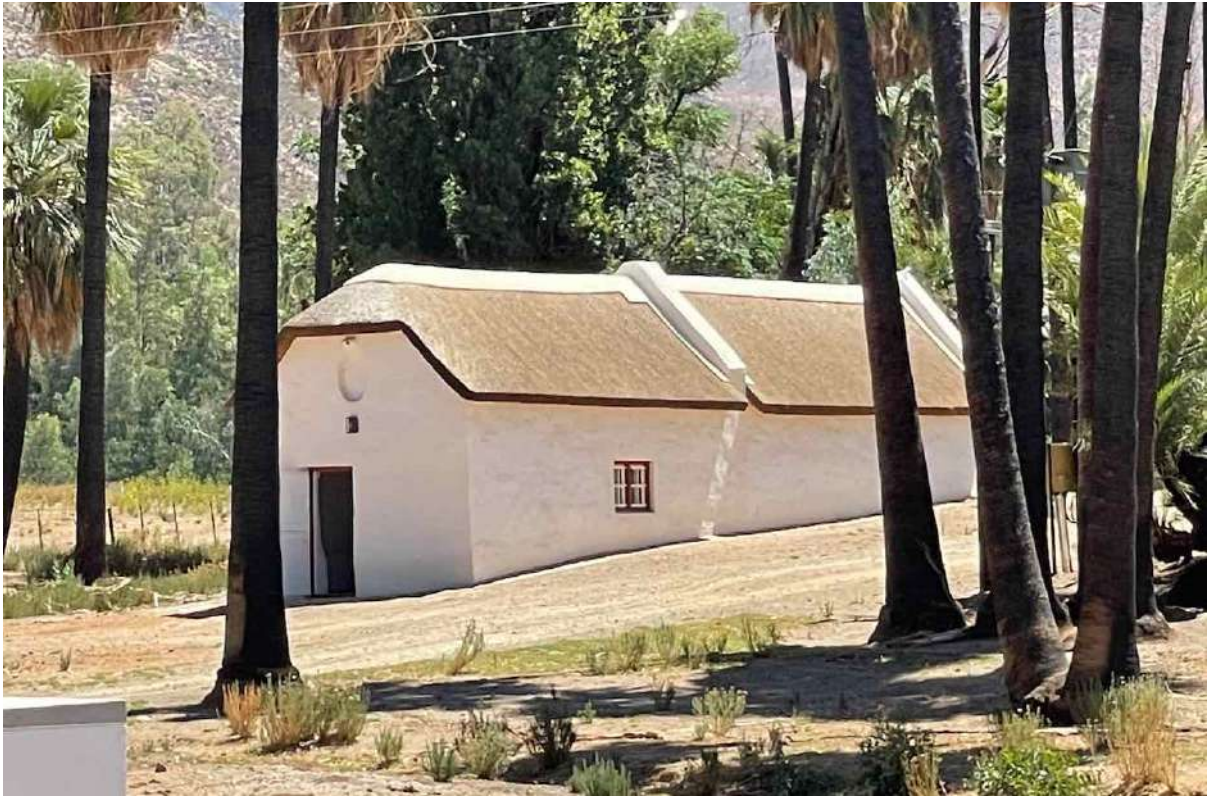
**FIGURE 22E:** *The Blacksmith's Shop after restoration.* (Image: ARCON, 23 February 2021).

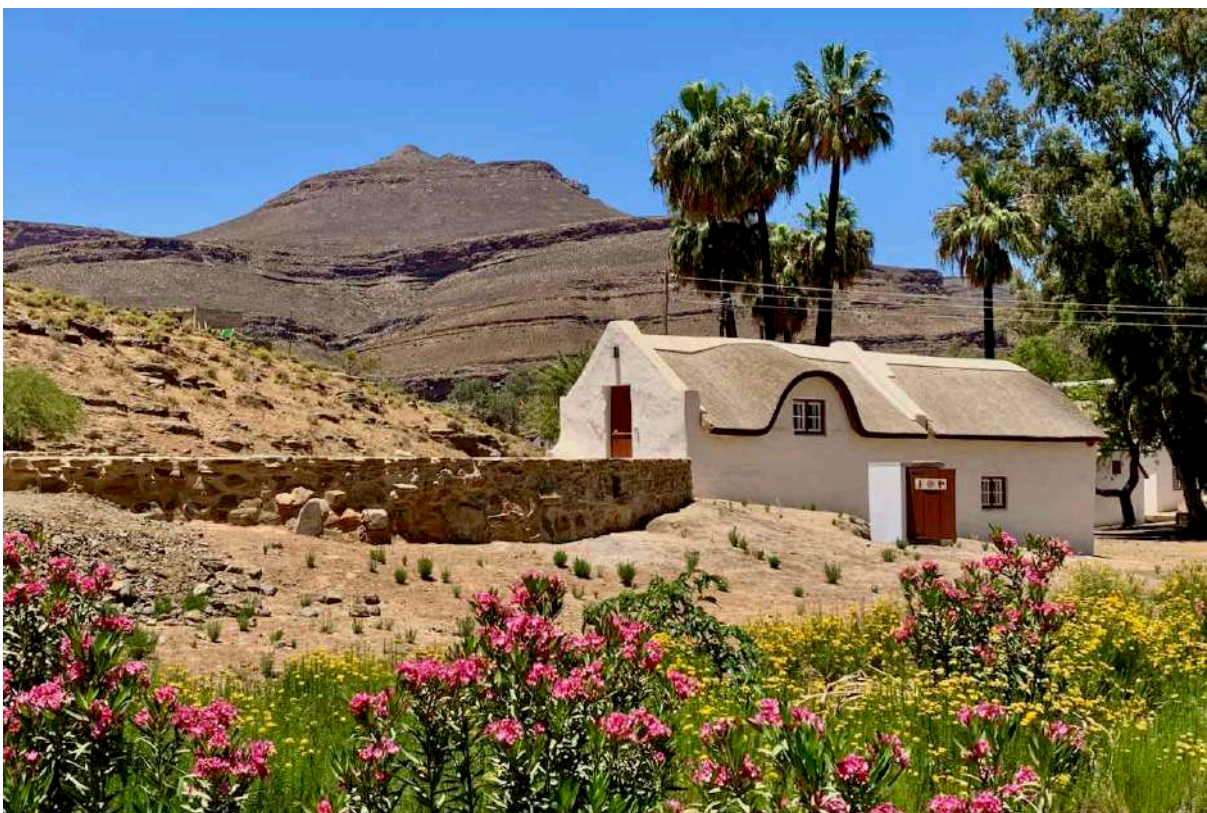
**FIGURE 22F:** *The Blacksmith's Shop with threshing floor on the left and a fire hydrant kiosk to its right. It was not initially intended to restore the threshing floor but it was in such bad condition that the Foundation agreed to include it in the program. The roof dormer is a new insert to provide natural light to an otherwise dark upper level after it was decided to use the building as the town's information centre.* (Image: ARCON, 23 February 2021).

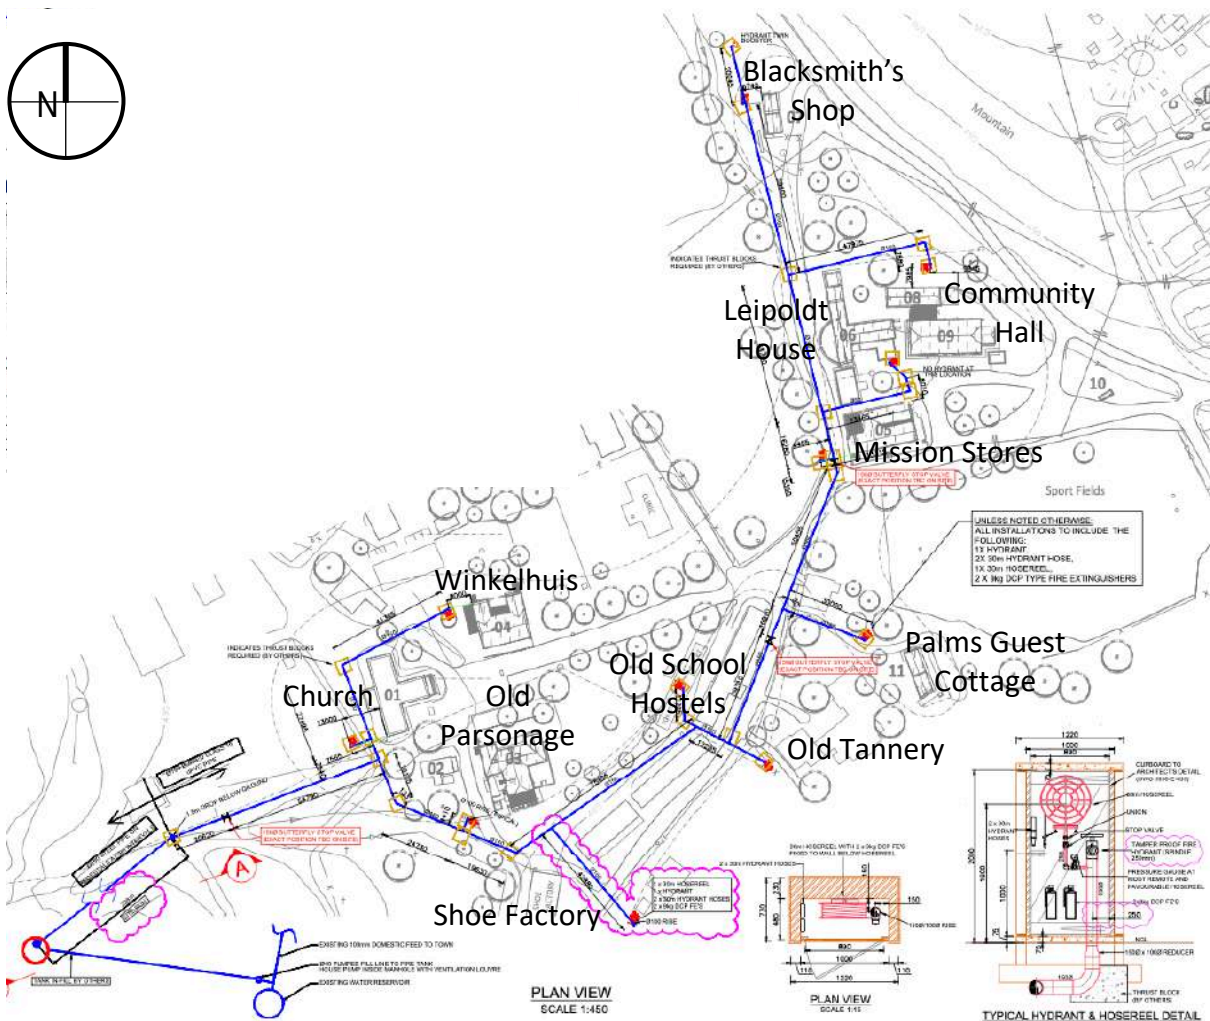
**FIGURE 23A:** Layout of the new fire hydrant reticulation system installed within the Wuppertal Church Precinct. (Image: SECURE FIRE, July 2019).

It would have been pointless to restore the town centre with thatch roofs without providing appropriate fire emergency systems. After much discussion with the project fire safety experts, it was decided to install a fully operational fire hydrant reticulation and electronic alarm system linked to fire sensors within the Church Precinct; all operated by local residents who underwent special training in firefighting and fire prevention as part of the project. This was considered better than installing thatch sprinkler systems due to their unreliability in strong winds.

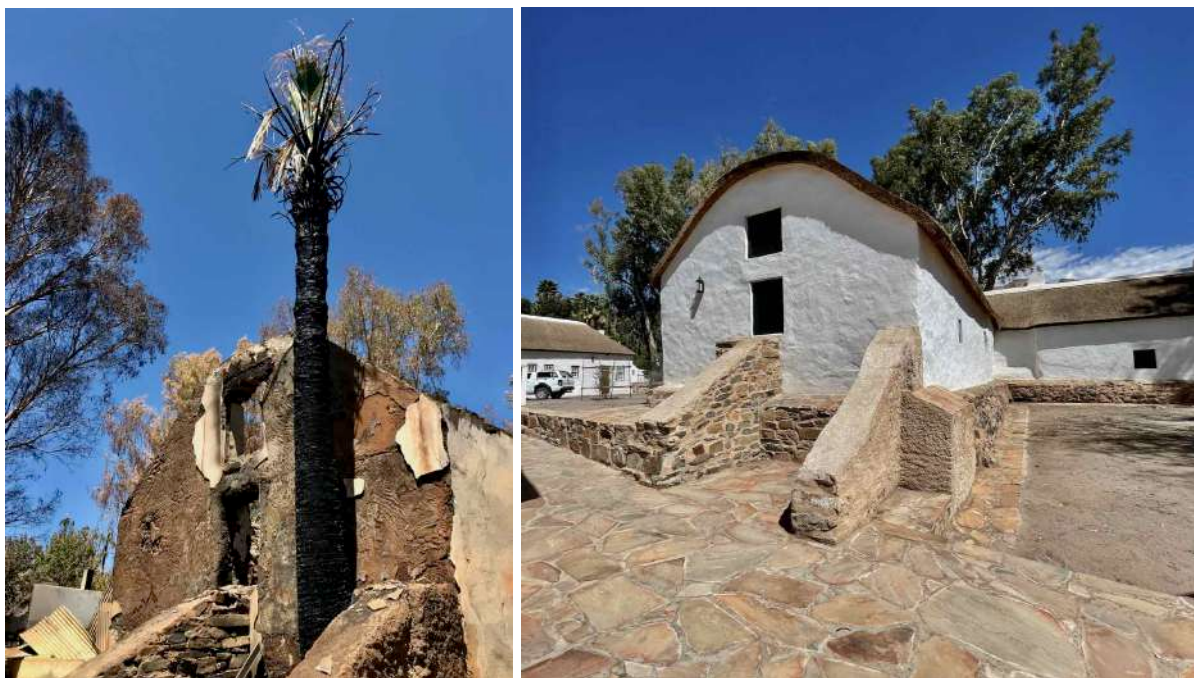
Trees, and especially palm trees, had played a significant role in spreading the fire in the strong wind that had prevailed on the day. As a future fire precaution, a number of these trees were removed with the approval of Heritage Western Cape (Wupperthal is a designated Heritage Area) while retaining the majority due to their strong role in defining the character of the Church Precinct.

**FIGURE 23B:** *Palms were likely the most instrumental in spreading the fire in the Church Precinct due to the aeration imparted by the shape of their fronds. Although palms strongly characterize the precinct, these and other trees close to the thatch buildings had to be removed as a precaution against the spreading of future fires. This example would have been at least partly responsible for the gutting of Leipoldt House. Its removal was debated at the time because of the risk its removal posed to the foundations of this historic building. Ultimately, it was removed and a small buttress constructed to reinforce the base of the wall in its place. (Images: ARCON, 24 February 2019 & 23 March 2021).*

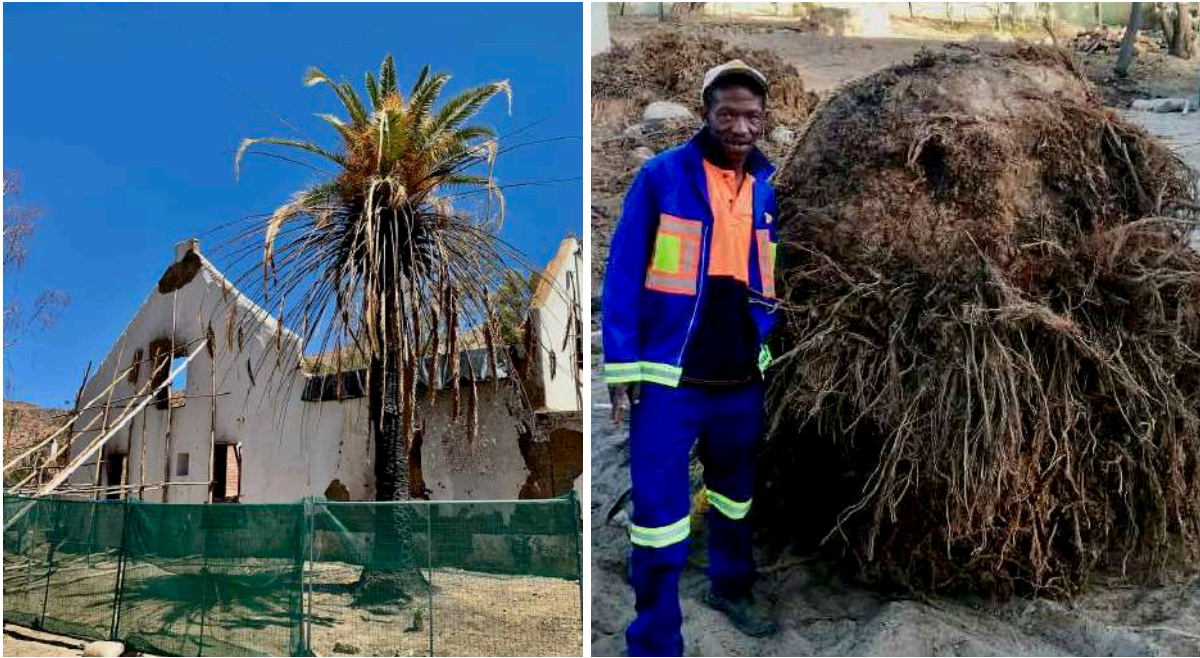
**FIGURE 23C:** *Left: A palm next to the Winkelhuis was another example of a tree removed for fire security reasons. This image also indicates the emergency propping installed shortly after the fire using locally available timber to prevent a gable collapse. Right: the size of the root bowl of the palm after its removal. (Images: ARCON, 24 February 2019 and 11 October 2019).*

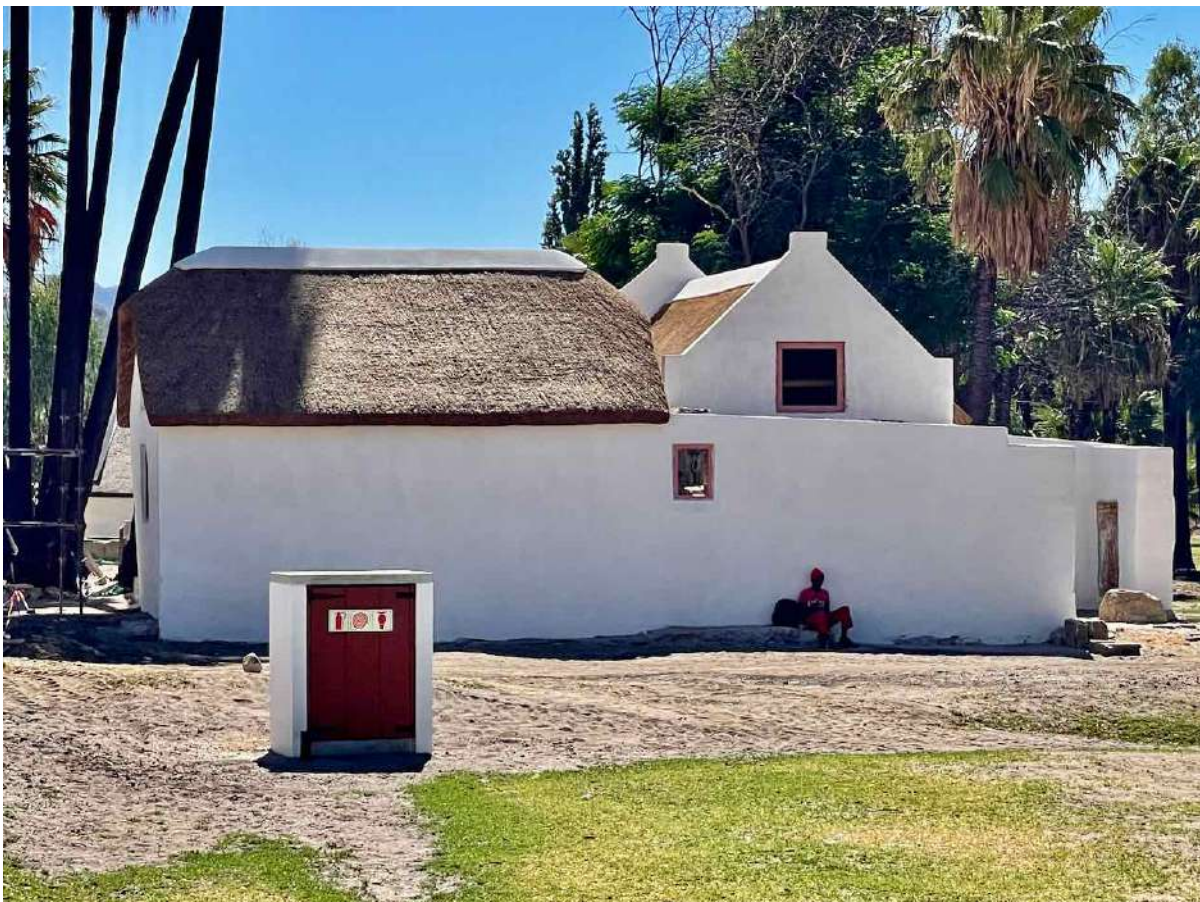
**FIGURE 23D:** *Typical example of a fire hydrant kiosk. These enclosures were scaled to respond to the simple architecture of the precinct while being as visually unobtrusive as possible. (Image: ARCON, 23 February 2021).*

A separate water tank dedicated to supplying the new fire hydrant system was installed behind an outcrop on the mountainside above the town. This made it invisible from within the Church Precinct, while a stone embankment was constructed to camouflage the new tank from scenic outlooks from the mountain pass approaching the town. Trenching for the hydrant system had, of course, to undergo archaeological scrutiny prior to its laying, while hose reel kiosks were specially located and scaled to minimize visual impacts on the Precinct.

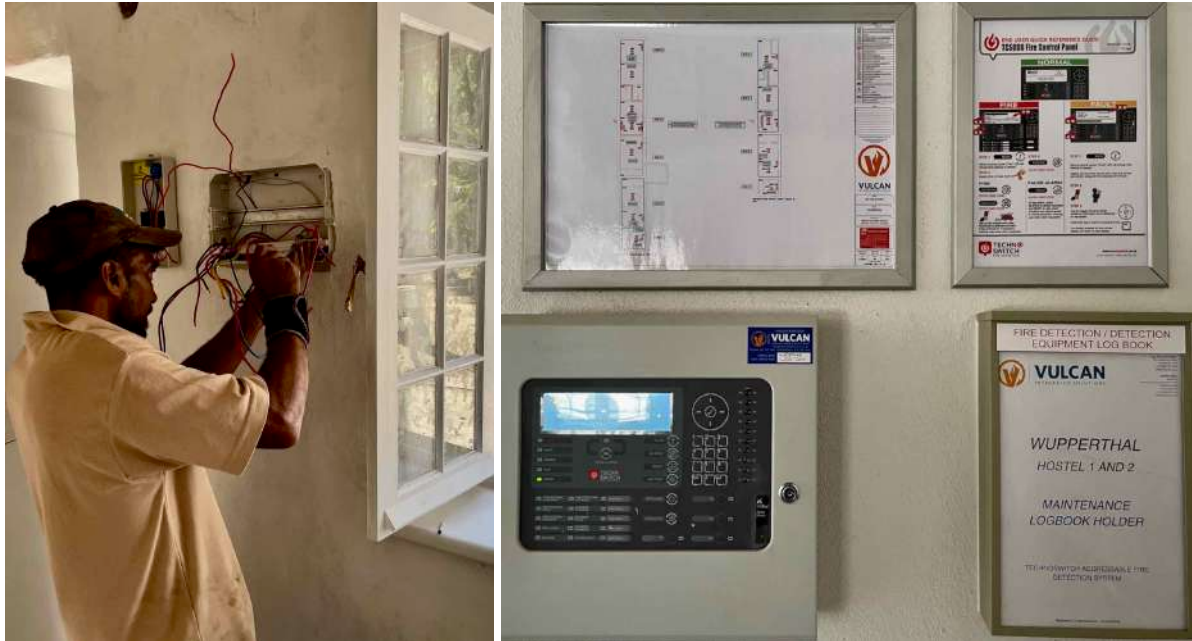
**FIGURE 23E:** *New fire sensor and alarm systems were installed in all of the restored buildings. Prior to the fire, the only alarm system in the settlement had been the church bell. (Images: ARCON, 7 April 2021).*

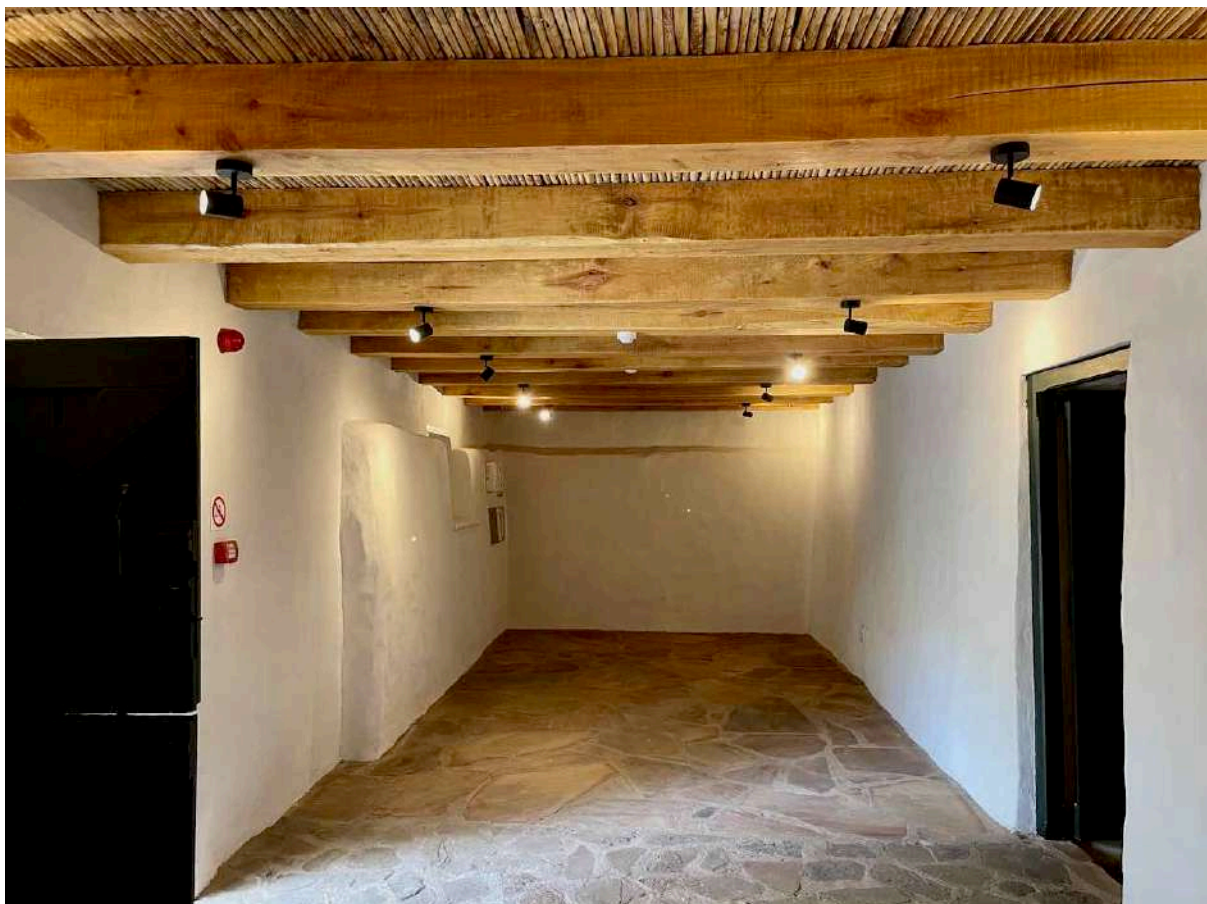
**FIGURE 23F:** *New fire alarm system in Leipoldt House. The panic button and red alarm light are next to the front door (left) with the control panels at the left far end. Smoke detectors are mounted to the underside of new rafters supporting a new brandsolder and reed ceiling. (Images: ARCON, 8 June 2021).*

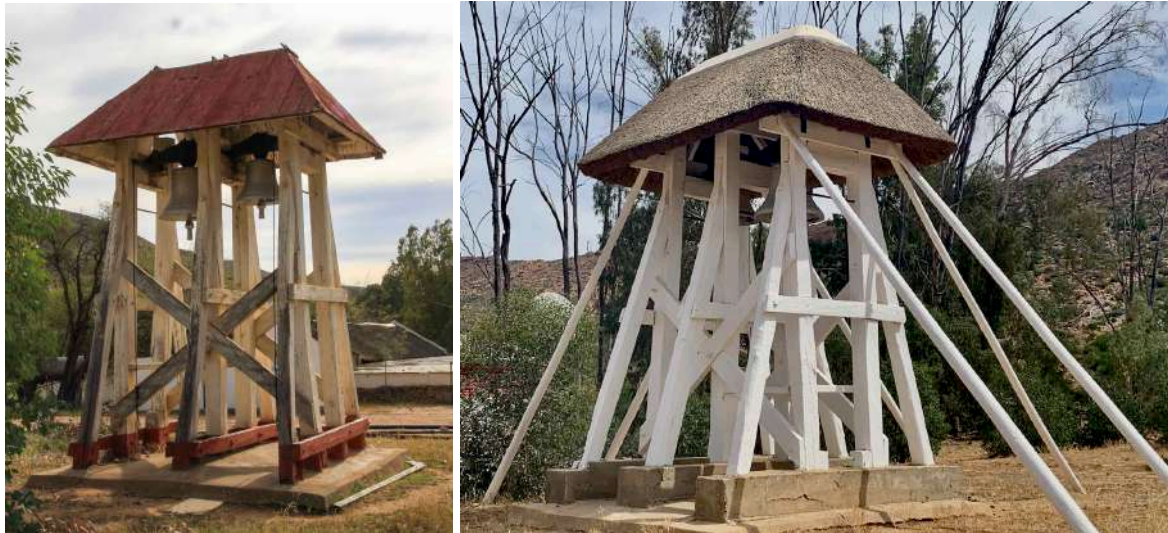
Due to the poor condition of the timber framed campanile and adjacent church ablution block it was decided to repair and refurbish these structures to bring them in line with the fire damaged buildings that were being restored.

**FIGURE 24A:** *The campanile behind the church. Left: before refurbishment. Right: the campanile after refurbishment. The stays had been added by the locals at some stage after the 2009 photograph on the left and did not form part of the restoration project. (Image left: Gabriel Fagan Architects, 22 September 2009; right: ARCON, 27 October 2020).*

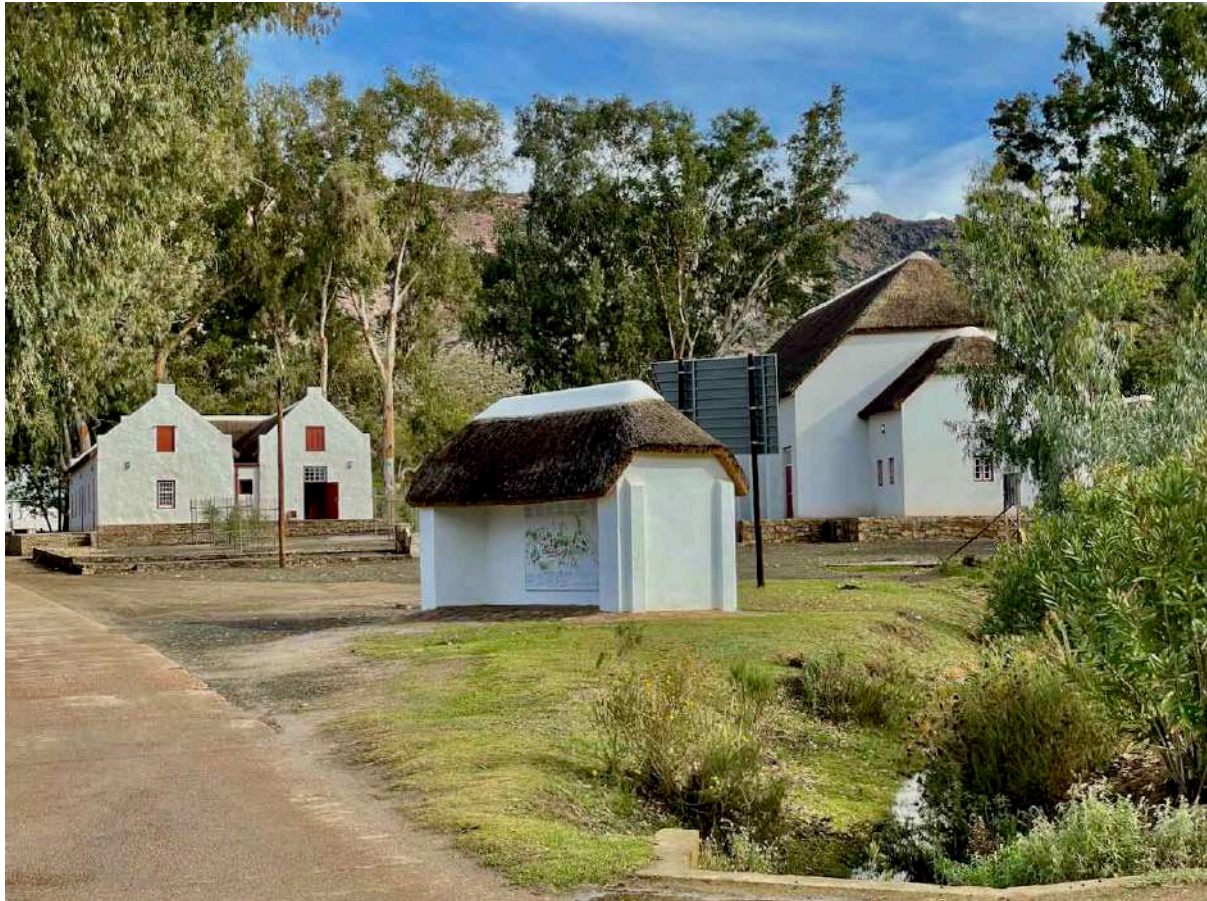
The information kiosk was another structure that was not damaged in the fire but was in need of upgrading. The work included re-thatching and the installation of two specially commissioned information boards for visitors.

**FIGURE 25A:** *The refurbished visitor information kiosk in the foreground with the Mission Stores building behind on the left and the Community Hall on the right. (Image ARCON, 27 October 2020).*

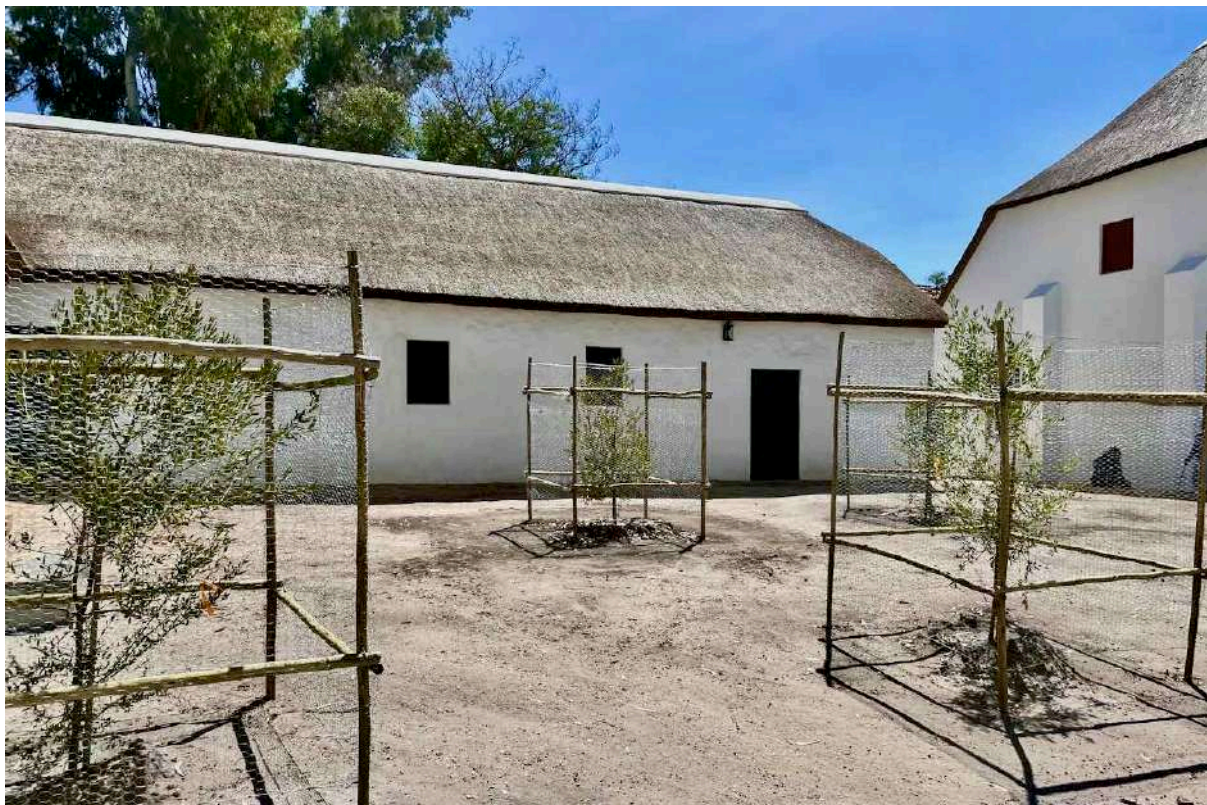
**FIGURE 26A:** *Simple new landscaping in the reclaimed open space after the demolition of a derelict café building between Leipoldt House and the Mission Stores. The tree enclosures comprise hand cut local laths and diamond mesh fencing to keep wandering donkeys at bay. The rear wing of Leipoldt House is in the background. (Image ARCON, 27 October 2020).*

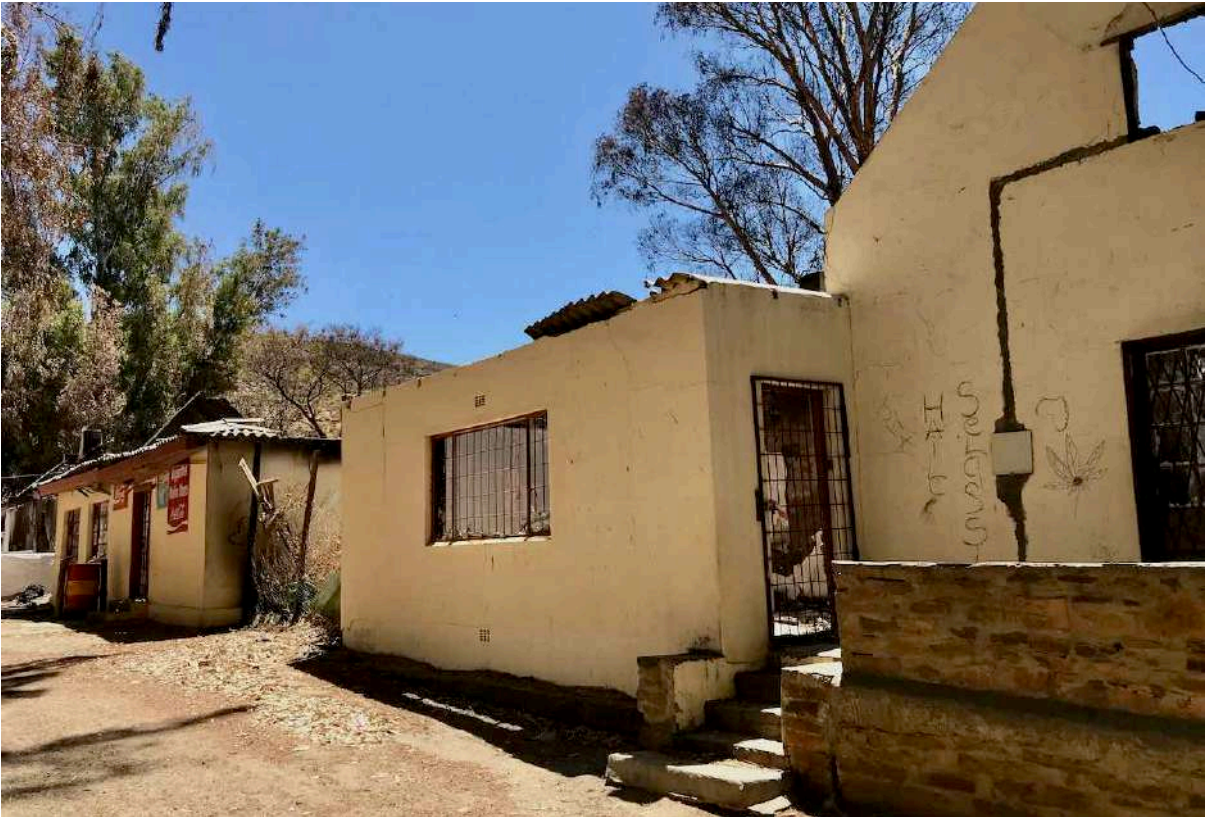
**FIGURE 26B:** *The western end of the Mission Stores with flat roofed kitchen extension (center) and the derelict café building on the far left. (Image ARCON, 24 February 2019).*

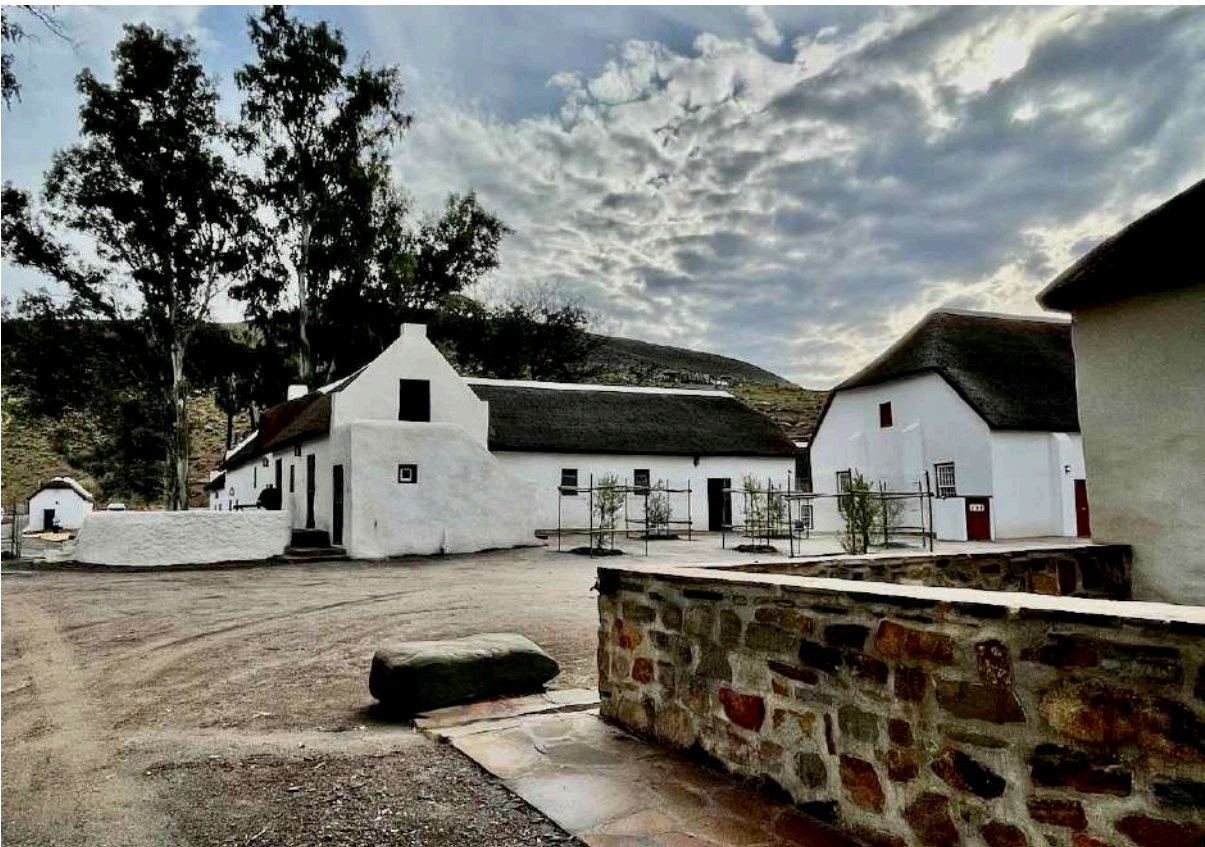
**FIGURE 26C:** *The same view but with the kitchen extension and derelict café now removed, reclaiming the open space between the mission Stores and Leipoldt House. (Image ARCON, 8 June 2021).*

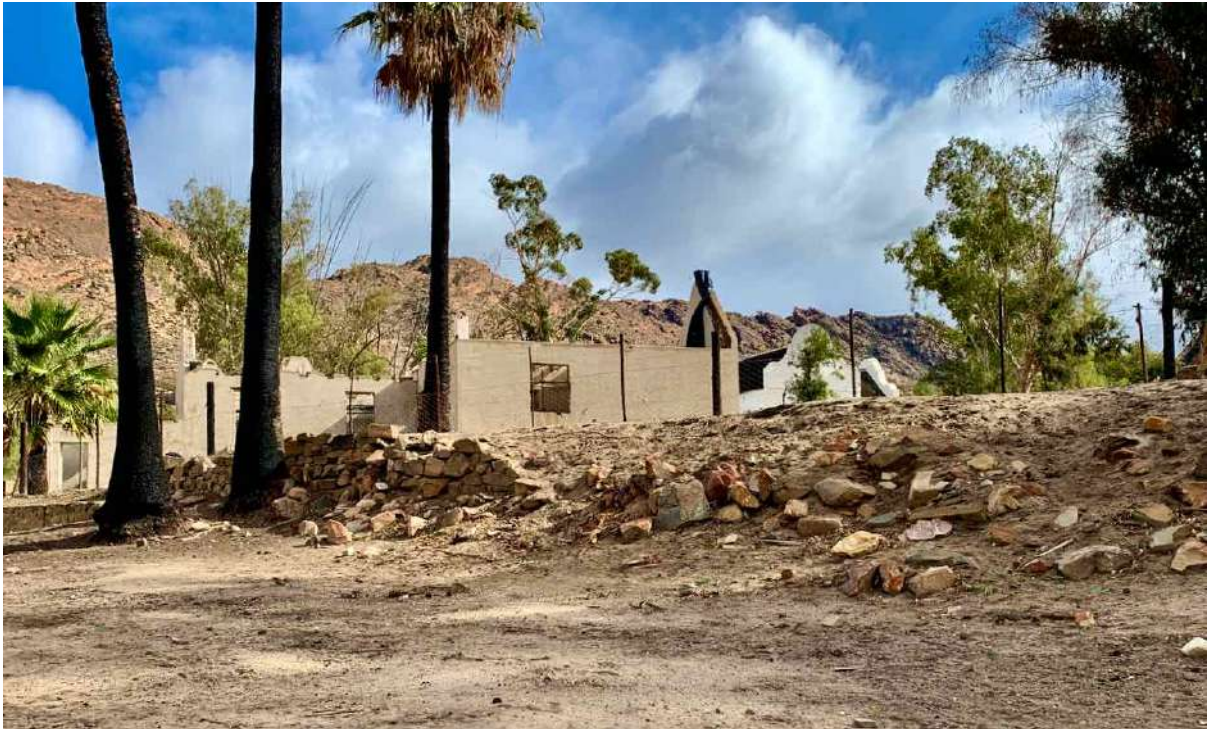
**FIGURE 26D:** *The stone retaining wall in very poor condition behind the Hostel Buildings. The Old Parsonage is left of center with the Church to the right of center beyond. (Image ARCON, 26 May 2020).*

It therefore wasn't long after the decision to add the hostels to the restoration program that it was realized that a logical extension of that work would be to repair the seriously deteriorated retaining walls behind these buildings. That was followed by a decision to repair the stone walls along the approach to the church and landscape the re-opened space between the Mission Stores and Leipoldt House. This space was created after demolishing a derelict, poorly built latter 20<sup>th</sup> C café building constructed out of cement blocks alongside Leipoldt House. After much discussion, it was decided, with the support of the Moravian Church, to plant olive trees in a part of the reclaimed open space and in the large, uncultivated area to the east of the Old Parsonage. The purpose was to keep the design very simple and in keeping with the biblically rustic quality of the area.

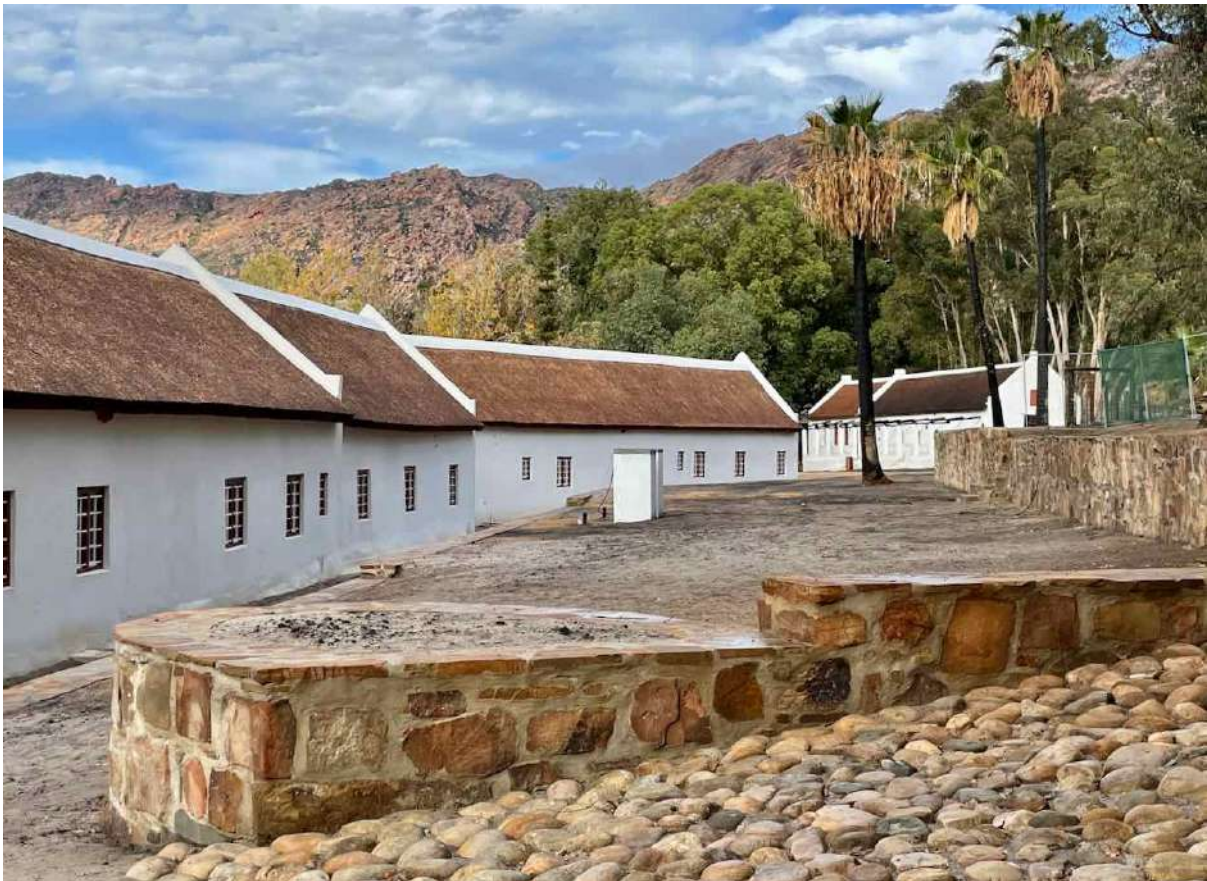
**FIGURE 26F:** *Reconstructed stone walls behind the restored Hostel Buildings (left). The Shoe Factory is in the background to the right.* (Image ARCON, 8 June 2021).

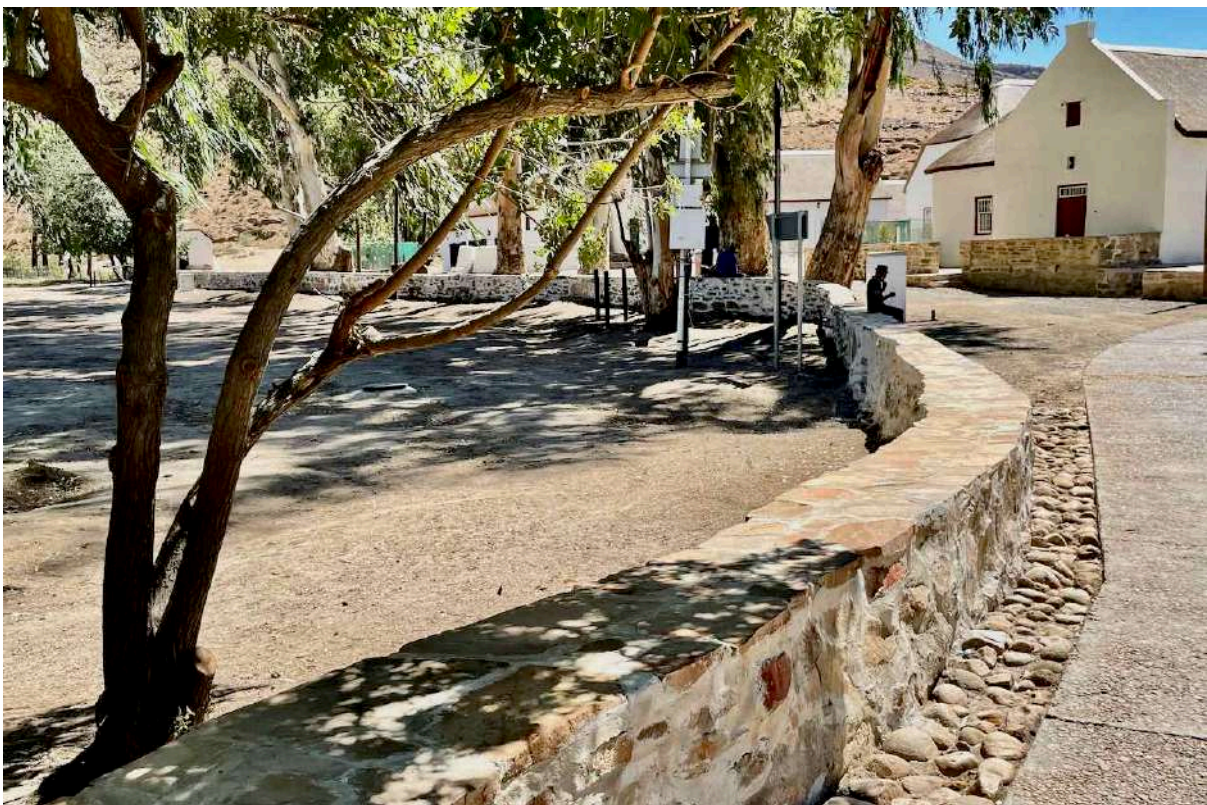
**FIGURE 26G:** *Reconstructed stone wall along the roadway between the Church and Mission Stores.* (Image ARCON, 23 February 2021).

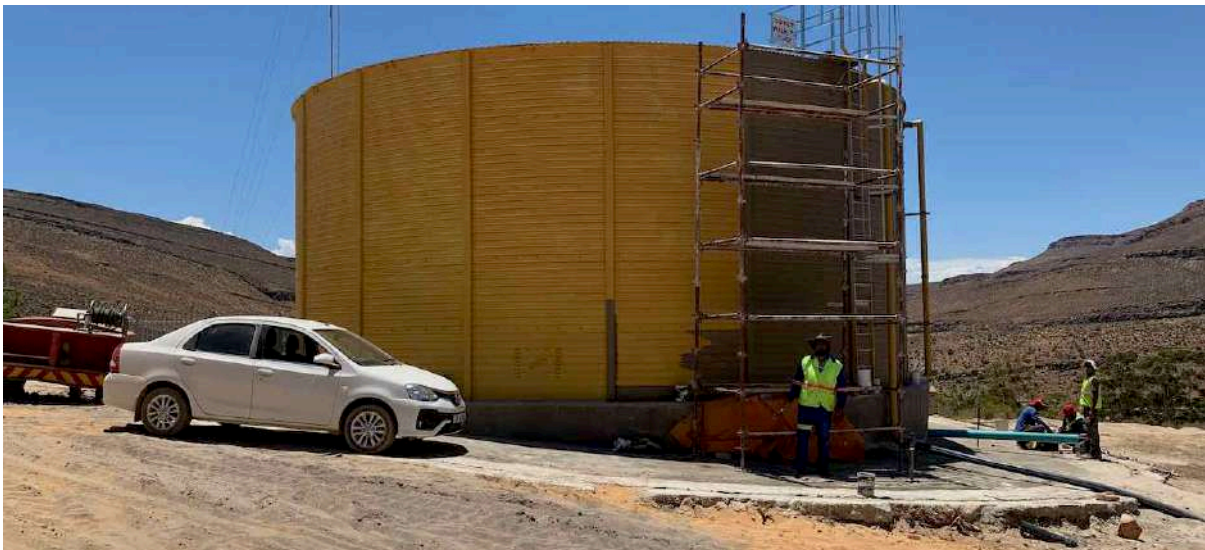
Before the fire, potable water for the town was stored in a reservoir on the hillside which was supplied from a stream approximately 3km away and then gravity fed to the settlement. This is pure, untreated mountain water. The elevation of the old cement reservoir was insufficient for supplying water to the top tier of dwellings in the residential area on the opposite side of the valley.

A further shortcoming was that the capacity of the old reservoir was only adequate for supplying the town with water for 24 hours in the event of a supply interruption. A 24 hour water reserve is half the statutory minimum capacity required. The Foundation therefore decided to fund a new reservoir of double the capacity of the old, and at a greater elevation to the old water storage facility. The improvements enabled all residents of Wupperthal to receive running water in their homes, many for the first time.

**FIGURE 27A:** *The new reservoir funded by the Foundation nearing completion.* (Image ARCON, 14 January 2021).

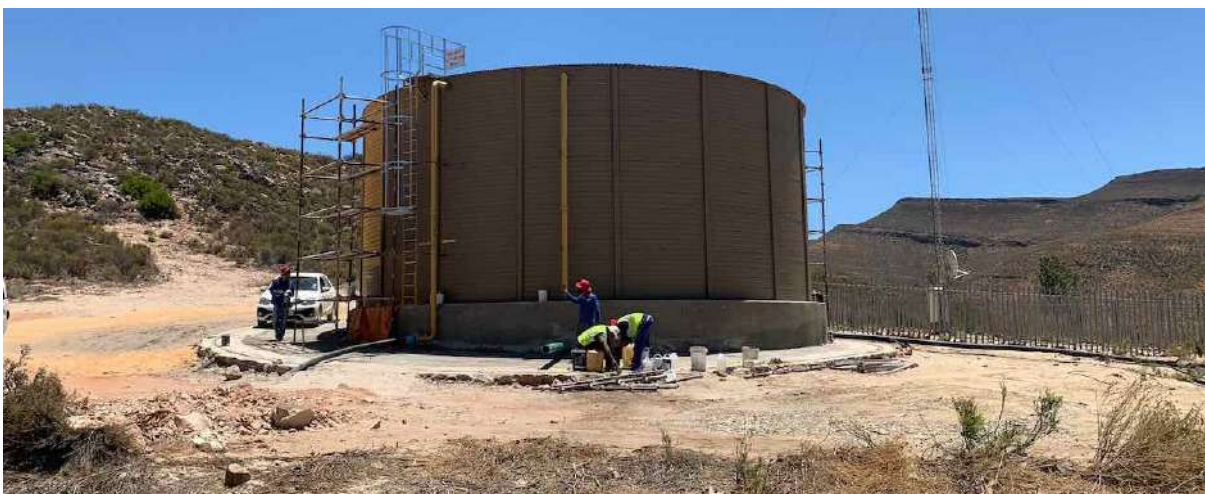
**FIGURE 27B:** *The new reservoir painted to match the surrounding mountainsides but is in any case largely obscured from the Church Precinct below.* (Image ARCON, 14 January 2021).

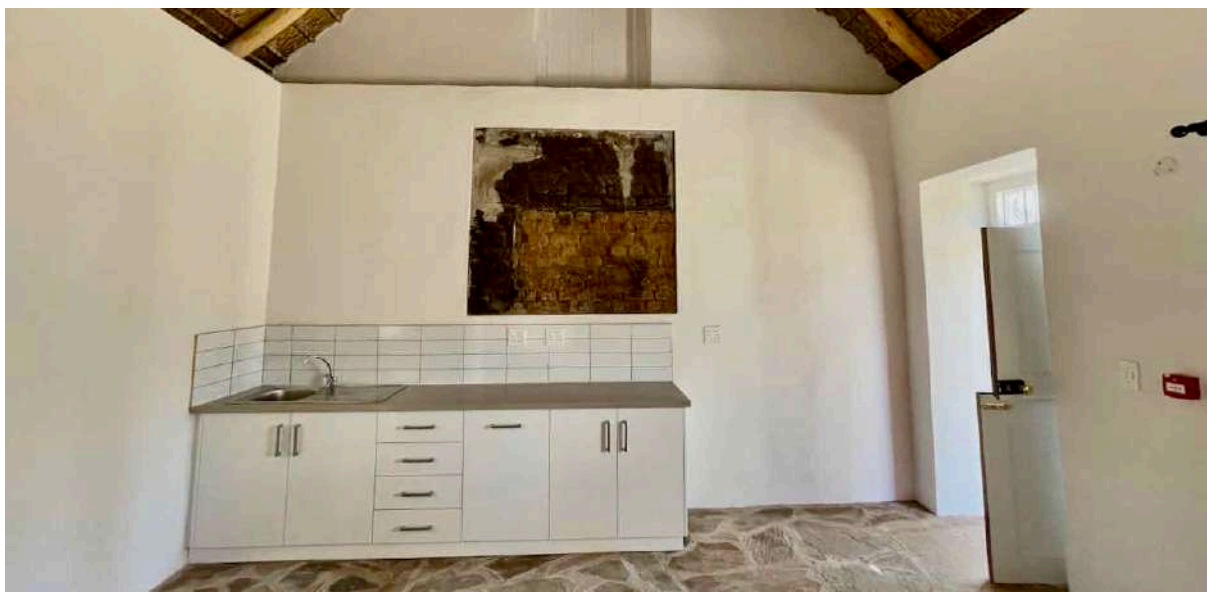
**FIGURE 28B:** *Masonry panel left un-plastered and treated with a special breathable fixative to prevent it from dusting. This panel shows three periods of construction with a partly charred lintel from the fire still in place. This image was taken before the interpretive plaque was fixed to the wall. (Image ARCON, 14 January 2021).*
