# HARNESSING HERITAGE TO EMPOWER PEOPLE IN THE WAKE OF DISASTER

The rescue restoration of the  
historic town centre of Wupperthal Mission Station  
Cedarberg, South Africa  
2019-2021

Graham Jacobs

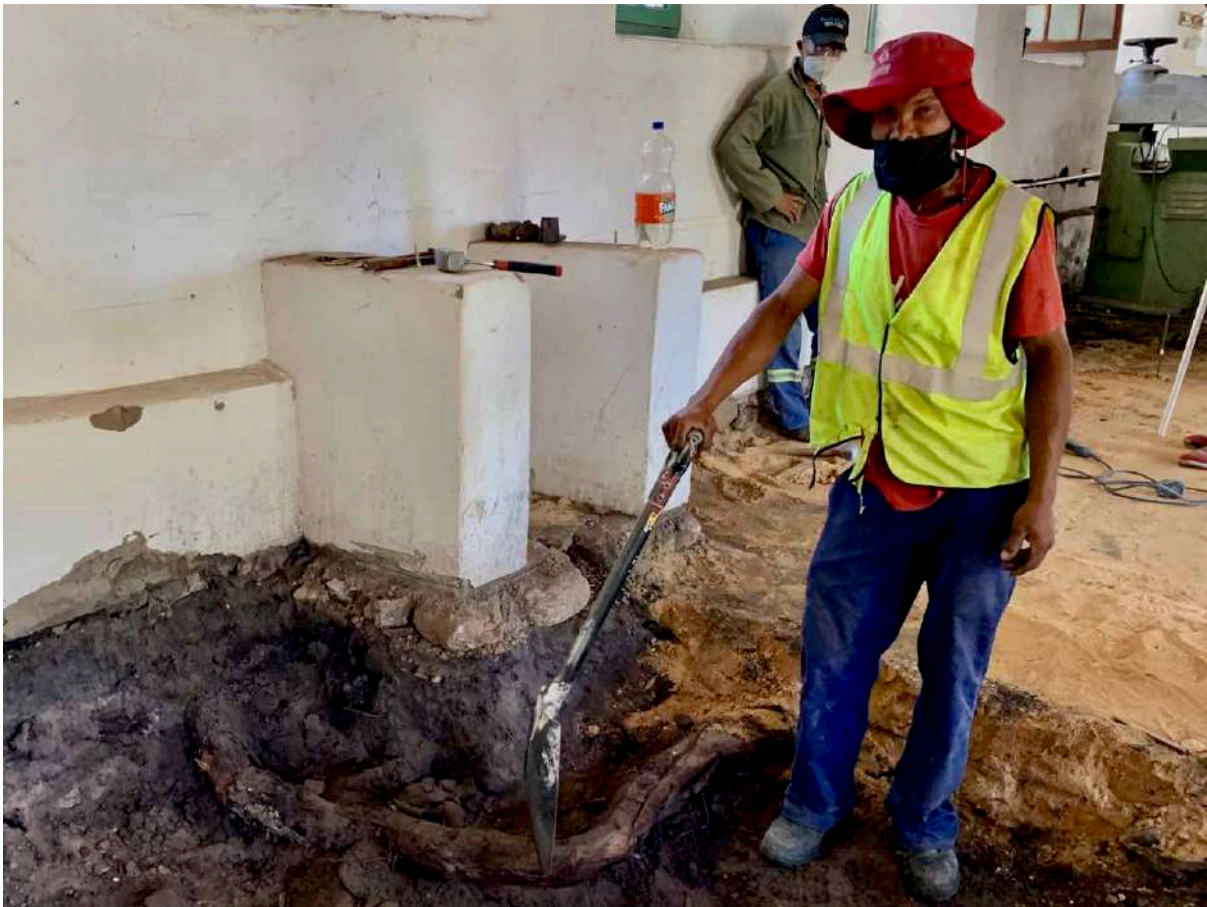
27 November 2020: Removing a massive tree root under the Shoe Factory floor.

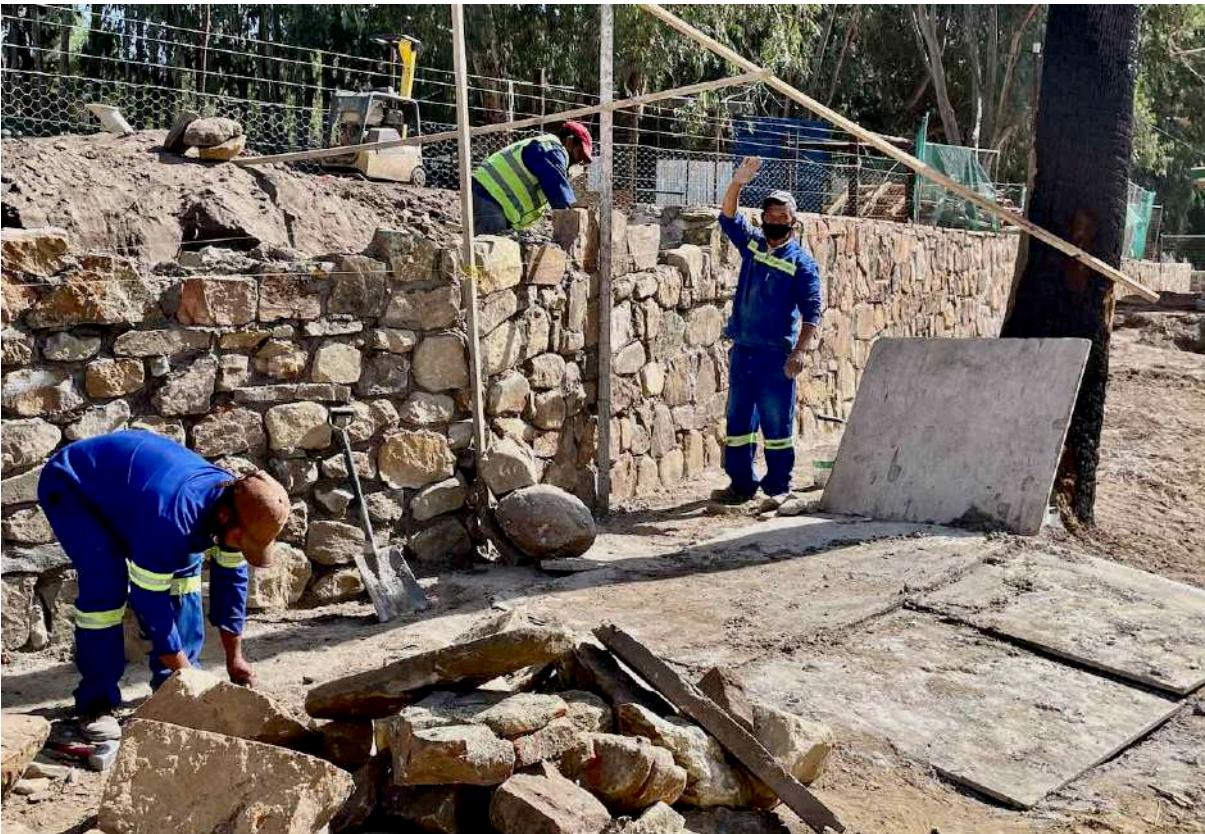
9 March 2021: Reconstructing the retaining walls behind the School Hostels.

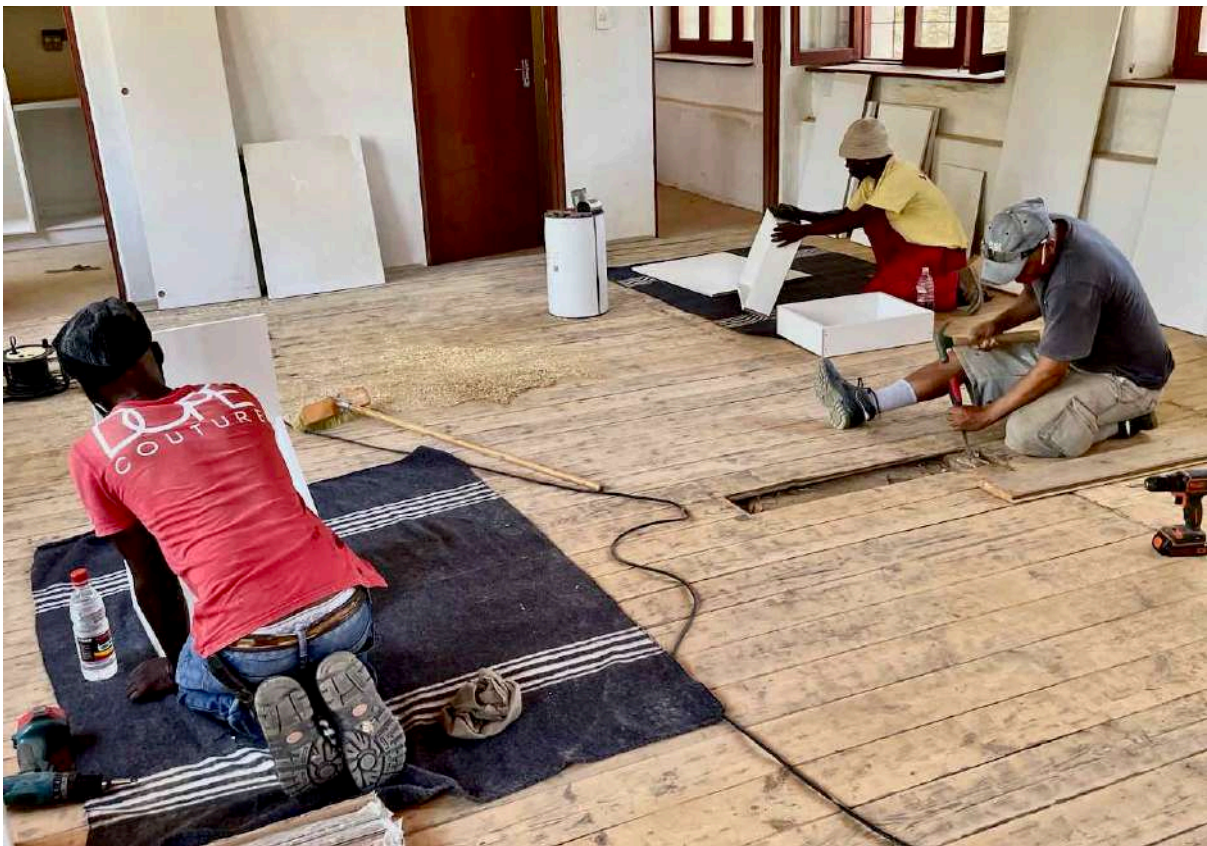
23 March 2021: Repairing the floor in the new Shoe Factory shop space.

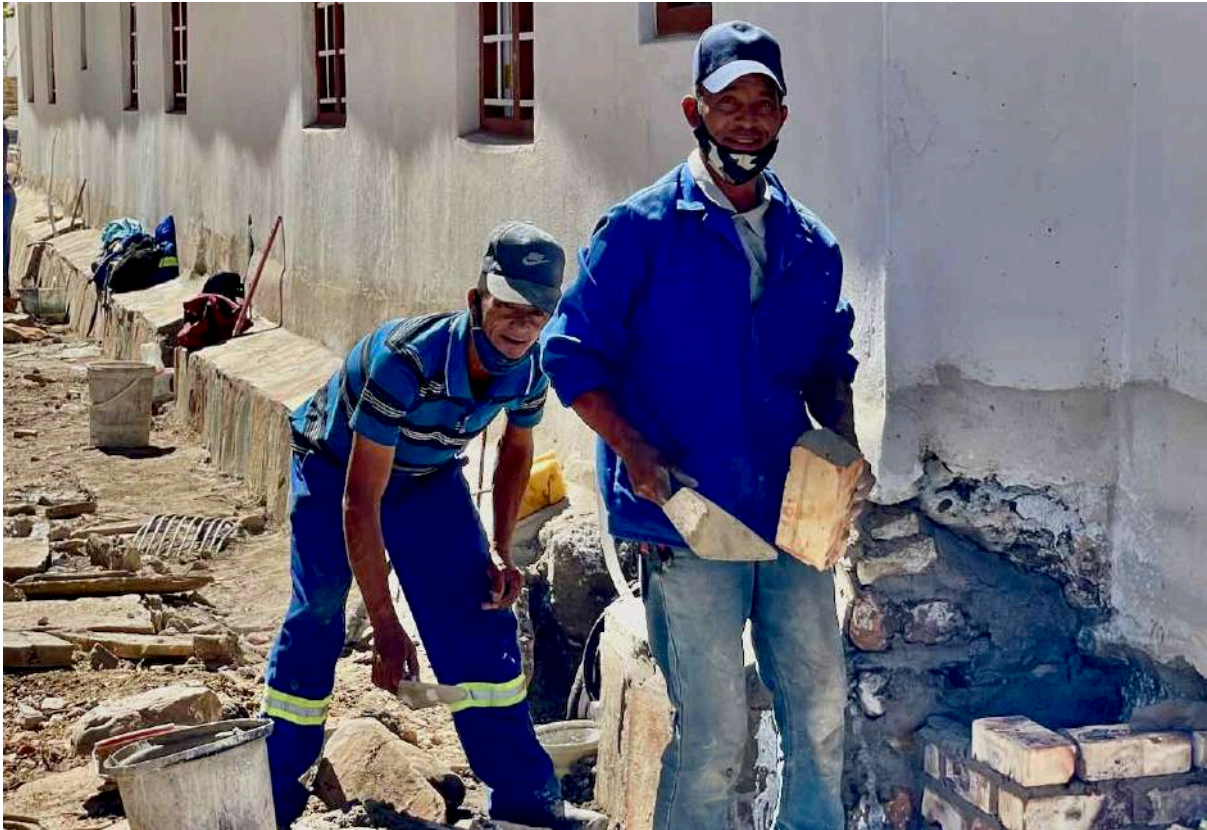
7 April 2021: Wall repairs at the back of one of the School Hostel buildings.
